To:	Amy Driessen	From:	Leslie Cho and Xiteng Liu
	Transportation and Economic Corridors		Stantec Consulting Ltd.
File:	123315222	Date:	June 18, 2024

Reference: North Central Region, Edson, Site NC059 - Highway 43:16 Little Paddle River Slide, Spring 2024 Instrumentation Monitoring Report

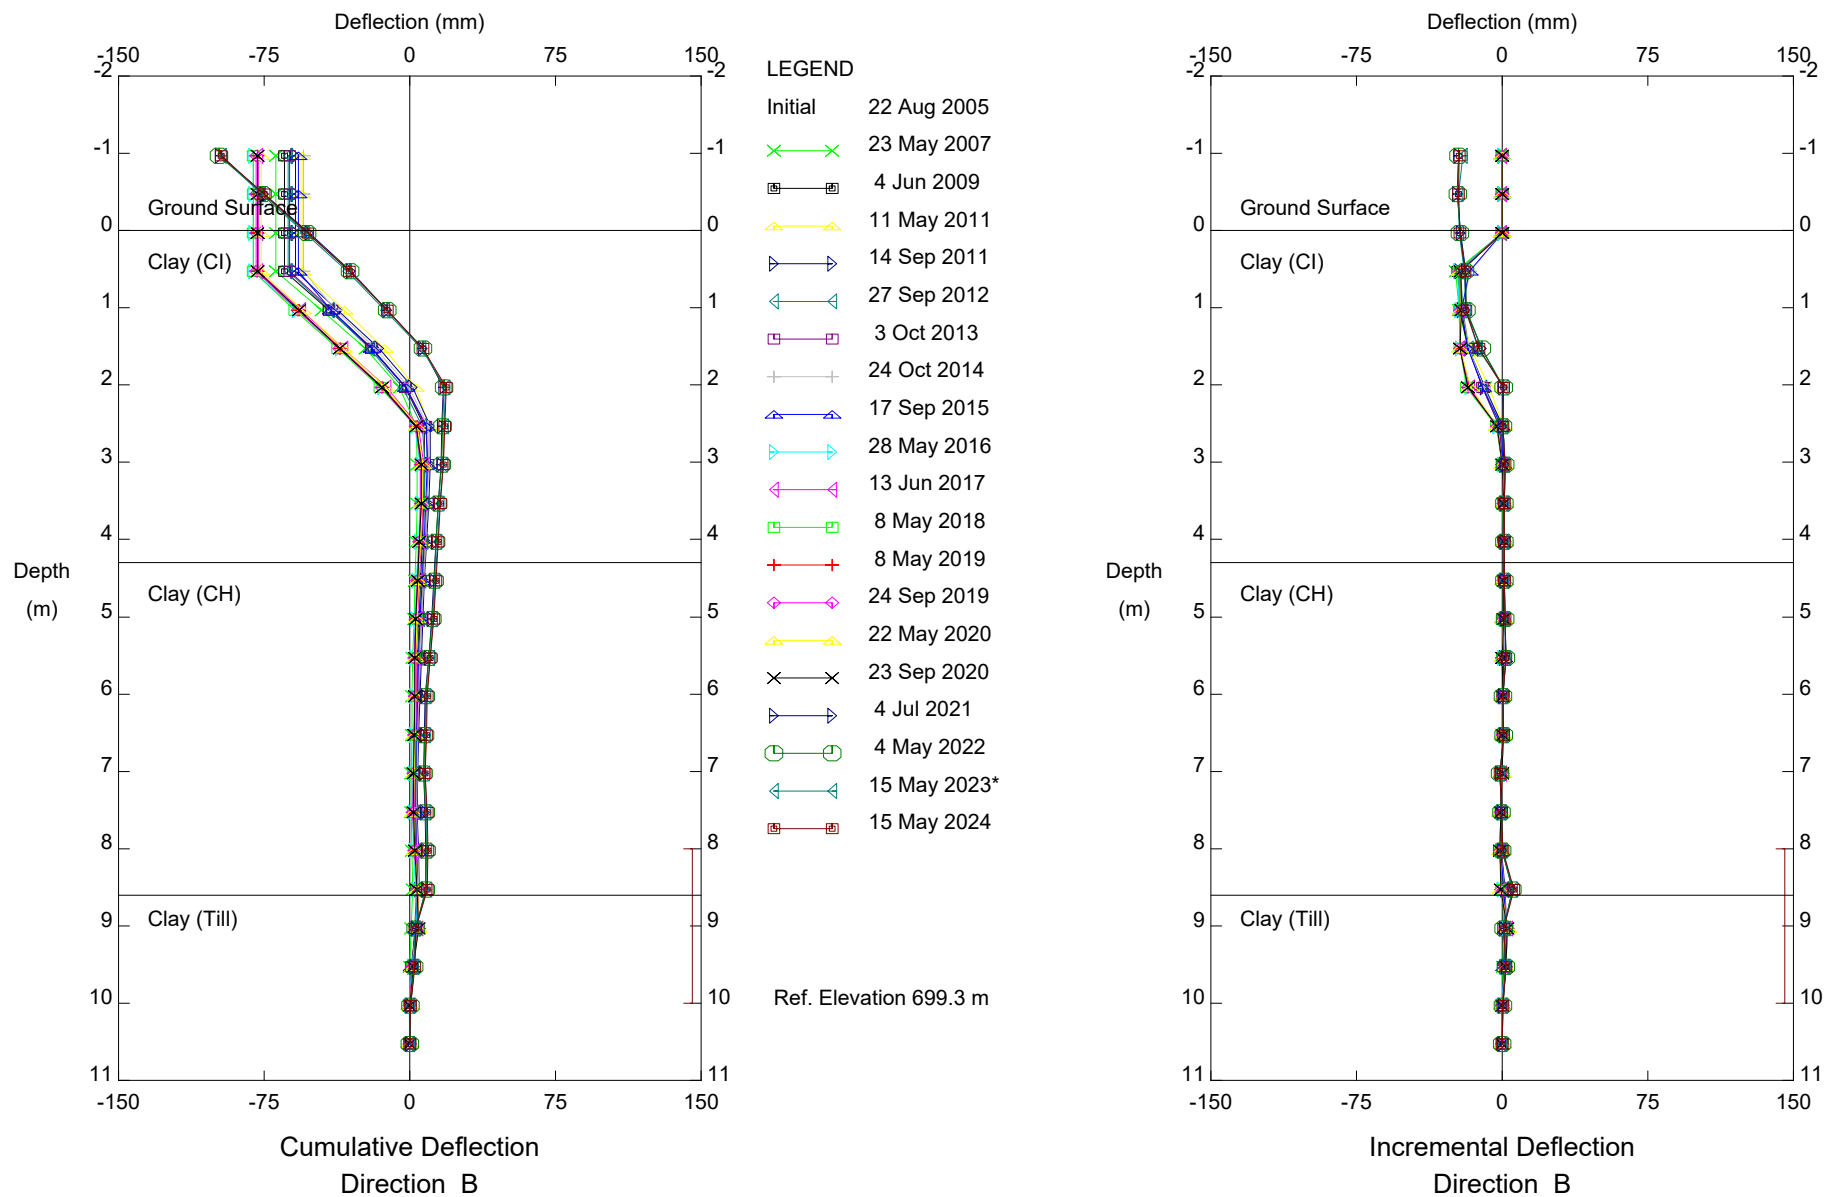
HWY 43:16 Little Paddle River (NC59), Inclinometer SI05-20

SI05-20 has been relatively steady since 2010 with an overall rate of movement of about 1 mm/yr.

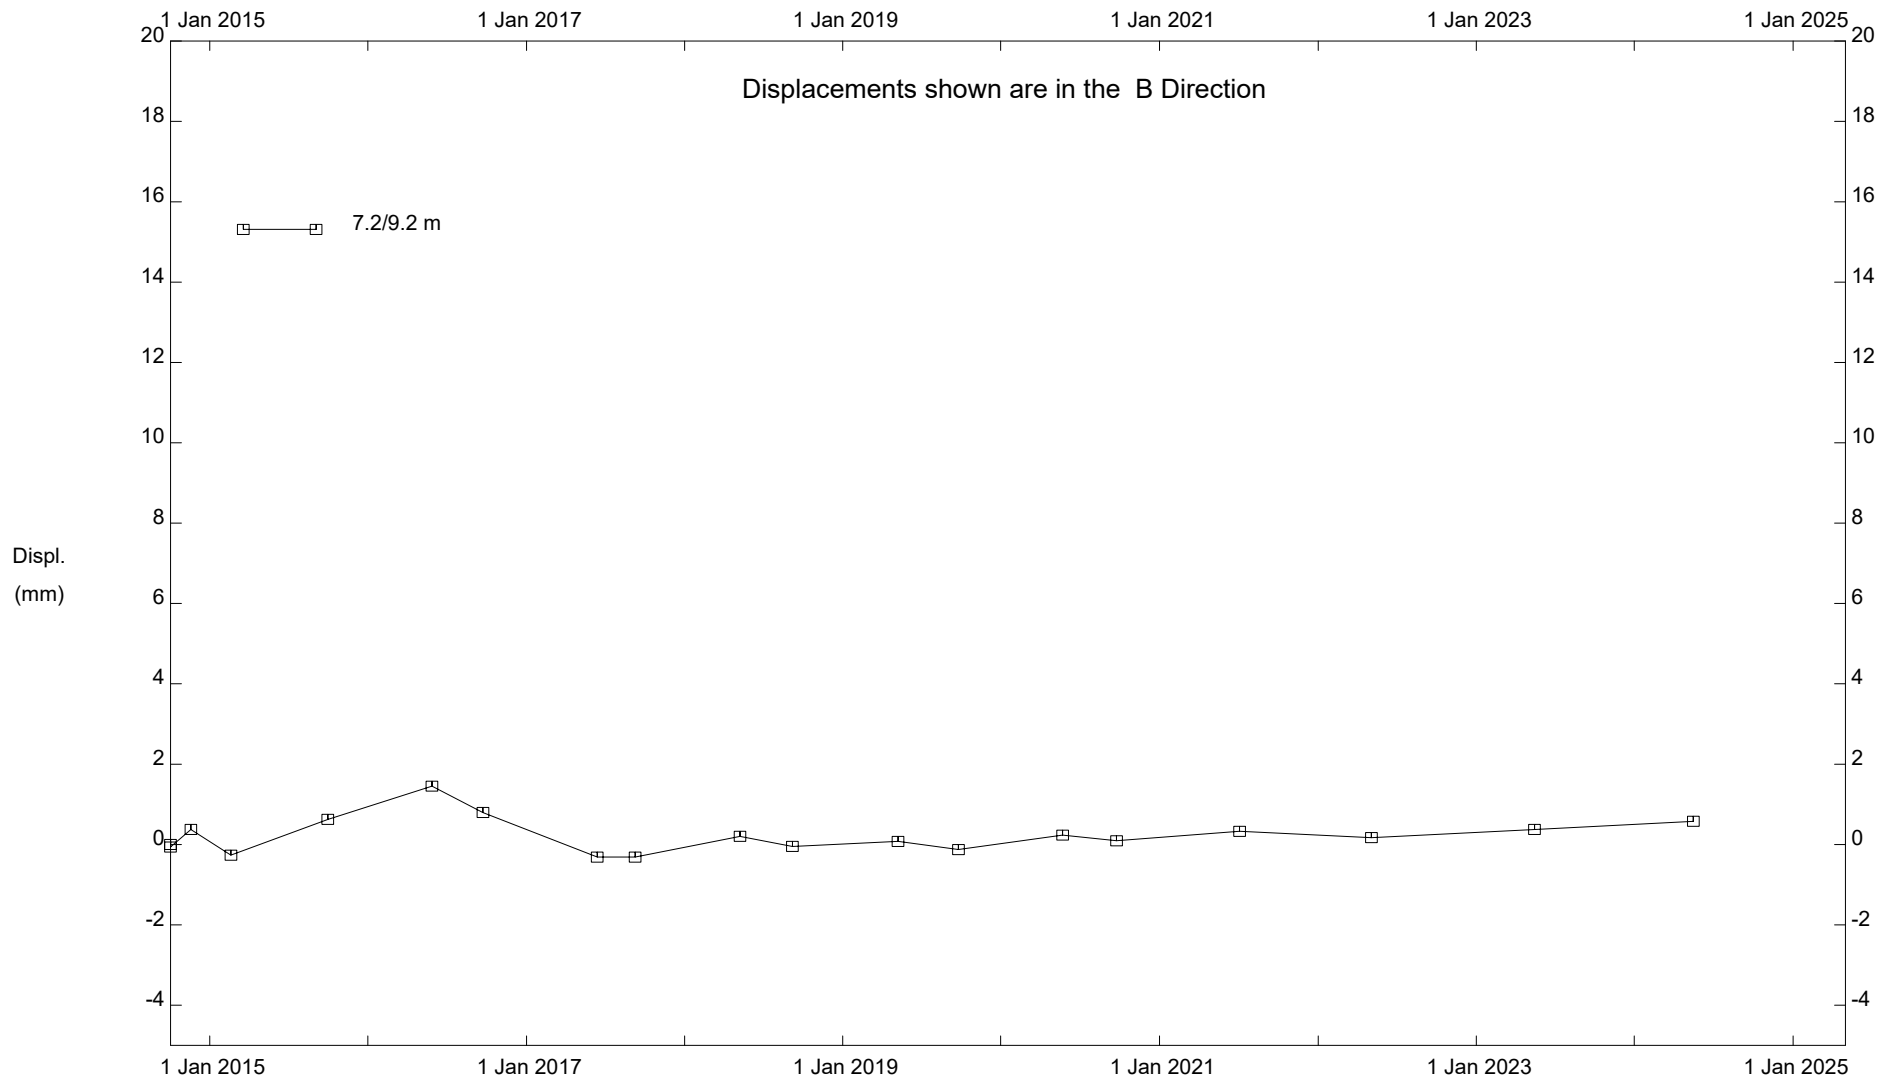
Hwy 43:16 Little Paddle River (NC59), Inclinometer SI14-27

SI14-27 has a current rate of movement of about 2 mm/year with cumulative movement of about 12 mm.

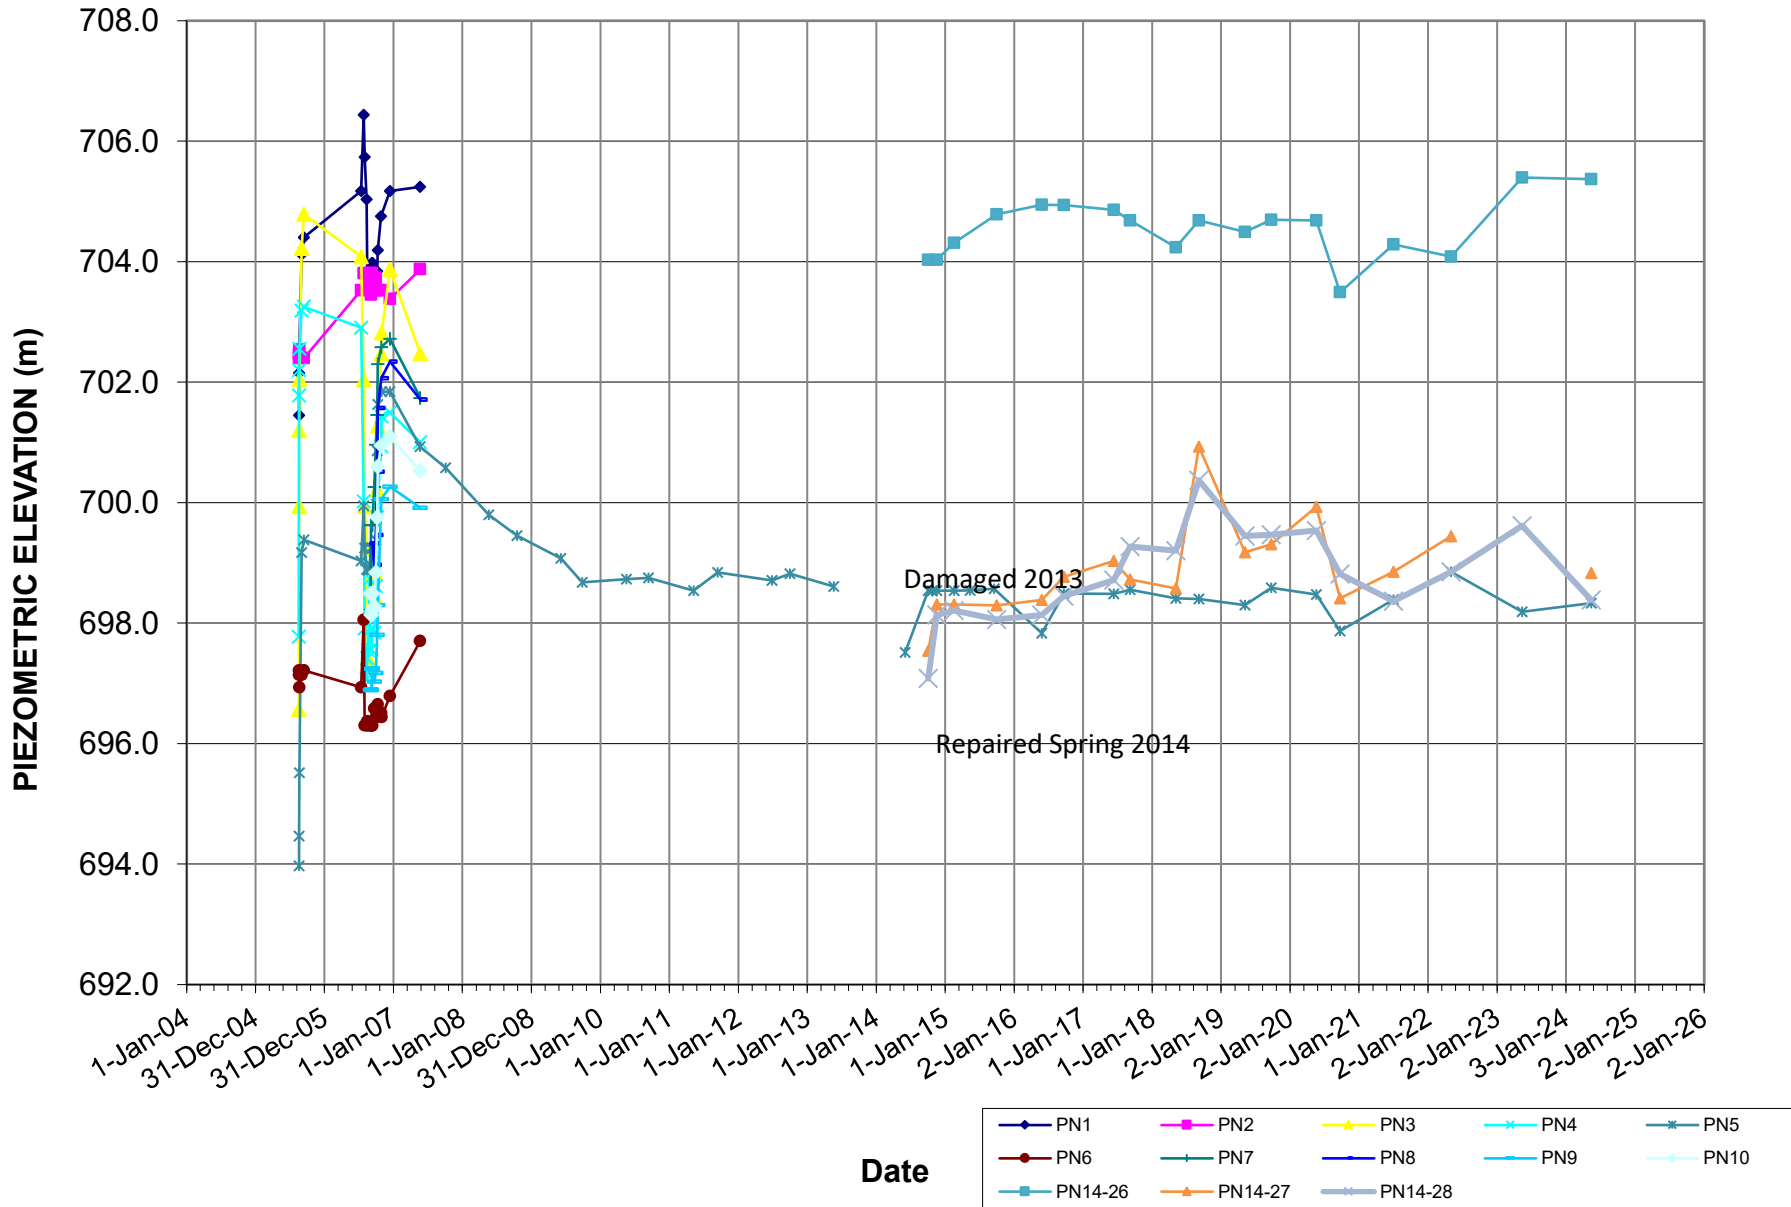
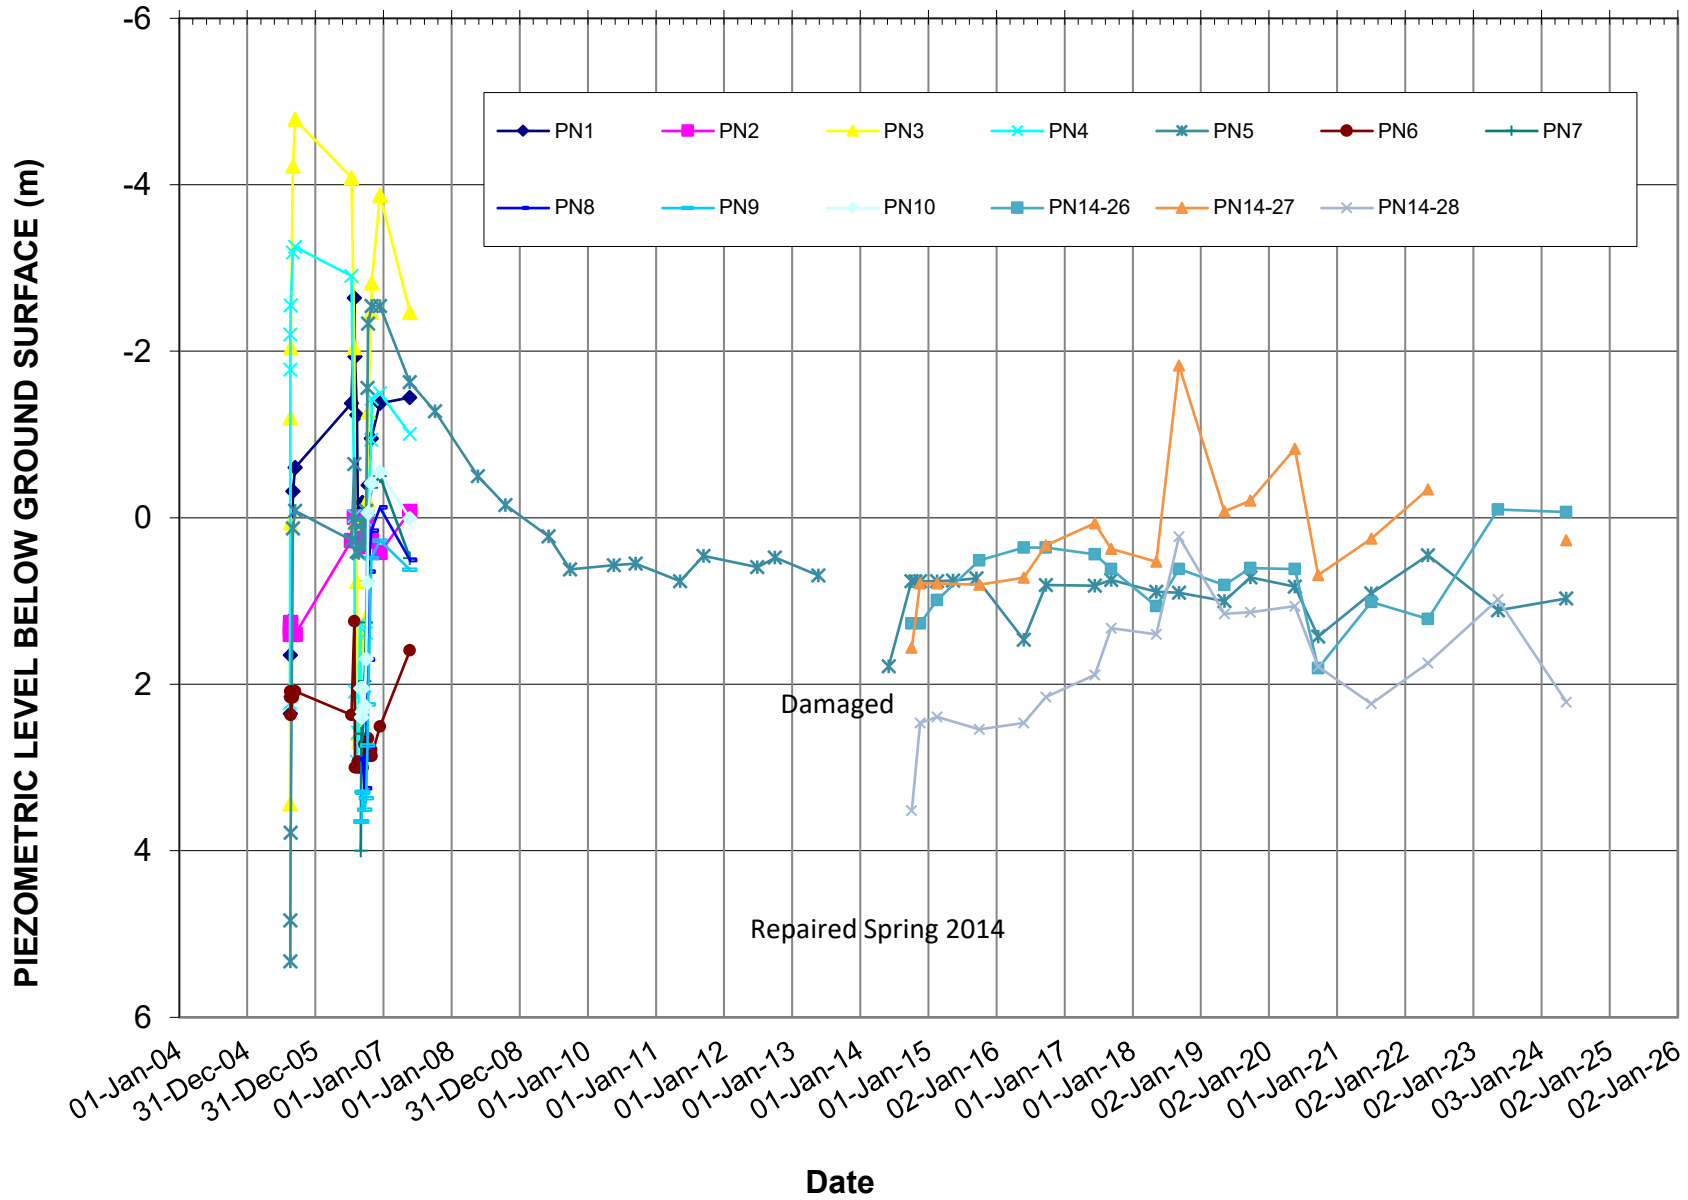
During the Spring 2024 reading cycle, PN-5 showed a slight increase in groundwater level of 0.1 m compared to the Spring 2023 reading cycle.

PN14-26 showed almost no change from the Spring 2023 reading cycle. The groundwater elevation again was above the ground surface, indicating that artesian condition exists at the time of Spring 2024 reading cycle.

The cable for PN14-27 was retrieved out of the casing during the current monitoring cycle and had a ground water elevation of about 697.8 m, which is consistent with values prior to the missed reading during Spring 2023.

PN14-28 showed a decrease of 1.2 m in piezometric levels corresponding to an elevation of 698.4 m since the Spring 2023 reading cycle. Despite the relatively large drop since the previous reading, the piezometric level is within the historical range.
