**ALBERTA TRANSPORTATION AND
ECONOMIC CORRIDORS GRMP
GRANDE PRAIRIE REGION –
(GRANDE PRAIRIE NORTH)
INSTRUMENTATION MONITORING - SPRING 2024**

Site Number	Location	Name	Hwy	km
GP004A	HWY 49:06 C1 10.586	Burnt River Bridge	49:06	Km 10.6
Legal Description: 12-10-78-4 W6		UTM Co-ordinates		
		11U E 403183.13	N	6178764.13

SITE GP004A: HWY 49:06, BURNT RIVER BRIDGE

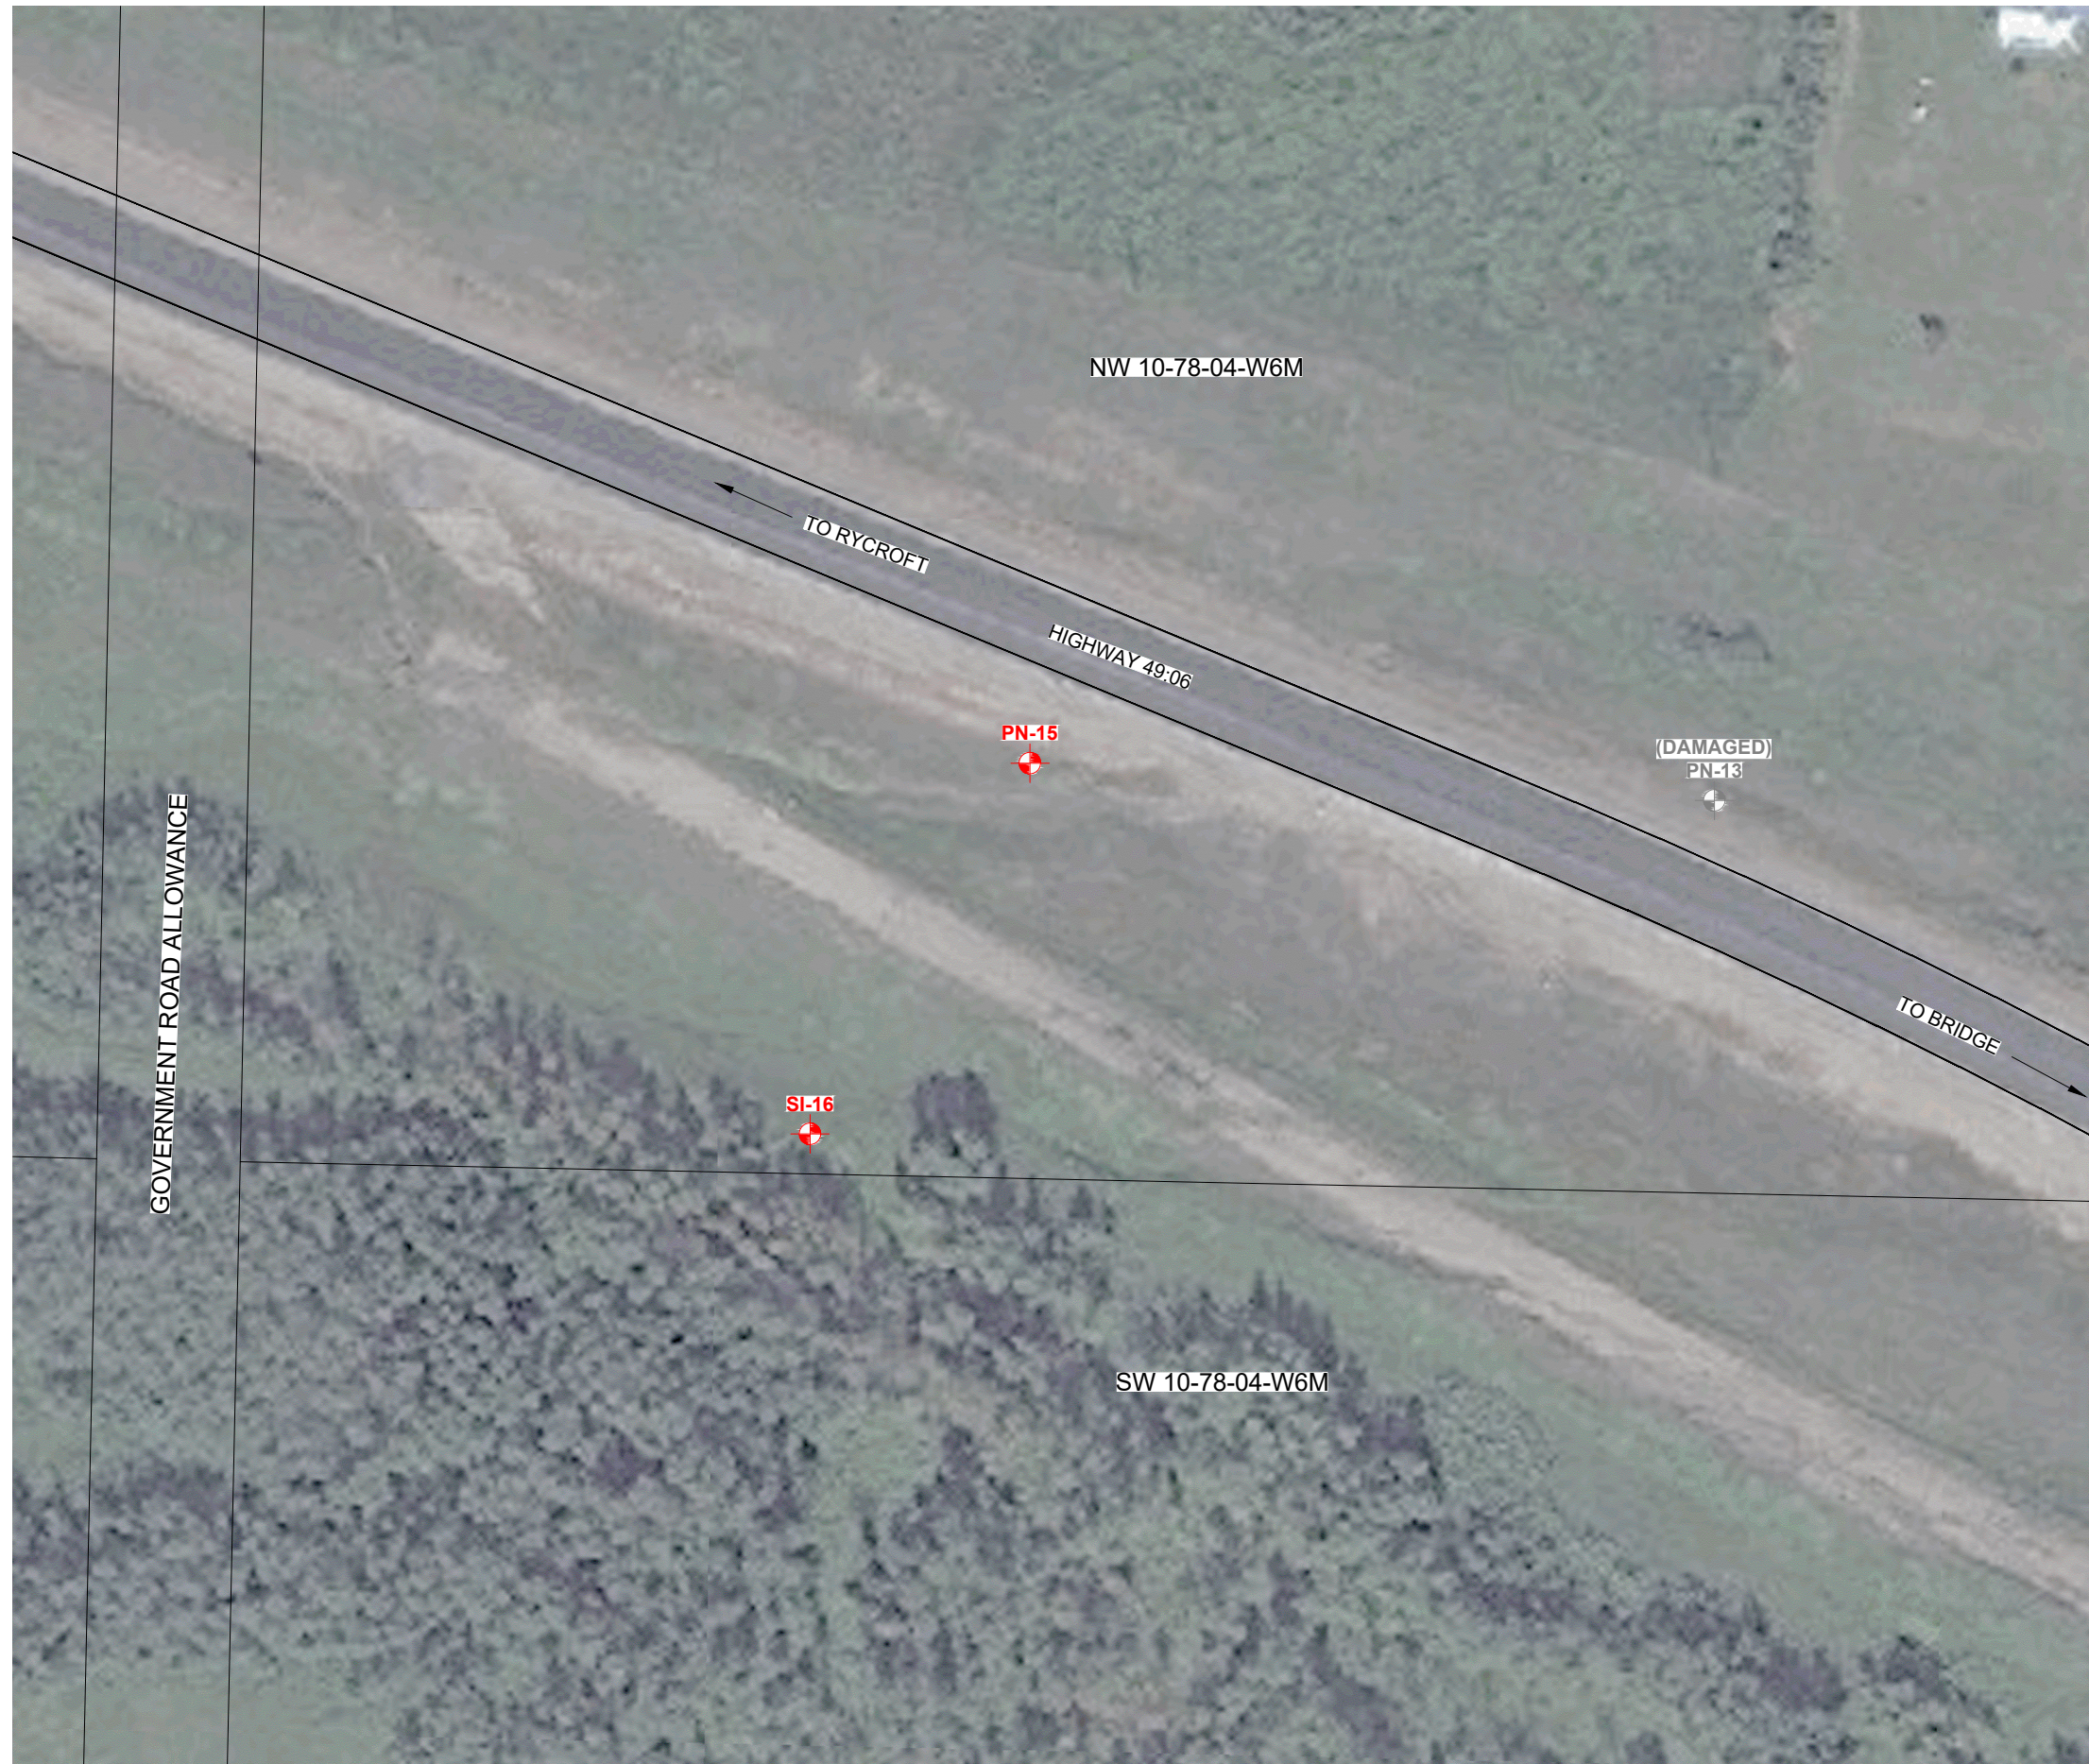
DWG No. 32123-GP004A

APPROXIMATE INSTRUMENT LOCATION
- SI SLOPE INCLINOMETER
- PN PNEUMATIC PIEZOMETER

**GP004A: HWY 49:06 BURNT RIVER BRIDGE
INSTRUMENT LOCATIONS**

Drawing 32123-GP004A in Appendix A provides a sketch of the approximate location of the monitoring instrumentation for this site

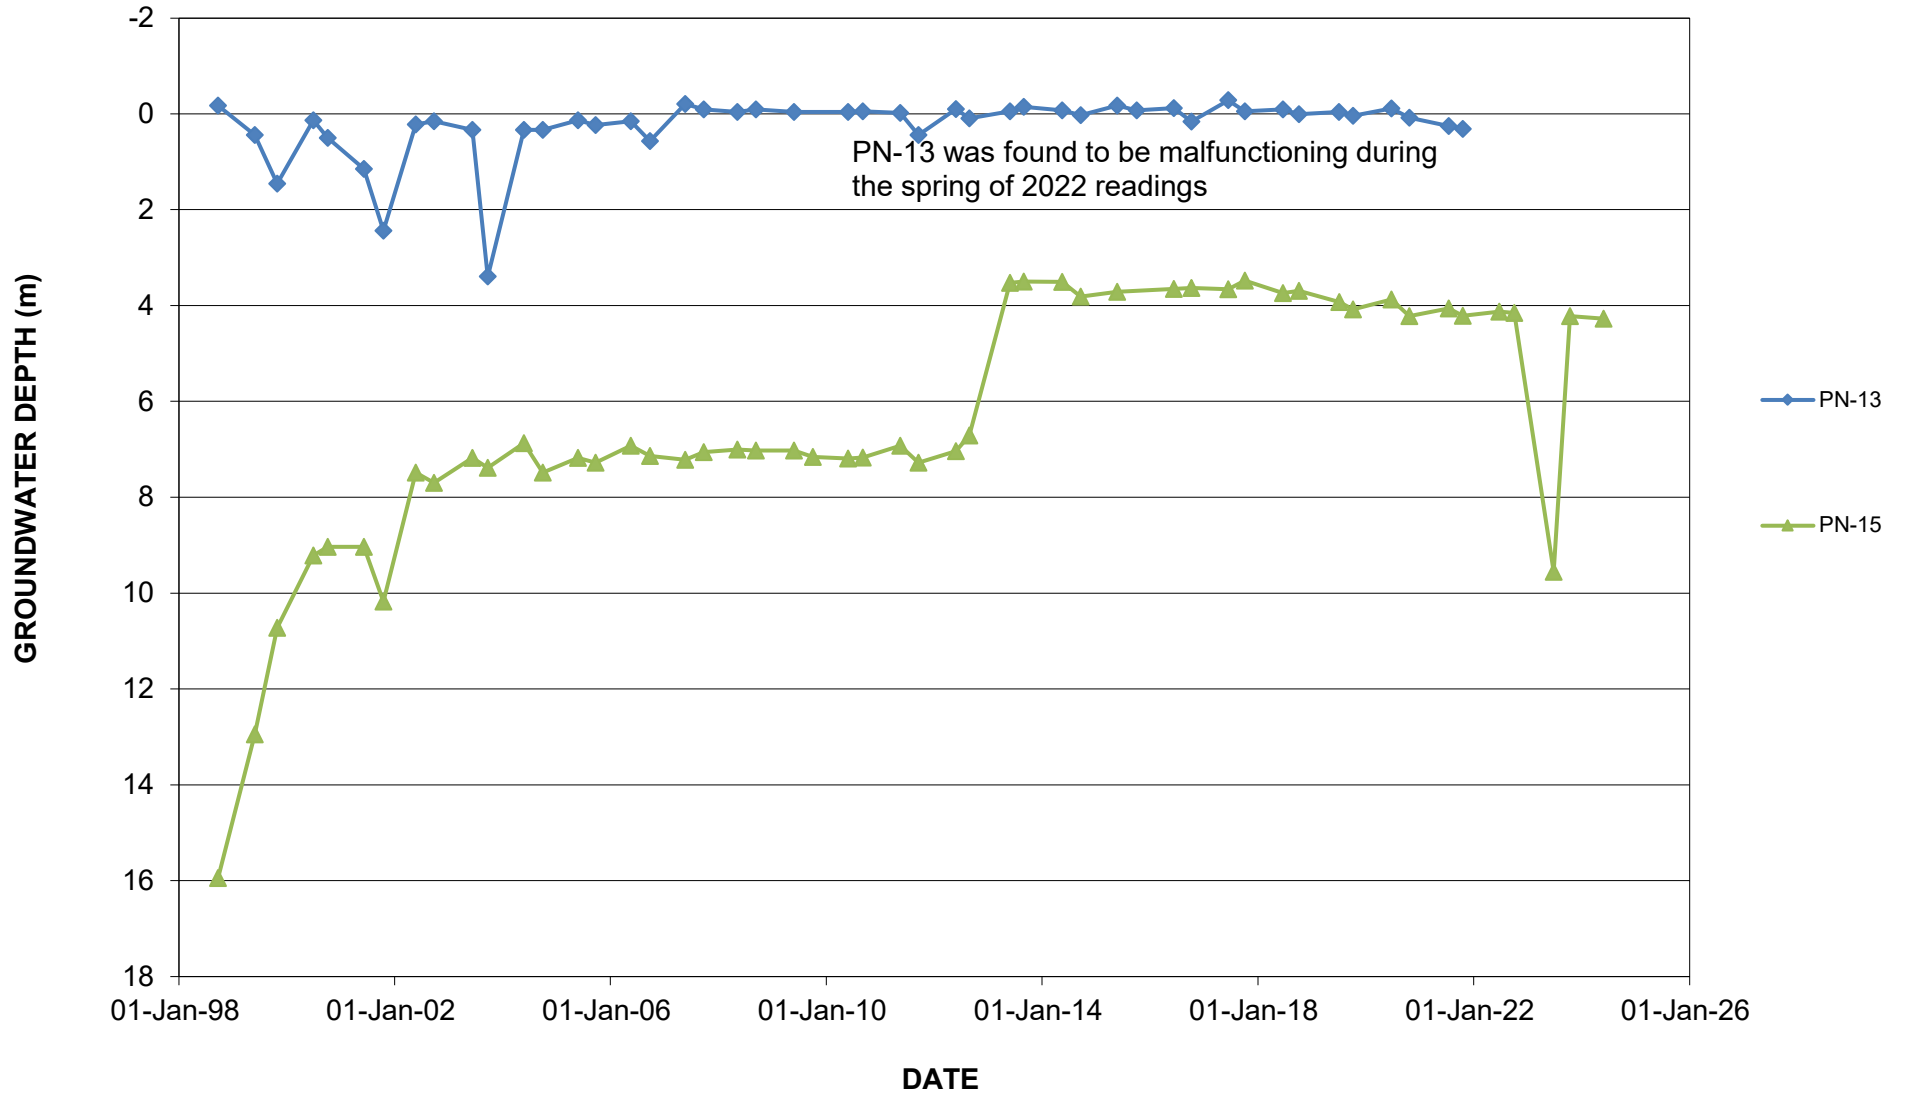
FIGURE GP004A-1
PIEZOMETER DATA FOR HWY 49:06, BURNT RIVER BRIDGE

INSTRUMENT #	DATE INITIALIZED	TIP DEPTH (m)	GROUND ELEV. (m)	CURRENT STATUS	HIGHEST MEASURED WATER LEVEL BGS (m)	MEASURED PORE PRESSURE (kPa)	CURRENT WATER LEVEL BGS (m)	PREVIOUS WATER LEVEL BGS (m)	CHANGE IN WATER LEVEL SINCE PREVIOUS READING (m)
PN-13	September 24, 1998	14.0	-	Malfunctioning	-0.29* in June 2017	N/A	N/A	N/A	N/A
PN-15	September 24, 1998	23.8	-	Operational	3.50 in August 2013	191.5	4.27	4.22	-0.05
