**PEACE REGION
(GRANDE PRAIRIE DISTRICT – SOUTH) GRMP**

SITE INSPECTION FORM

SITE NUMBER AND NAME: GP017 Grande Cache Lake Slide		HIGHWAY & KM: 40:34, 26.680	PREVIOUS INSPECTION DATE: October 12, 2021	INSPECTION DATE: June 12, 2023
LEGAL DESCRIPTION: SW 12-57-08-W6M	NAD 83 COORDINATES: UTM Northing Easting 11 5974943 364960		RISK ASSESSMENT: PF: 9 CF: 8 TOTAL: 72	
AVERAGE ANNUAL DAILY TRAFFIC (AADT): 1,400 (west) & 1,300 (east) (Reference No. 70000983, 2022)			CONTRACT MAINTENANCE AREA (CMA): 504

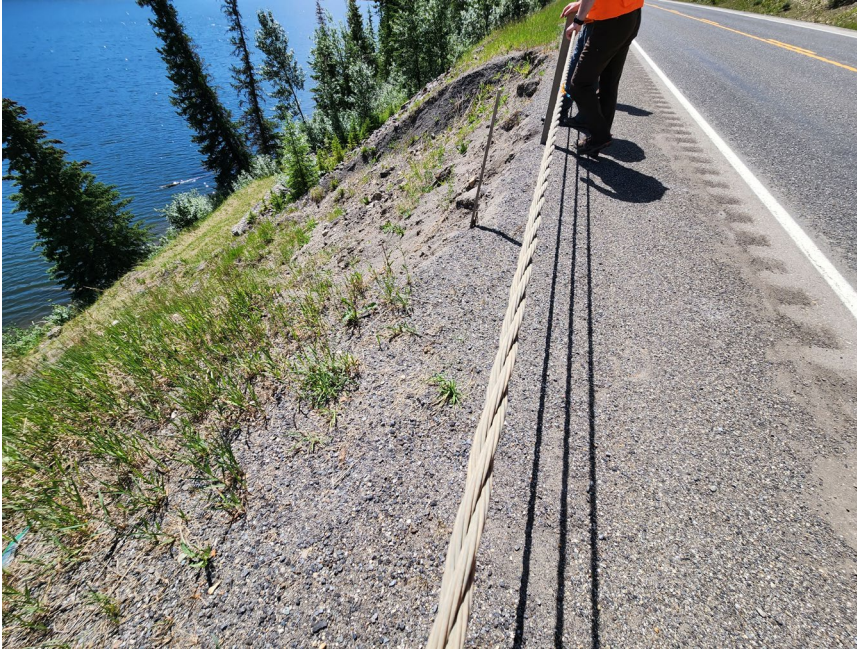
- Photo 1** Slide and erosion area adjacent to previously repaired section on south side of Hwy 40:34. Note scarp at pavement edge and Grande Cache Lake at toe of slope. Photo taken June 13, 2023, facing southwest.

- Request for Quotation (RFQ) prepared and issued in May 2023, and Environmental Overview Assessment (EOA) underway. Repair consists of excavation/removal of slide mass, reconstruction of slope/slide area with granular fill, installation of three buried subdrains (perforated pipe) in granular fill, and construction of a bench/toe berm and low-height gabion basket retaining wall at toe of slide area.
- Additional work should be considered to reduce the possibility of the slope to the north of the current slide area from failing in the future, including redirecting surface water flow from the highway away from the slope.

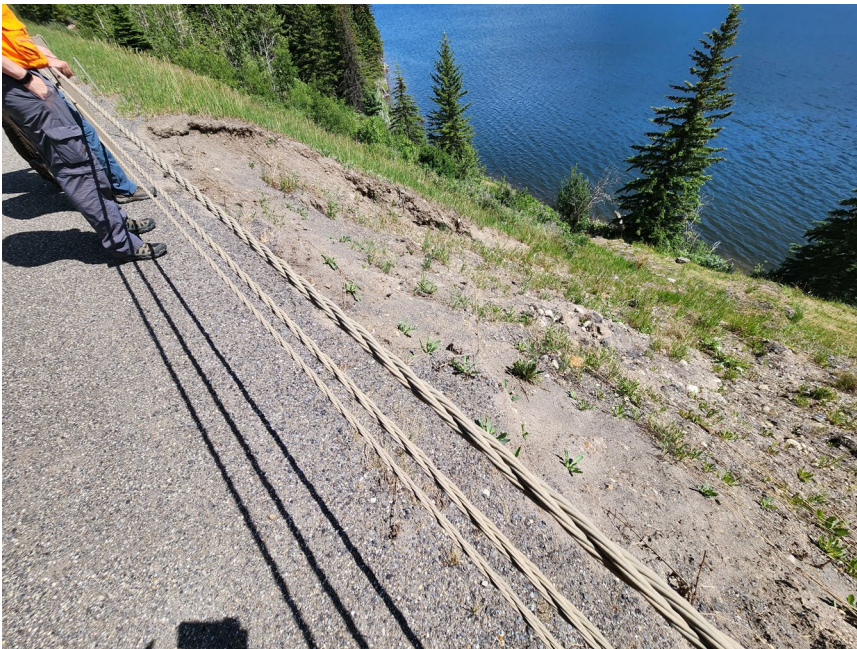
- Photo 2** Slide and erosion area adjacent to previously repaired section on south side of Hwy 40:34. Note scarp at pavement edge. Photo taken June 13, 2023, facing northeast.

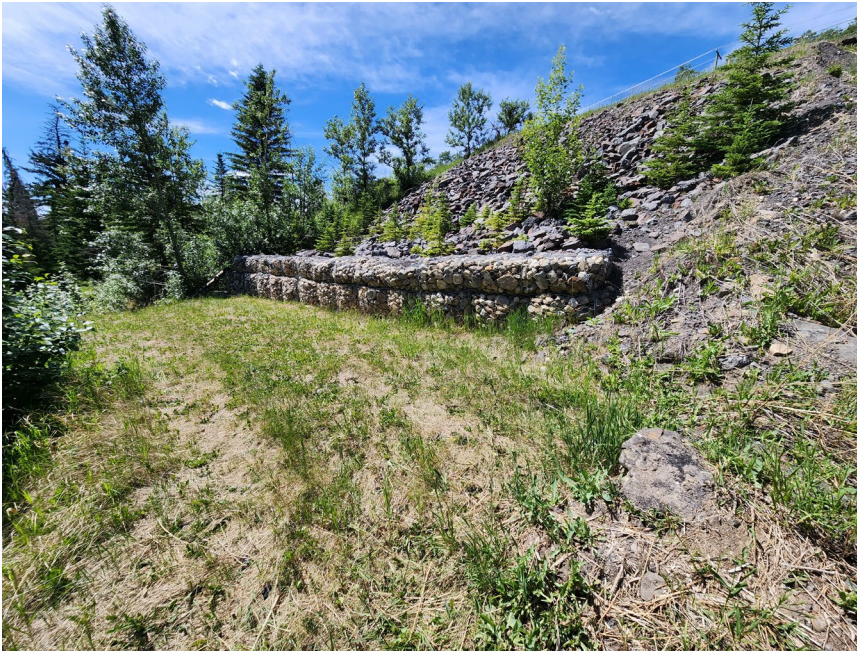
Photo 3 Section of site previously repaired in 2002 on south side of Hwy 40:34. Note trail at toe of highway embankment. Photo taken June 13, 2023, facing northwest.

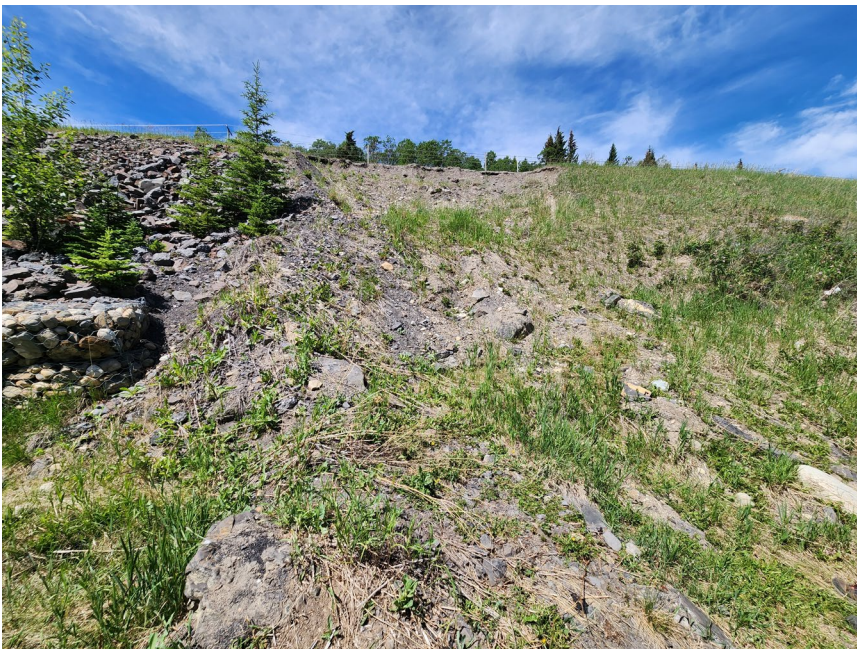
Photo 4 Slide and erosion area adjacent to previously repaired section on south side of Hwy 40:34. Photo taken June 13, 2023, facing northwest.

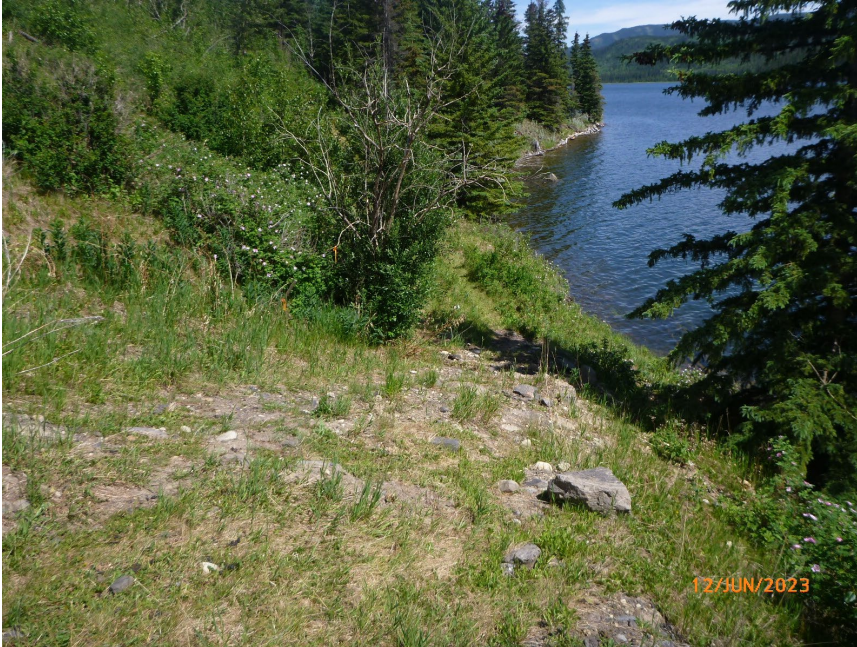
Photo 5 Material, including sand and gravel, eroded from slope/slide area in flow path from bottom of slide to edge of Grande Cache Lake. Photo taken June 13, 2023, facing northwest.

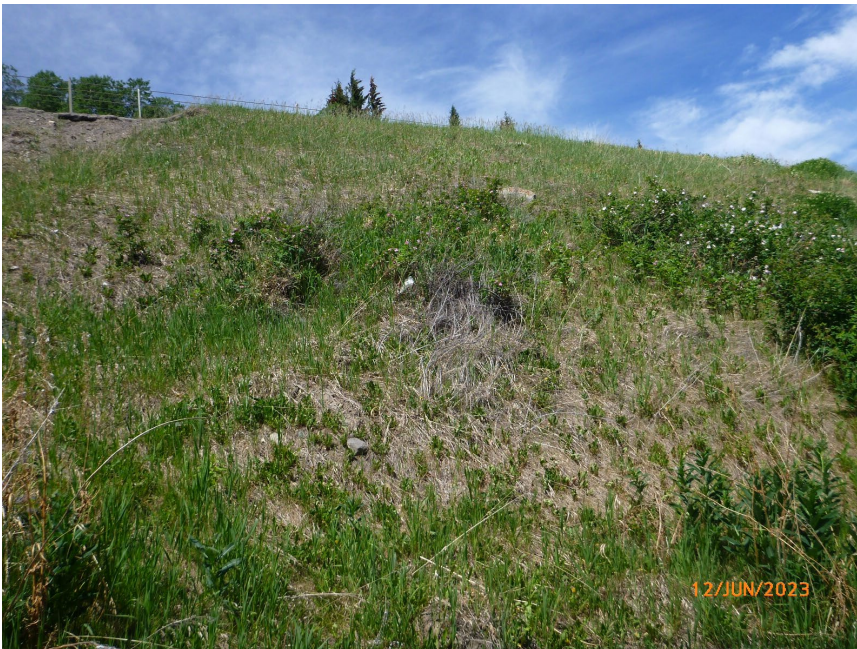
COMMENTS
It is our understanding that the initial slide occurred in 1999 and the current slide occurred in 2020. The slope to the east of the current slide area could fail in the future.
2002 repair appears to have addressed the 1999 slide area.
Mechanism for initial slide could be a high-water table in the sliver fill due to periods of seasonally high groundwater (possibly discharging into the natural slope and sliver fill from or on top of bedrock).
Material, including sand and gravel, eroded from the slope/slide area observed along the flow path from the bottom of the slide to the edge of Grande Cache Lake.
Approximate 2-m trail at toe of slide area used for the Great Canadian Death Race.

Photo 6 Highway embankment slope to east of current slide area on south side of Hwy 40:34. Photo taken June 13, 2023, facing north.
