Site Number	Location	Name	Hwy	km
PH081	HWY 684:02 28+600 to 28+400	Shaftesbury Trail	684:02	28.35 to 30.30
Legal Description: 1-30-83-21 W5		UTM Co-ordinates		
		11U E 481435	N	6230499

**ALBERTA TRANSPORTATION AND ECONOMIC CORRIDORS GRMP (CON0022164)
PEACE REGION (PEACE RIVER DISTRICT)
INSTRUMENTATION MONITORING RESULTS**

SPRING 2024

SITE PH081: HWY 684:02, SHAFTESBURY TRAIL

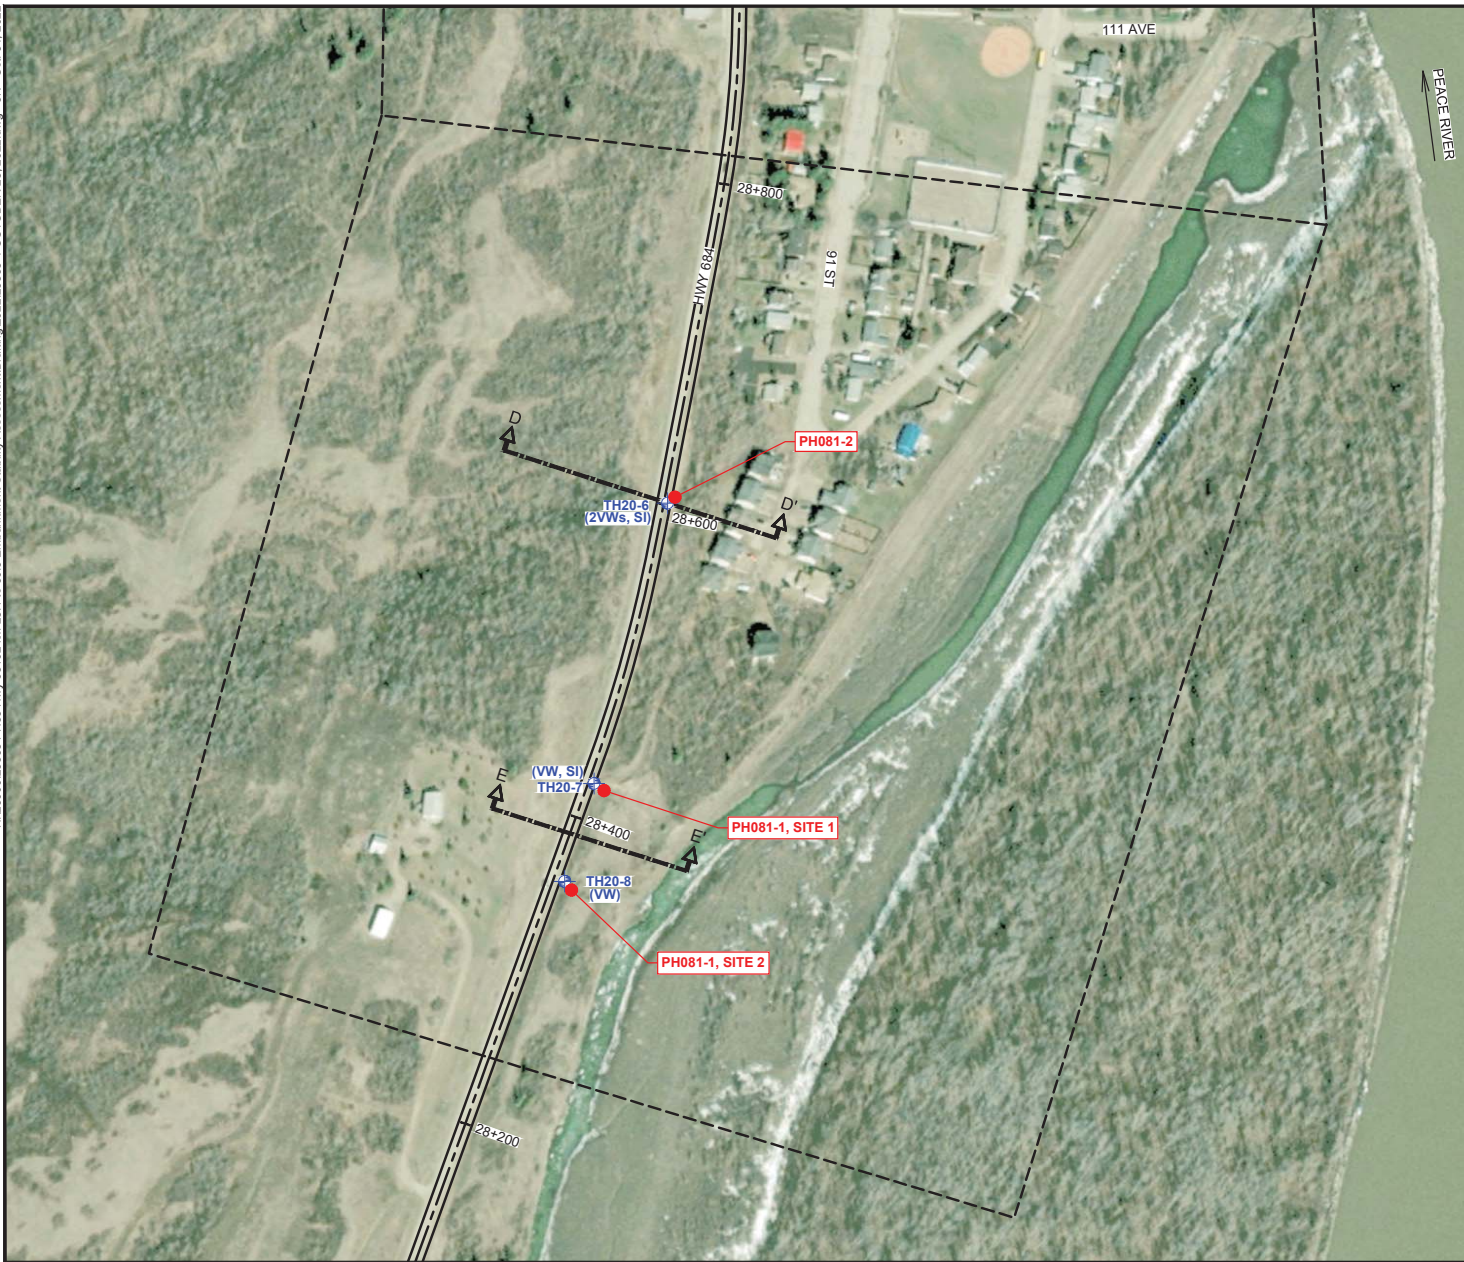
DWG No. 23838-5

Drawings 23838-5 in Appendix A provides a sketch of the approximate locations of the monitoring instrumentation for this site.

**SHAFTESBURY TRAIL - HWY 684, km 28.3 TO 30.3
GEOTECHNICAL INVESTIGATION AND PRELIMINARY
ENGINEERING ASSESSMENT
DETAIL PLAN
(SHEET 4 OF 4)**

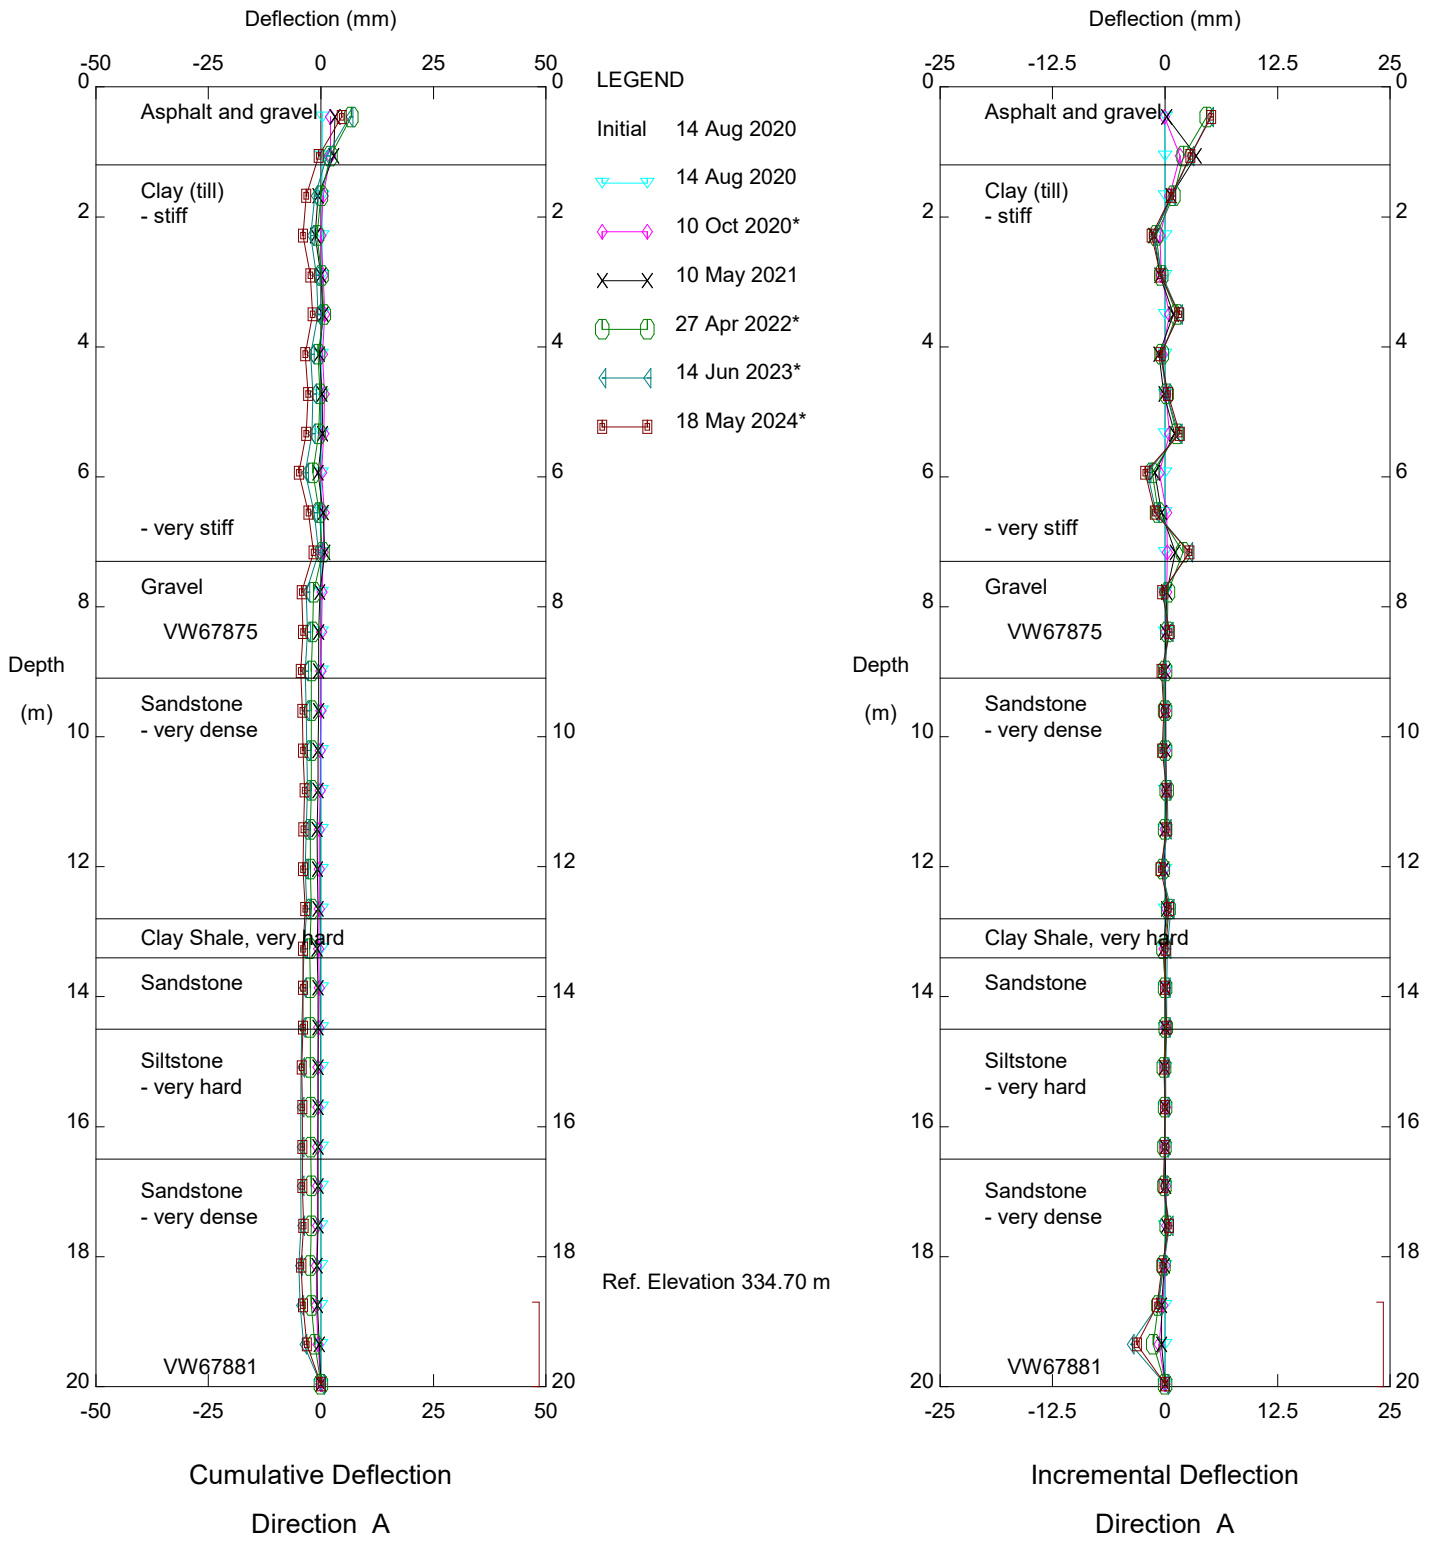
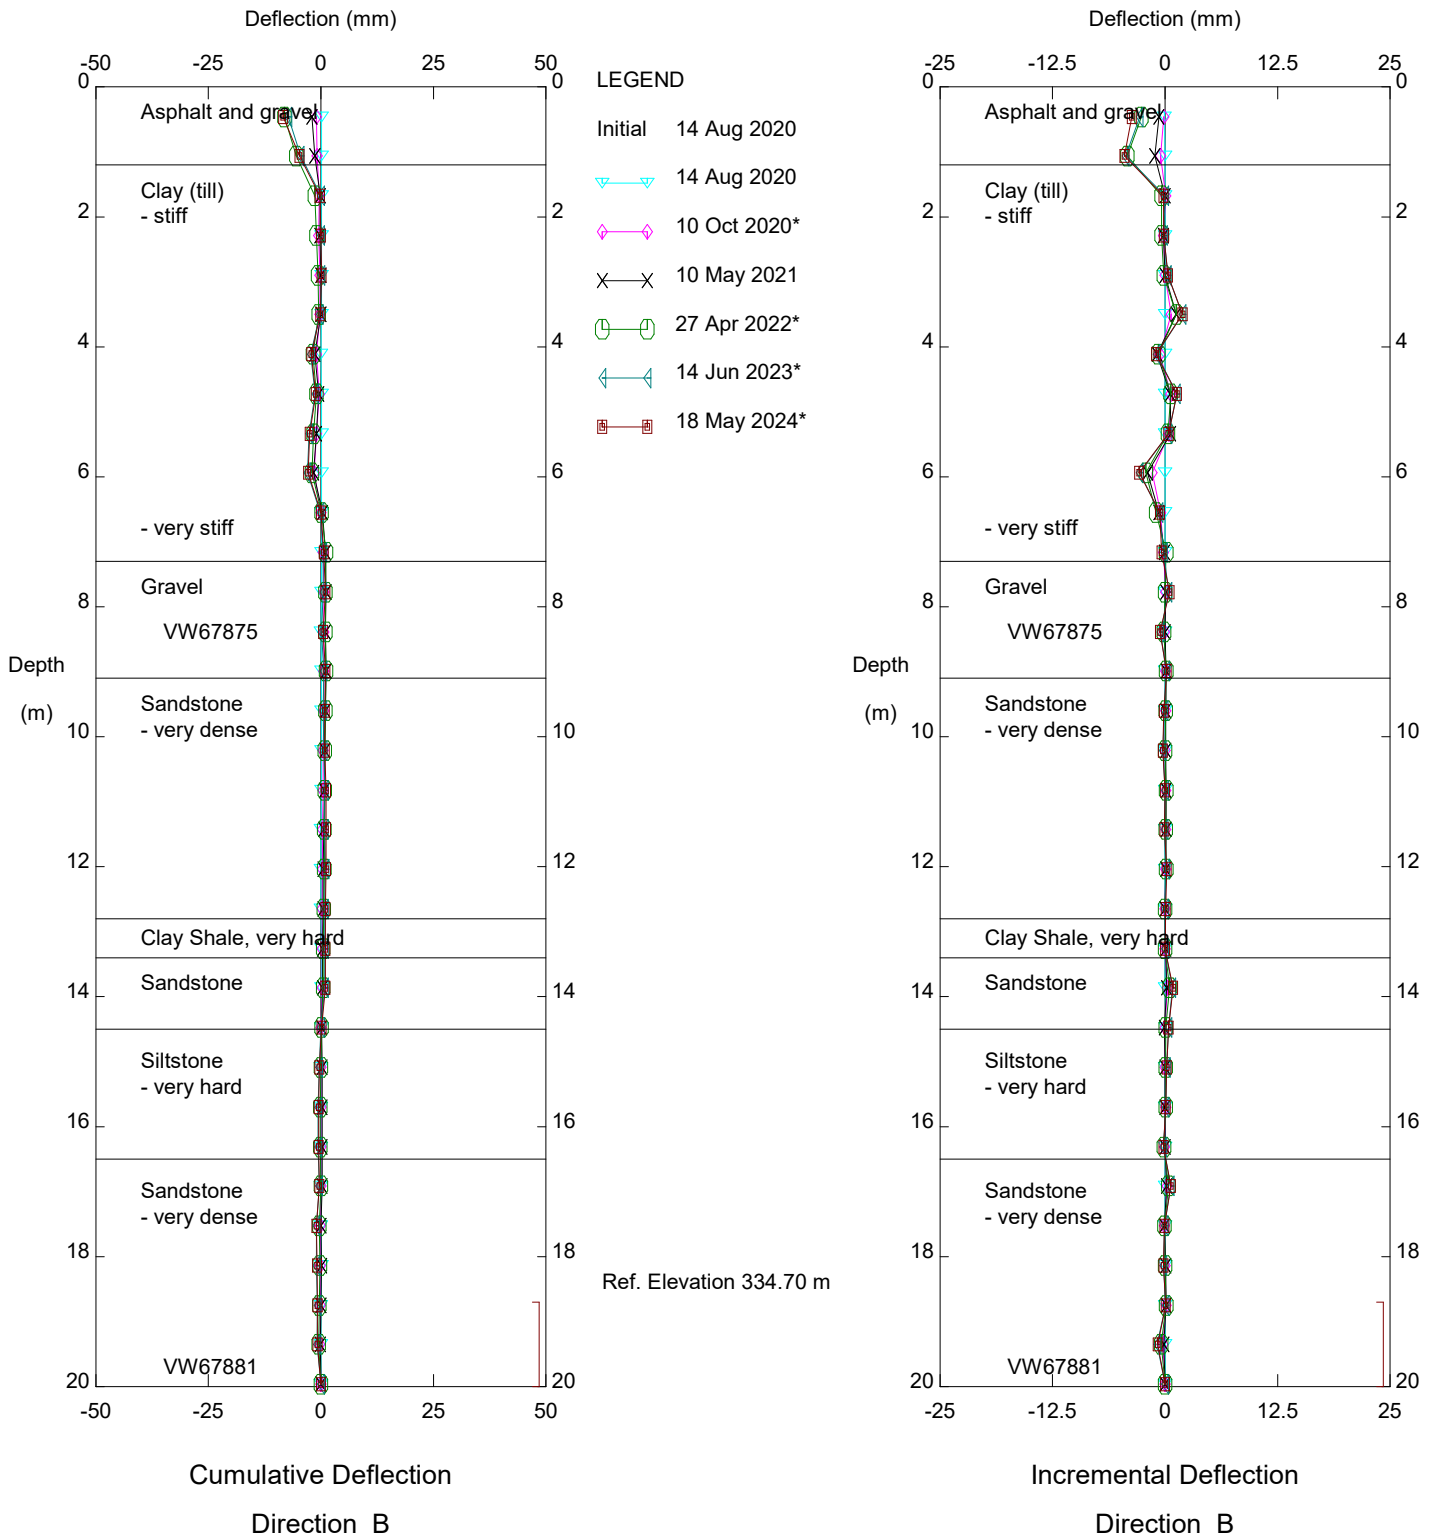
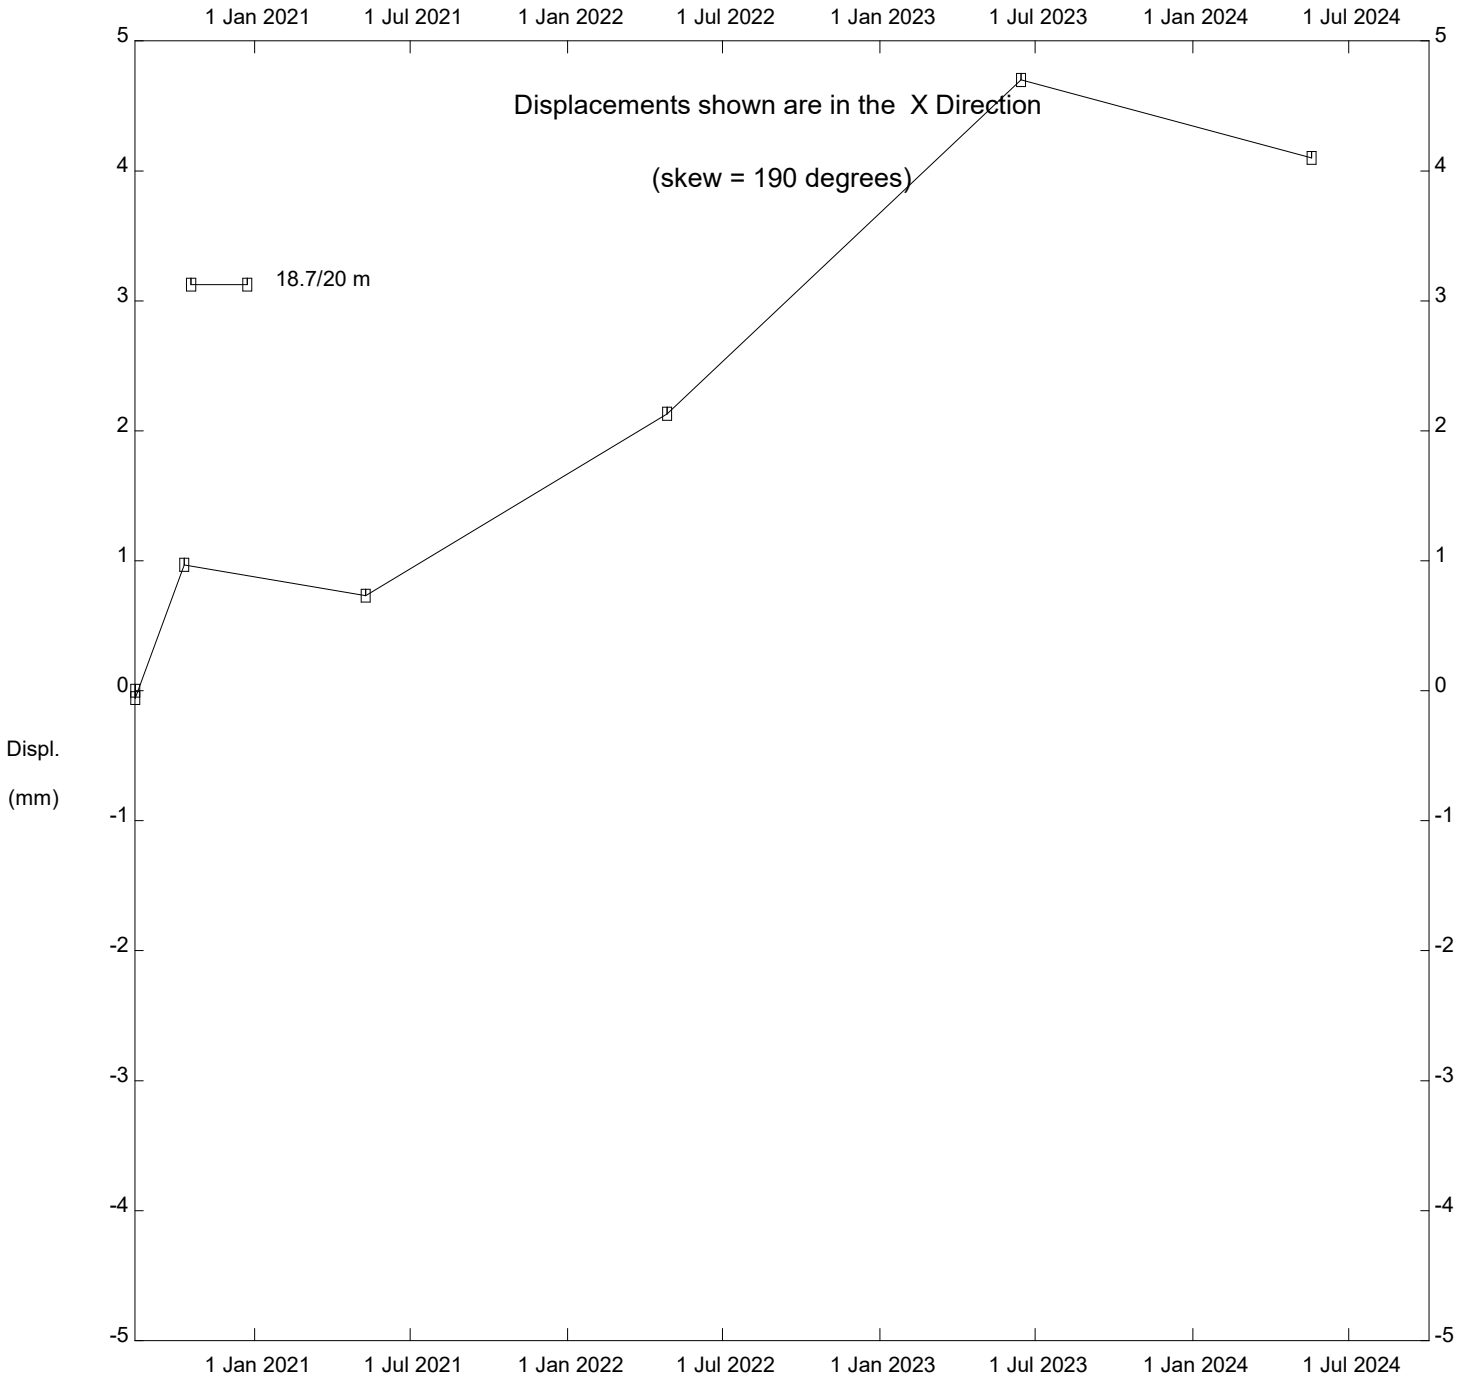
HWY 684 Shaftesbury trail, Inclinometer SI20-6

Discussion	
Zones of New Movement:	None
Interpretation of Monitoring Results:	SI20-6 showed a cumulative movement of 1.4 mm over 6.6 m to 8.4 m depth, with no discernible movement since the previous readings on June 14, 2023. SI20-7 showed a cumulative movement of 12.4 mm over 0.3 m to 13.7 m depth, with a rate of movement of 1.9 mm/yr since the previous readings on June 14, 2023. Vibrating wire piezometer VW20-6A was found to be dry since January 6, 2024. Vibrating wire VW20-6B and VW20-8 showed decreases in groundwater levels of 1.17 m and 0.19 m, respectively, compared to the June 14, 2023 readings. Vibrating wire piezometer VW20-7 has been dry since the instrument was initialized.
Future Work:	The instruments should be read again in the spring of 2025.
Instrumentation Repairs:	No instrument repairs are required at this time.
Additional Comments:

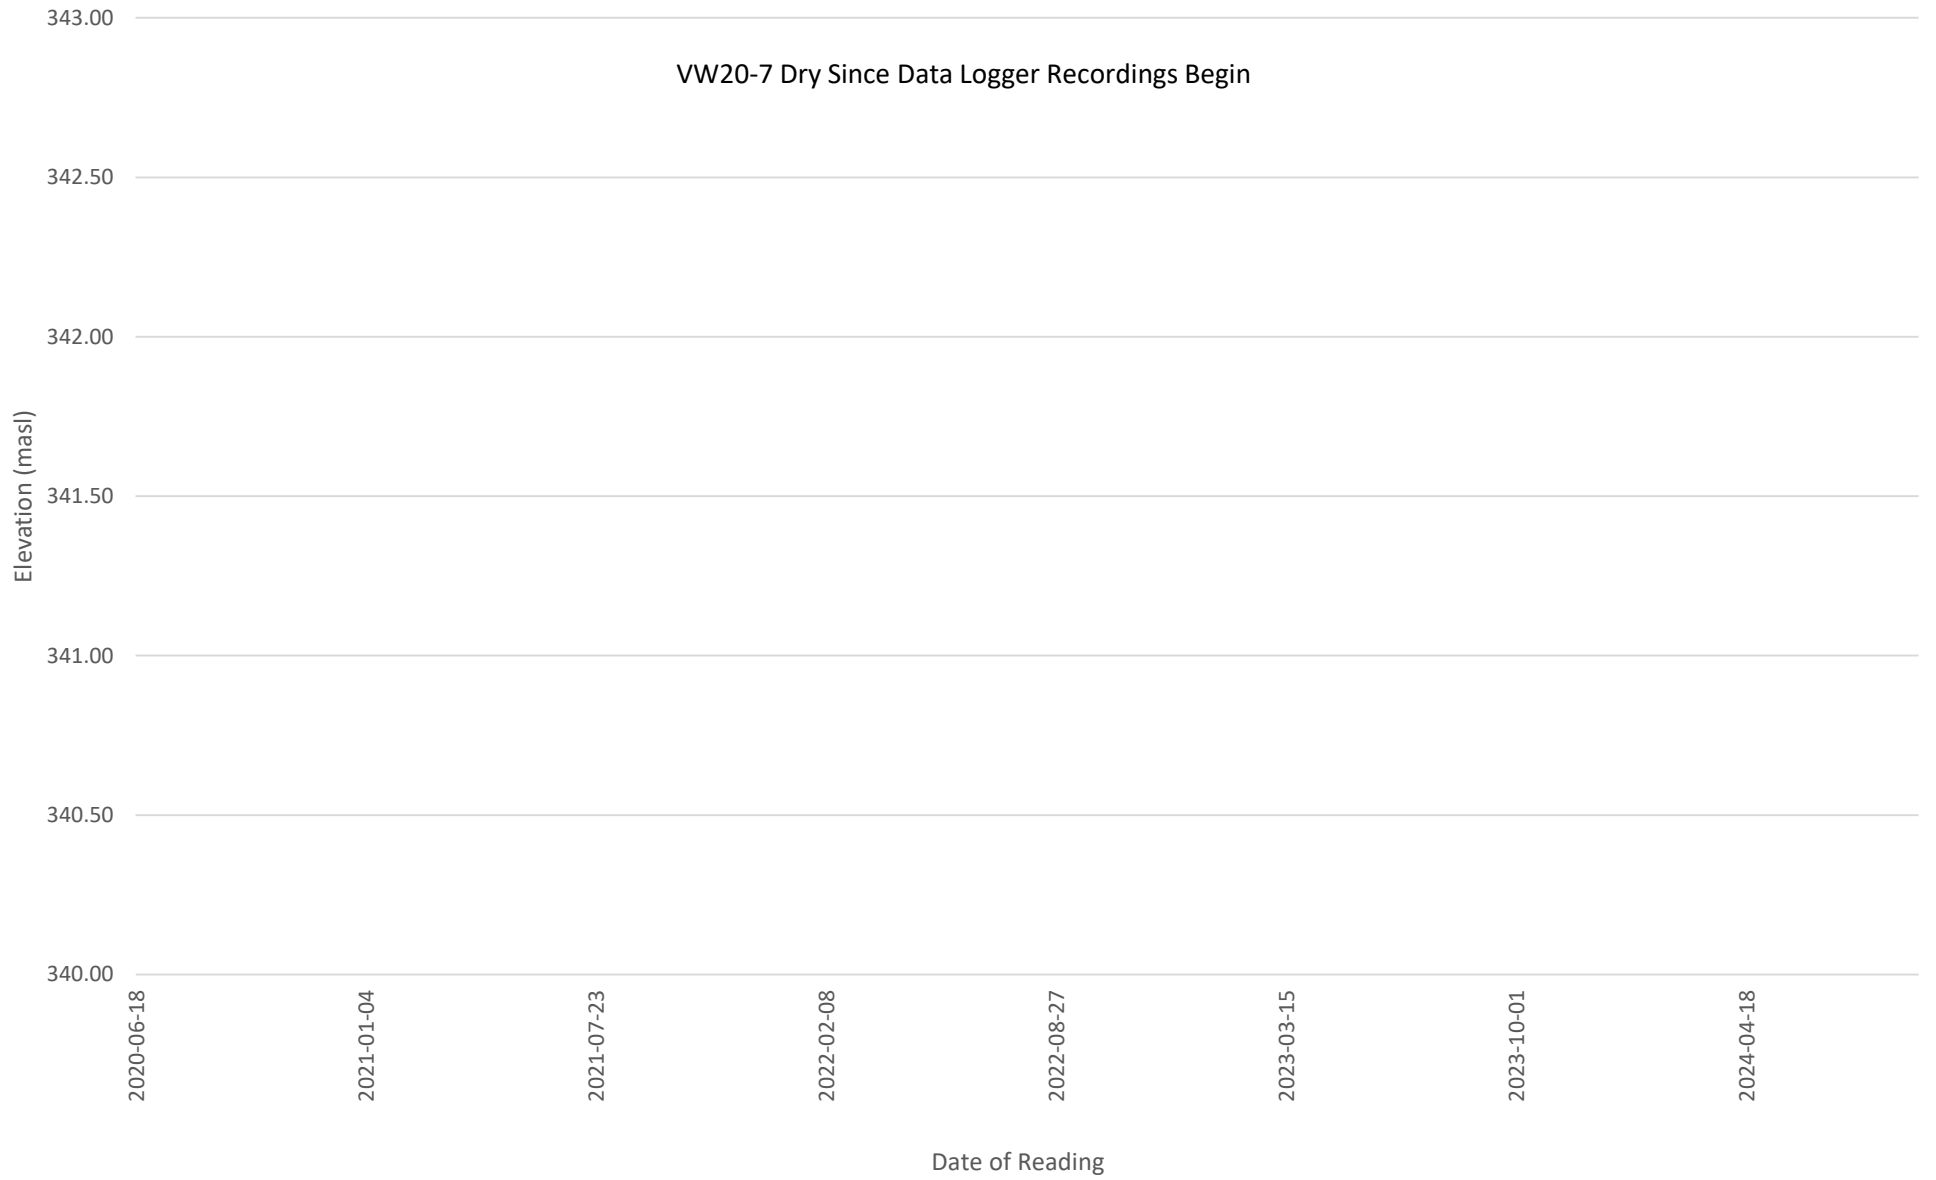
PH081-2-VW20-7A

VW20-7 Dry Since Data Logger Recordings Begin
