**PEACE REGION (PEACE – HIGH LEVEL AREA) GEOHAZARD ASSESSMENT
SHAFTSBURY TRAIL (SOUTH SITE)
2007 CALLOUT INSPECTION REPORT**

This letter documents the 2007 callout site inspection of an area of slope instability located below Shaftsbury Trail (Hwy 2A:36) within the Town of Peace River. The site is located 2.2 km south of the intersection of Shaftsbury Trail and Highway 2.

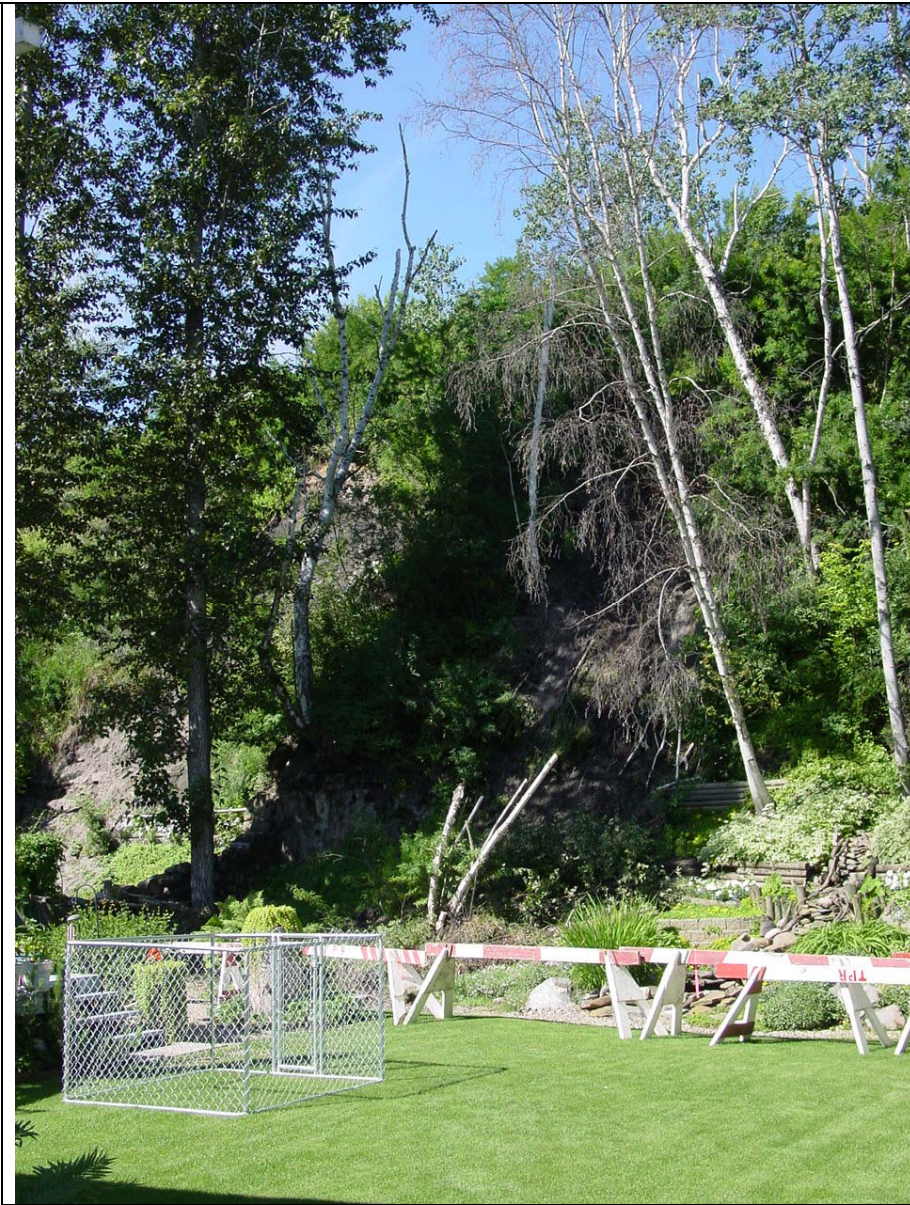
As shown in Photos 1 and 2, the failed materials have a relatively small volume, but appear to be very mobile, flowing from the slope to the terrace below. There does not appear to be a threat to the highway at this time.

These failures can be described as small debris flows. They would have been triggered by saturation of the colluvial soils by either an increase in groundwater or a concentration of surface water at this location. Either of these could have been caused by the reported heavy rainfall prior to the slides. The clay soils would have essentially liquefied and flowed down the slope. The sandstone appears to be relatively intact. The vegetation and soil on the slope flowed with the failures, but remains intact on adjacent portions of the slope.

Photo 1.
Cartier residence slide.
Debris from the slope has entered the developed area below. Note some apparently dead trees on the slope.

Managing the debris from potential future slides by construction of a berm along the toe of the slope to collect it should be feasible. Such a berm would have to be properly designed in terms of height and "storage" capacity. Note that periodic "cleaning out" of the berm would be required. As an initial estimate, we would expect the cost of such a berm to be in the order of \$50,000, but would depend on access, which may require the use of small equipment.

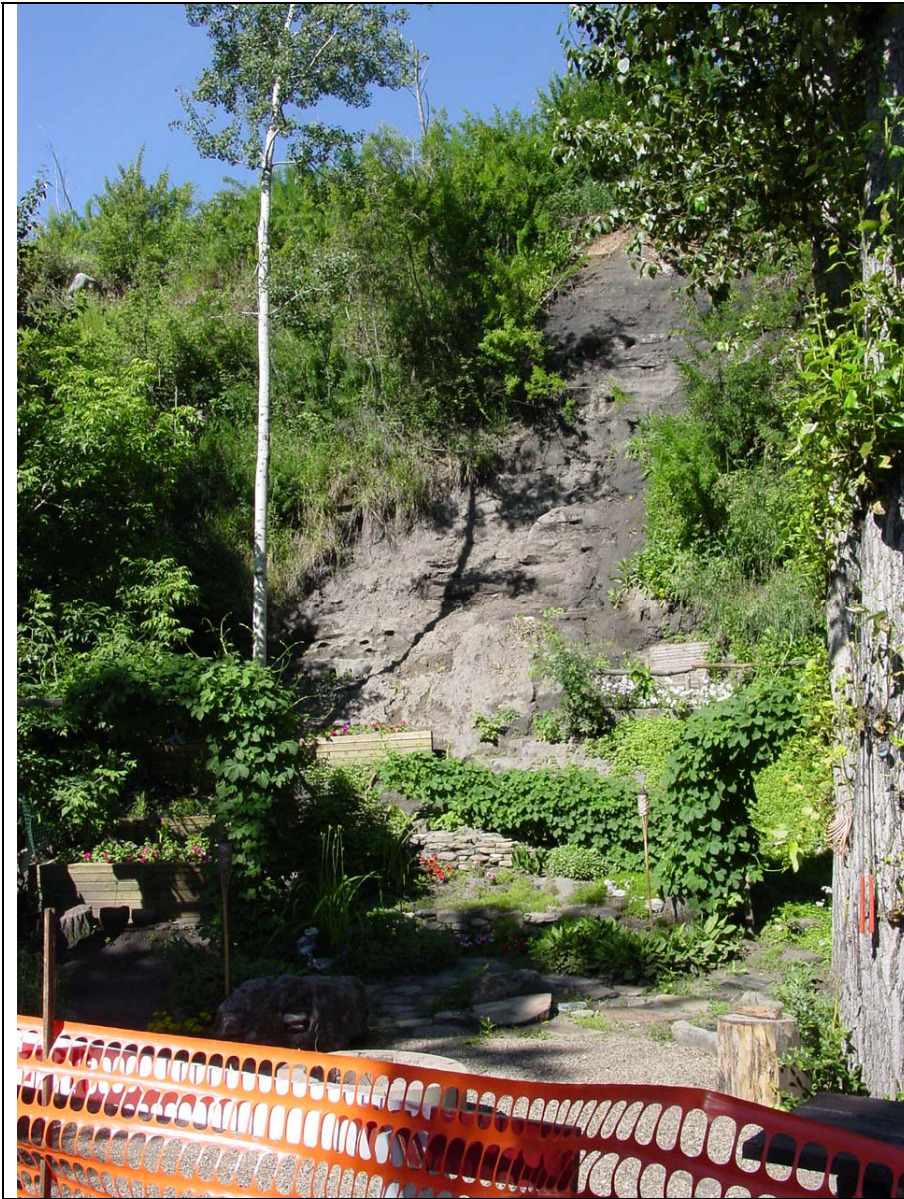
Photo 2.
Slide to the south of the
Cartier residence.

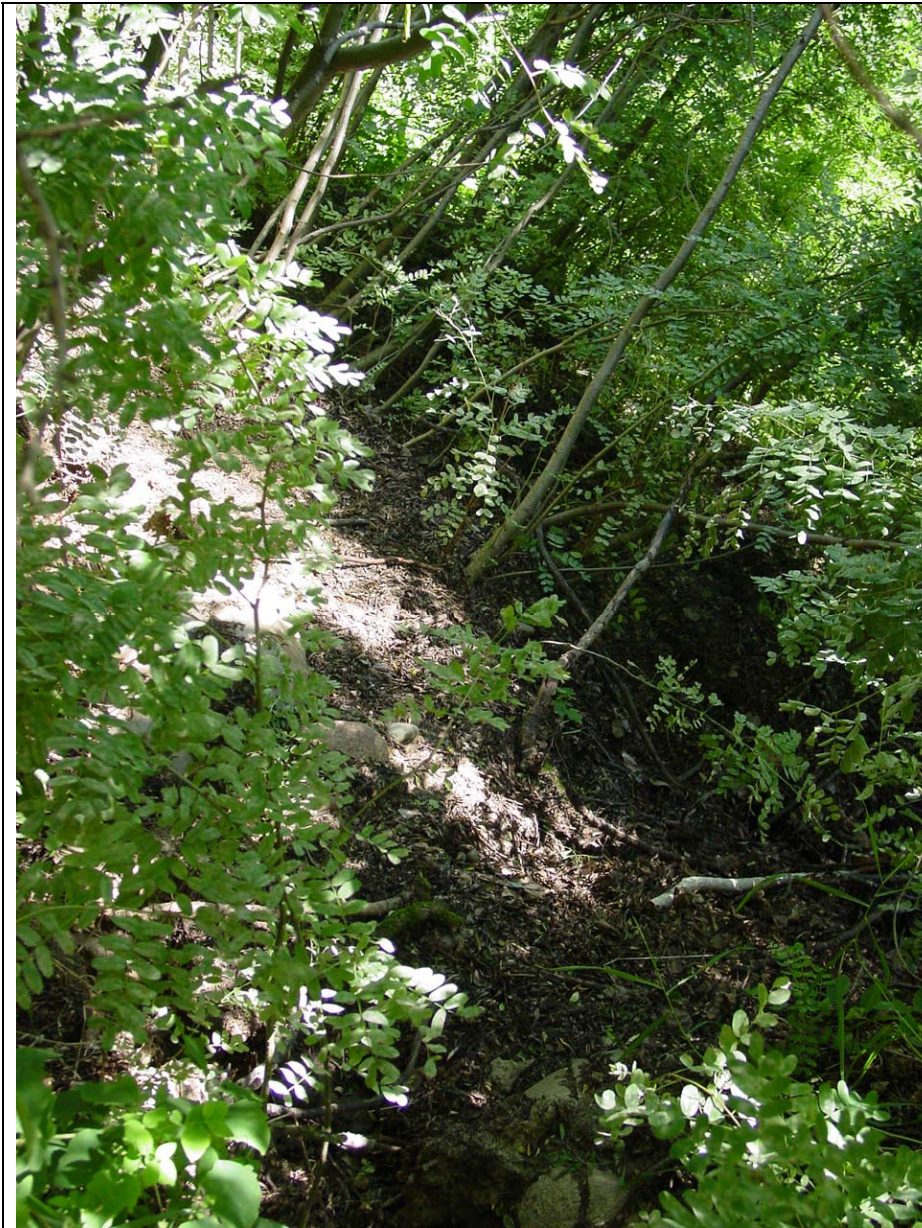
Photo 3.
Crest of the slope above the
Cartier residence slide.

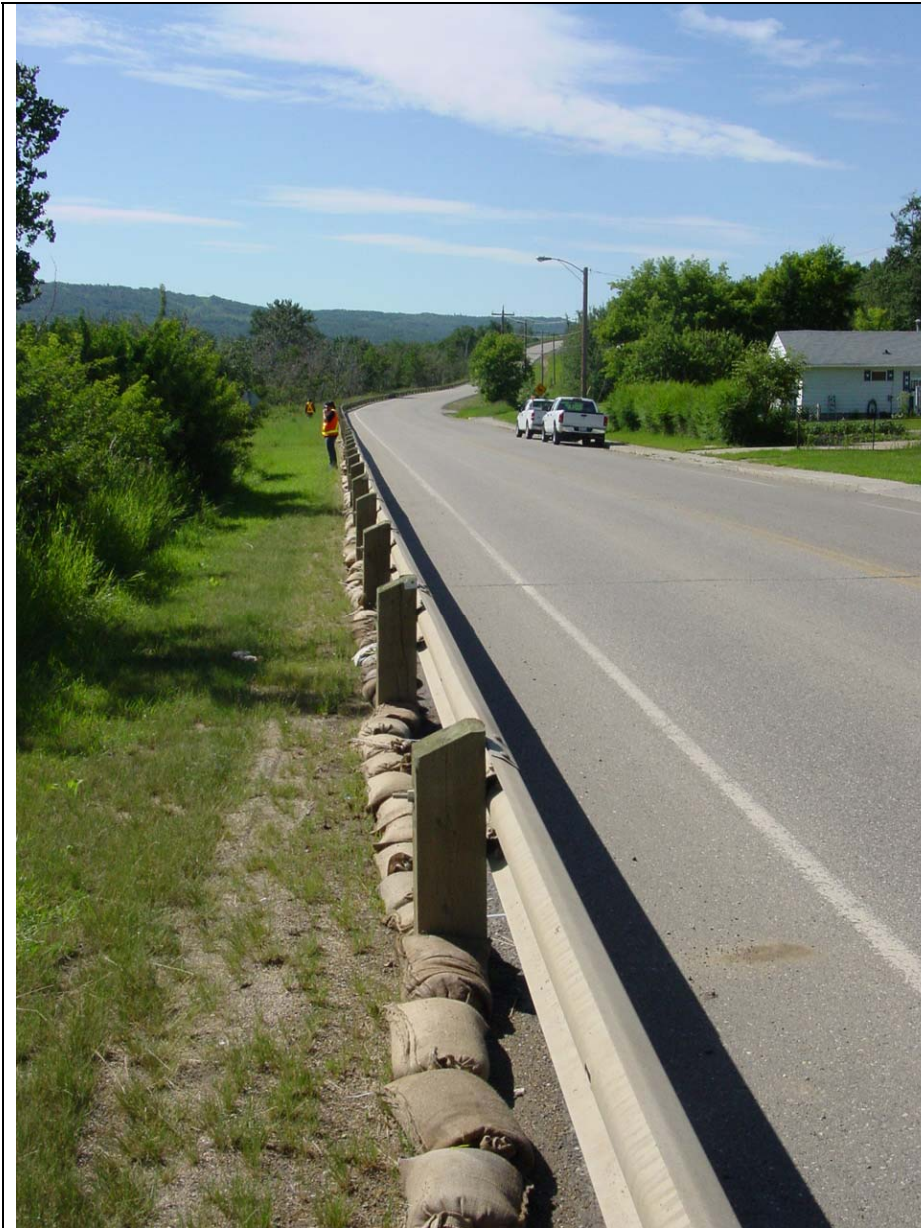
In this area, Shaftsbury Trail runs north-south along the crest of a slope over a terrace of the Peace River, with several residences located on the terrace below the road. The slope has a height of about 15 m to 20 m and an overall slope angle steeper than 40°. The crest of the slope is approximately 10 m from the highway. The area between the highway and the slope is well vegetated, and has a very shallow slope.

Photo 4.
Highway upslope of the failure area. The edge of pavement is roughly 10 m away from the crest of the slope.

Installation of a curb along the highway may be beneficial, to direct surface water to a controlled location. Note that surface water from the road is only considered as a possible contributor to the slide(s) and hence should not be relied upon as the sole solution. A catch basin is located 150 m south of the site, which may be an appropriate point to direct surface water – grades and elevations should be checked to confirm this. The estimated cost of constructing a 200 m long asphalt curb in this area is \$10,000.
