ALBERTA TRANSPORTATION AND
ECONOMIC CORRIDORS GRMP
PEACE REGION – (PEACE RIVER DISTRICT)
INSTRUMENTATION MONITORING - FALL 2024

Site Number	Location	Name	Hwy	km
SH014	HWY 750:02 C1 30.582	Salt Creek Slide	750:02	Km 30.6
Legal Description: 16-34-76-14 W5		UTM Co-ordinates		
		11U E 558275	N	6165556

Current Monitoring:	18-Sep-2024	Previous Monitoring	16-May-2024
Instruments Read By:	Mr. Niraj Regmi, G.I.T and Mr. Nixon Mationg, of Thurber

SITE SH014: HWY 750:02 (SALT CREEK SLIDE)

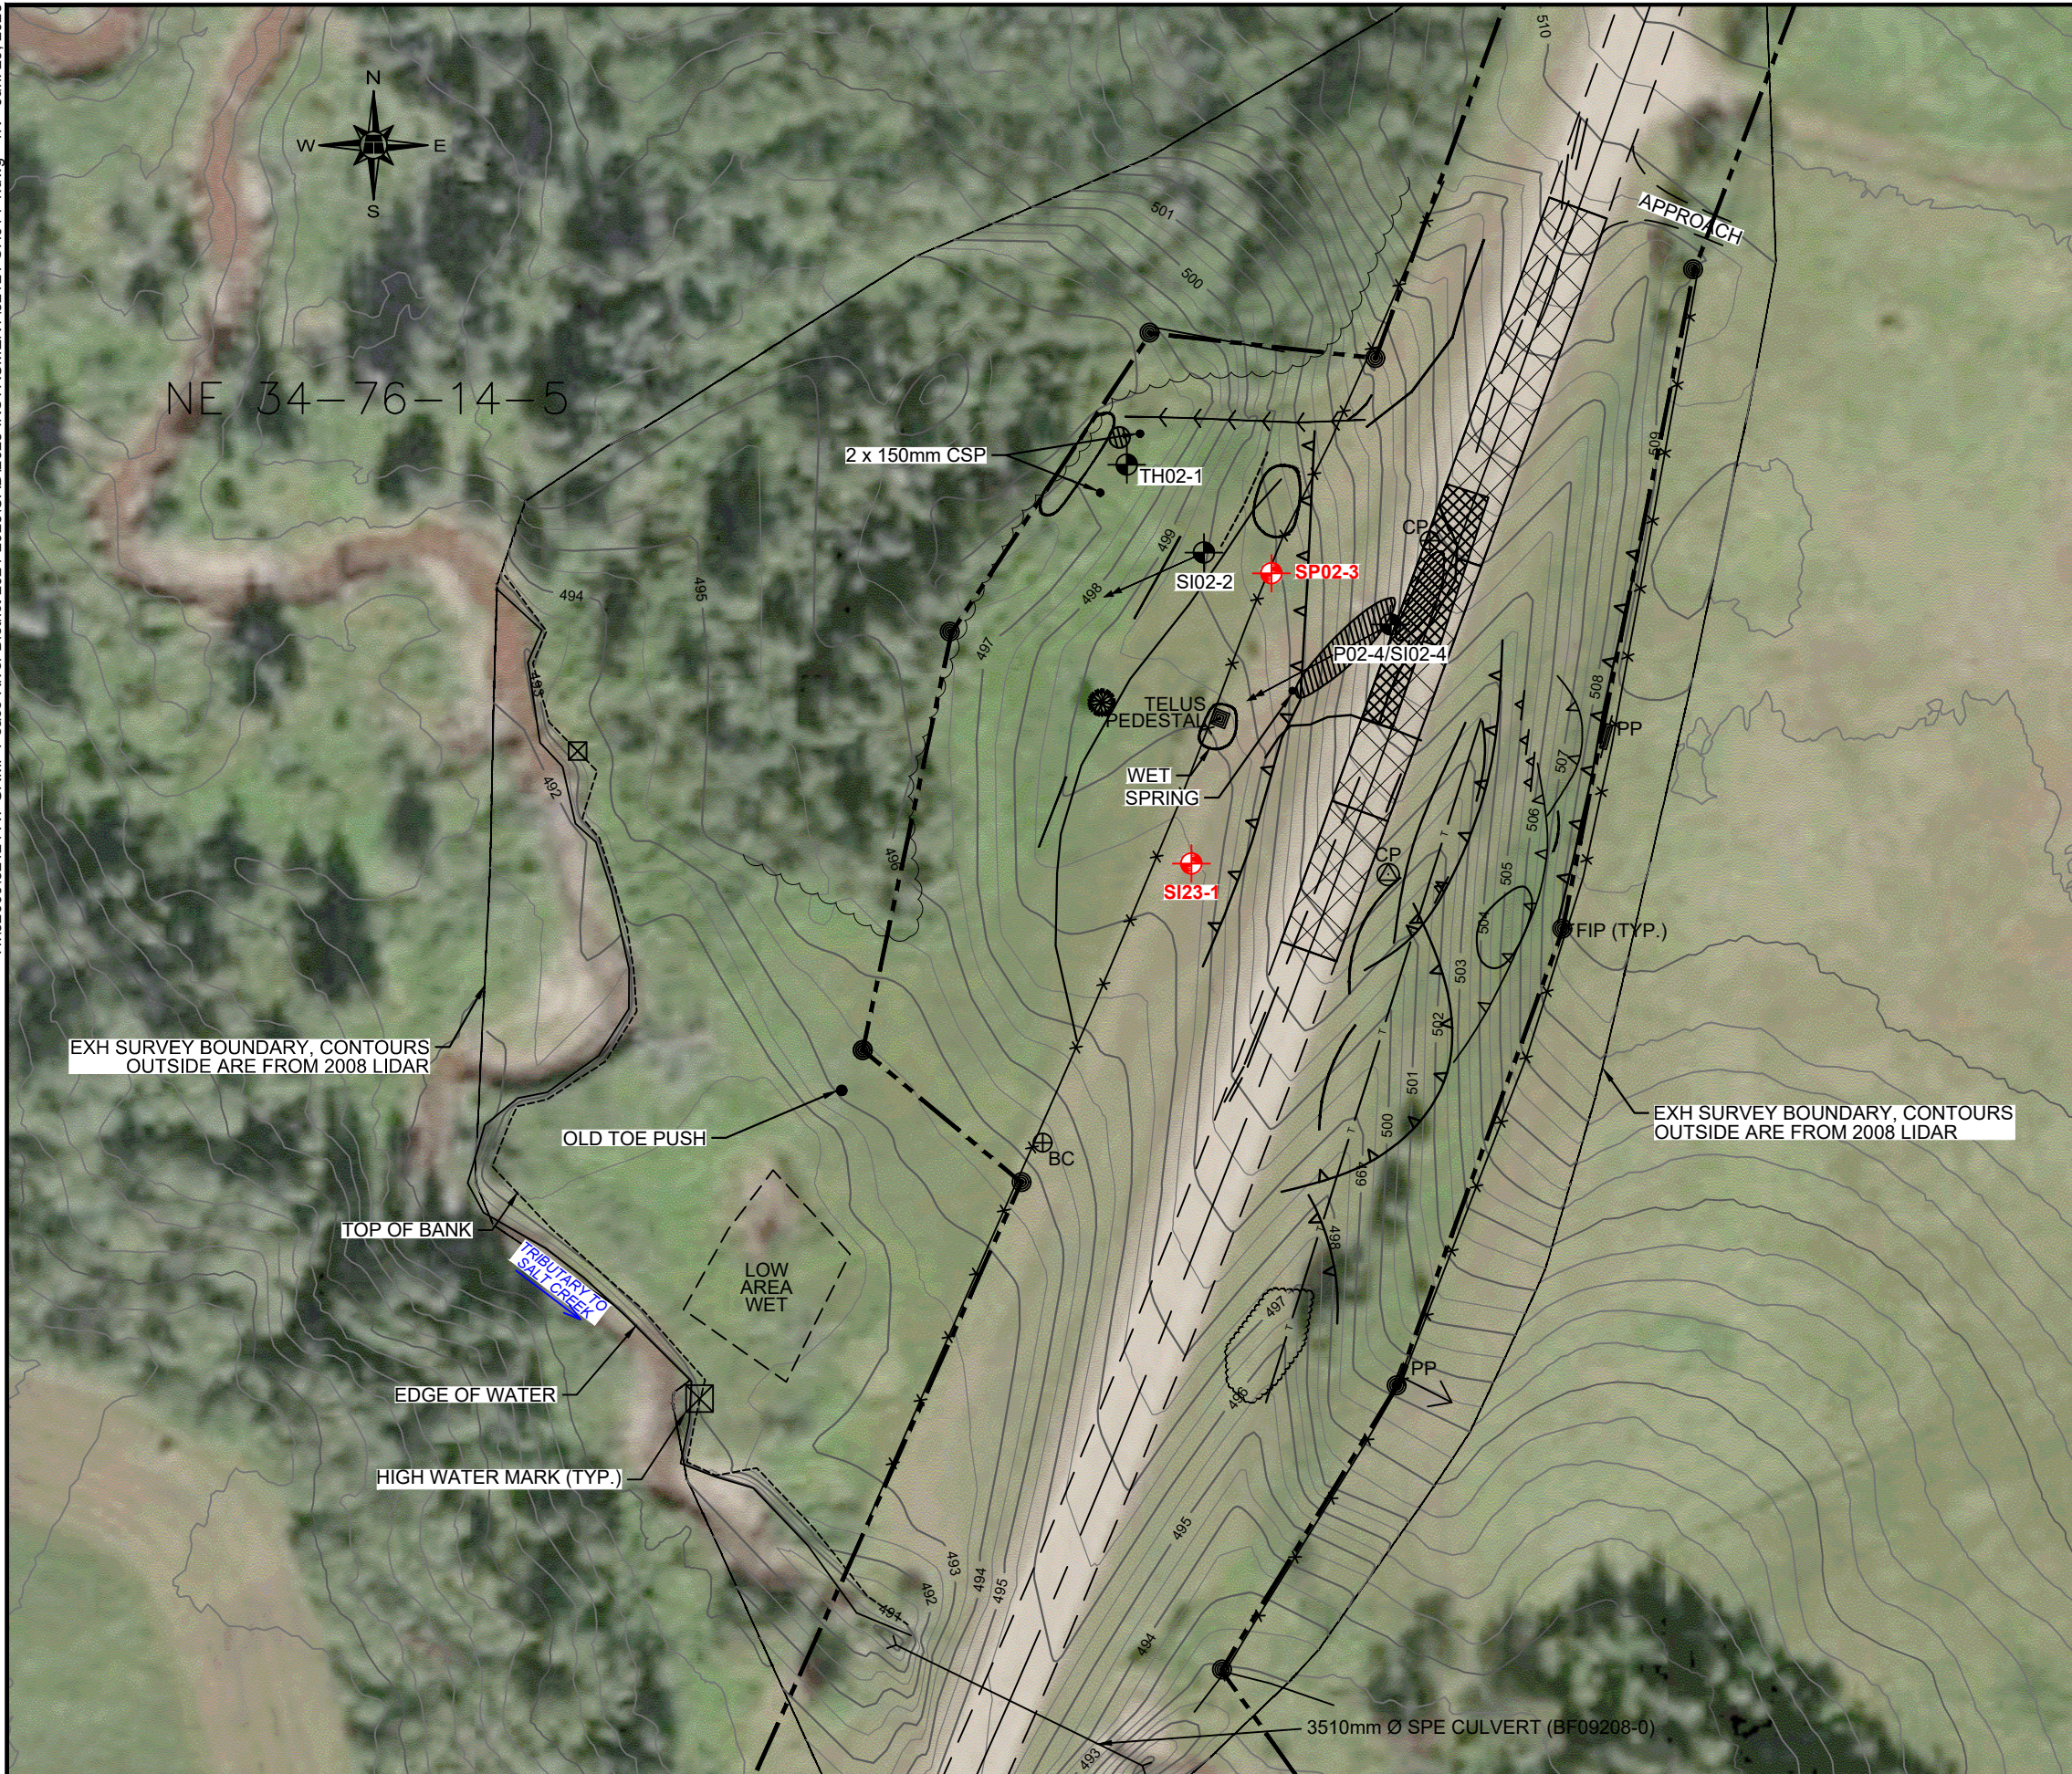
DWG NO. 32121-SH014-1

Drawing 32121-SH014 in Appendix A provides a sketch of the approximate location of the monitoring instrumentation for this site.

**SITE PLAN SHOWING APPROXIMATE
INSTRUMENT LOCATIONS**

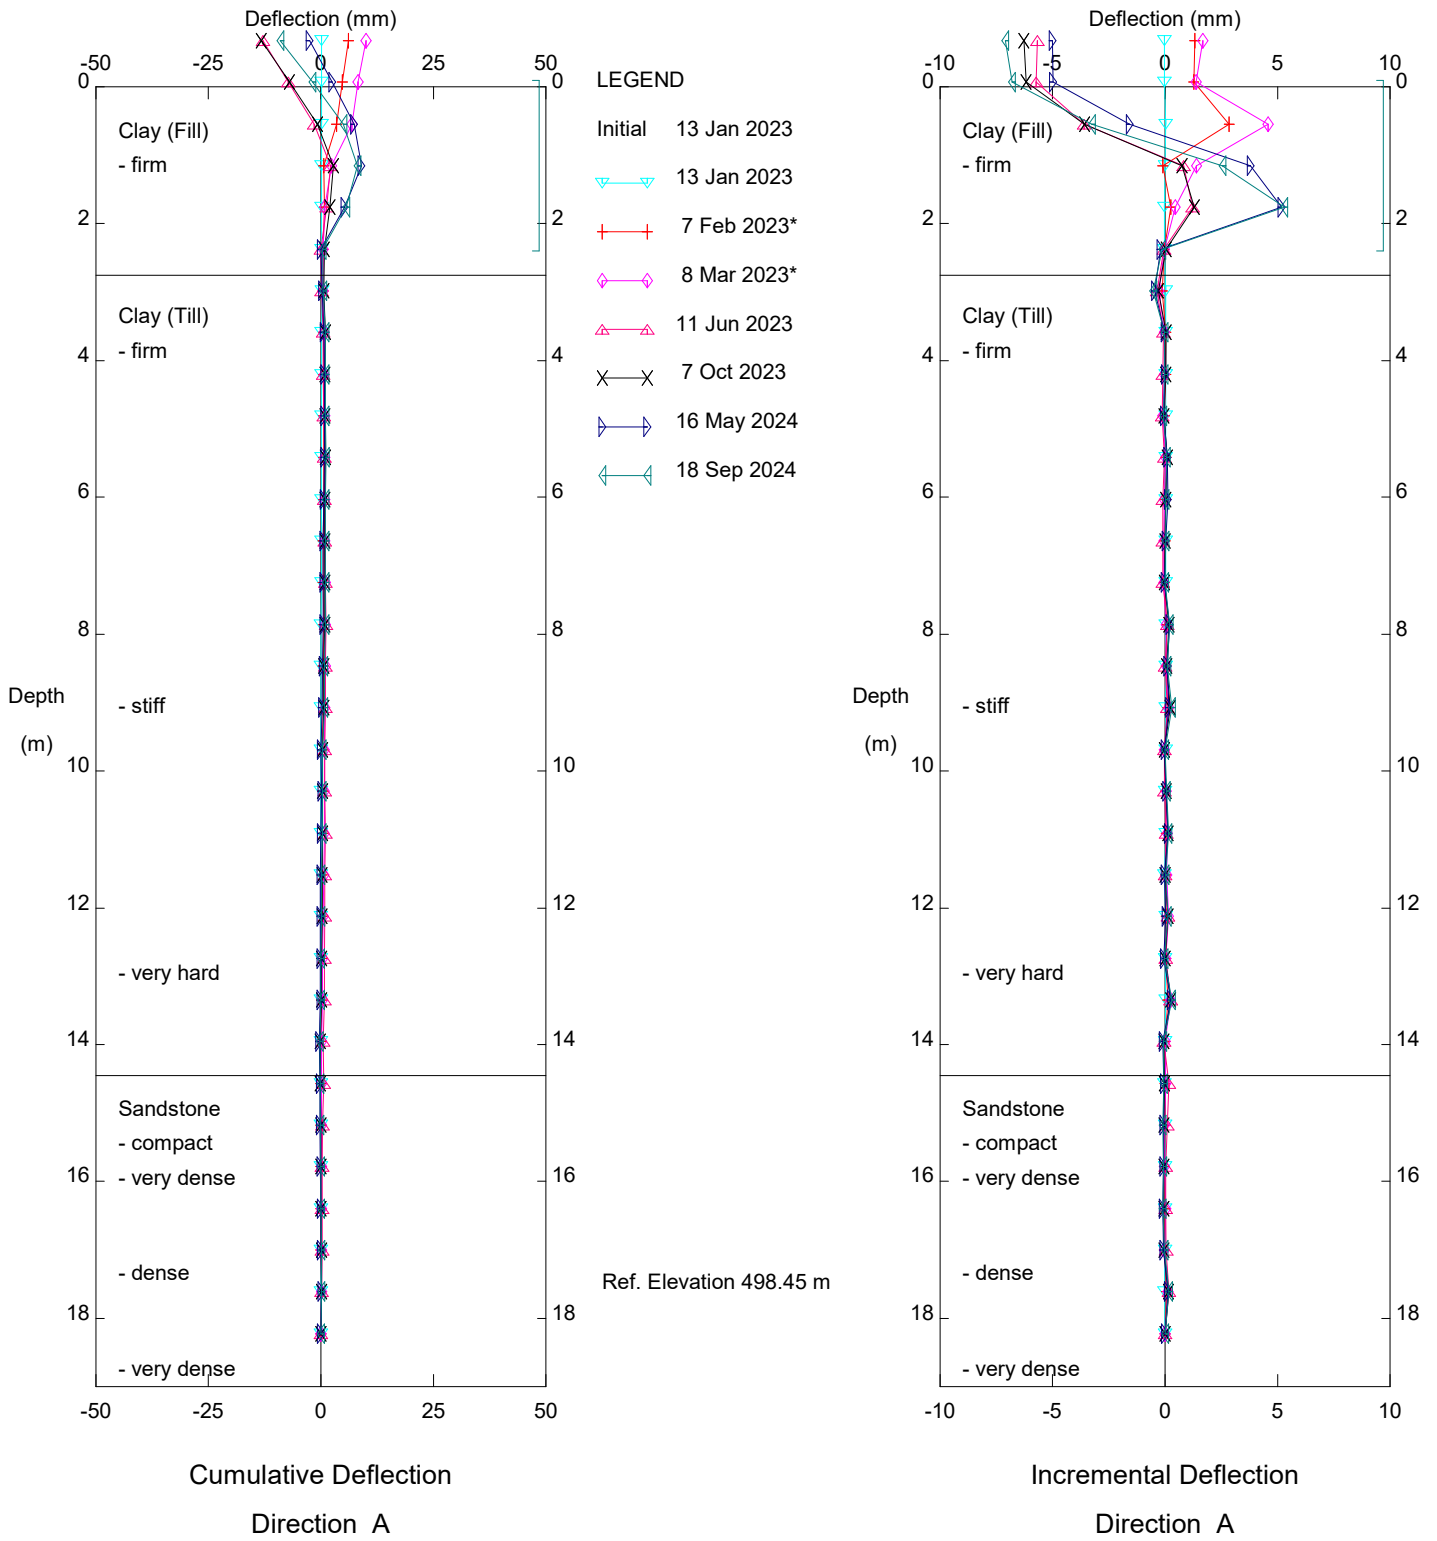
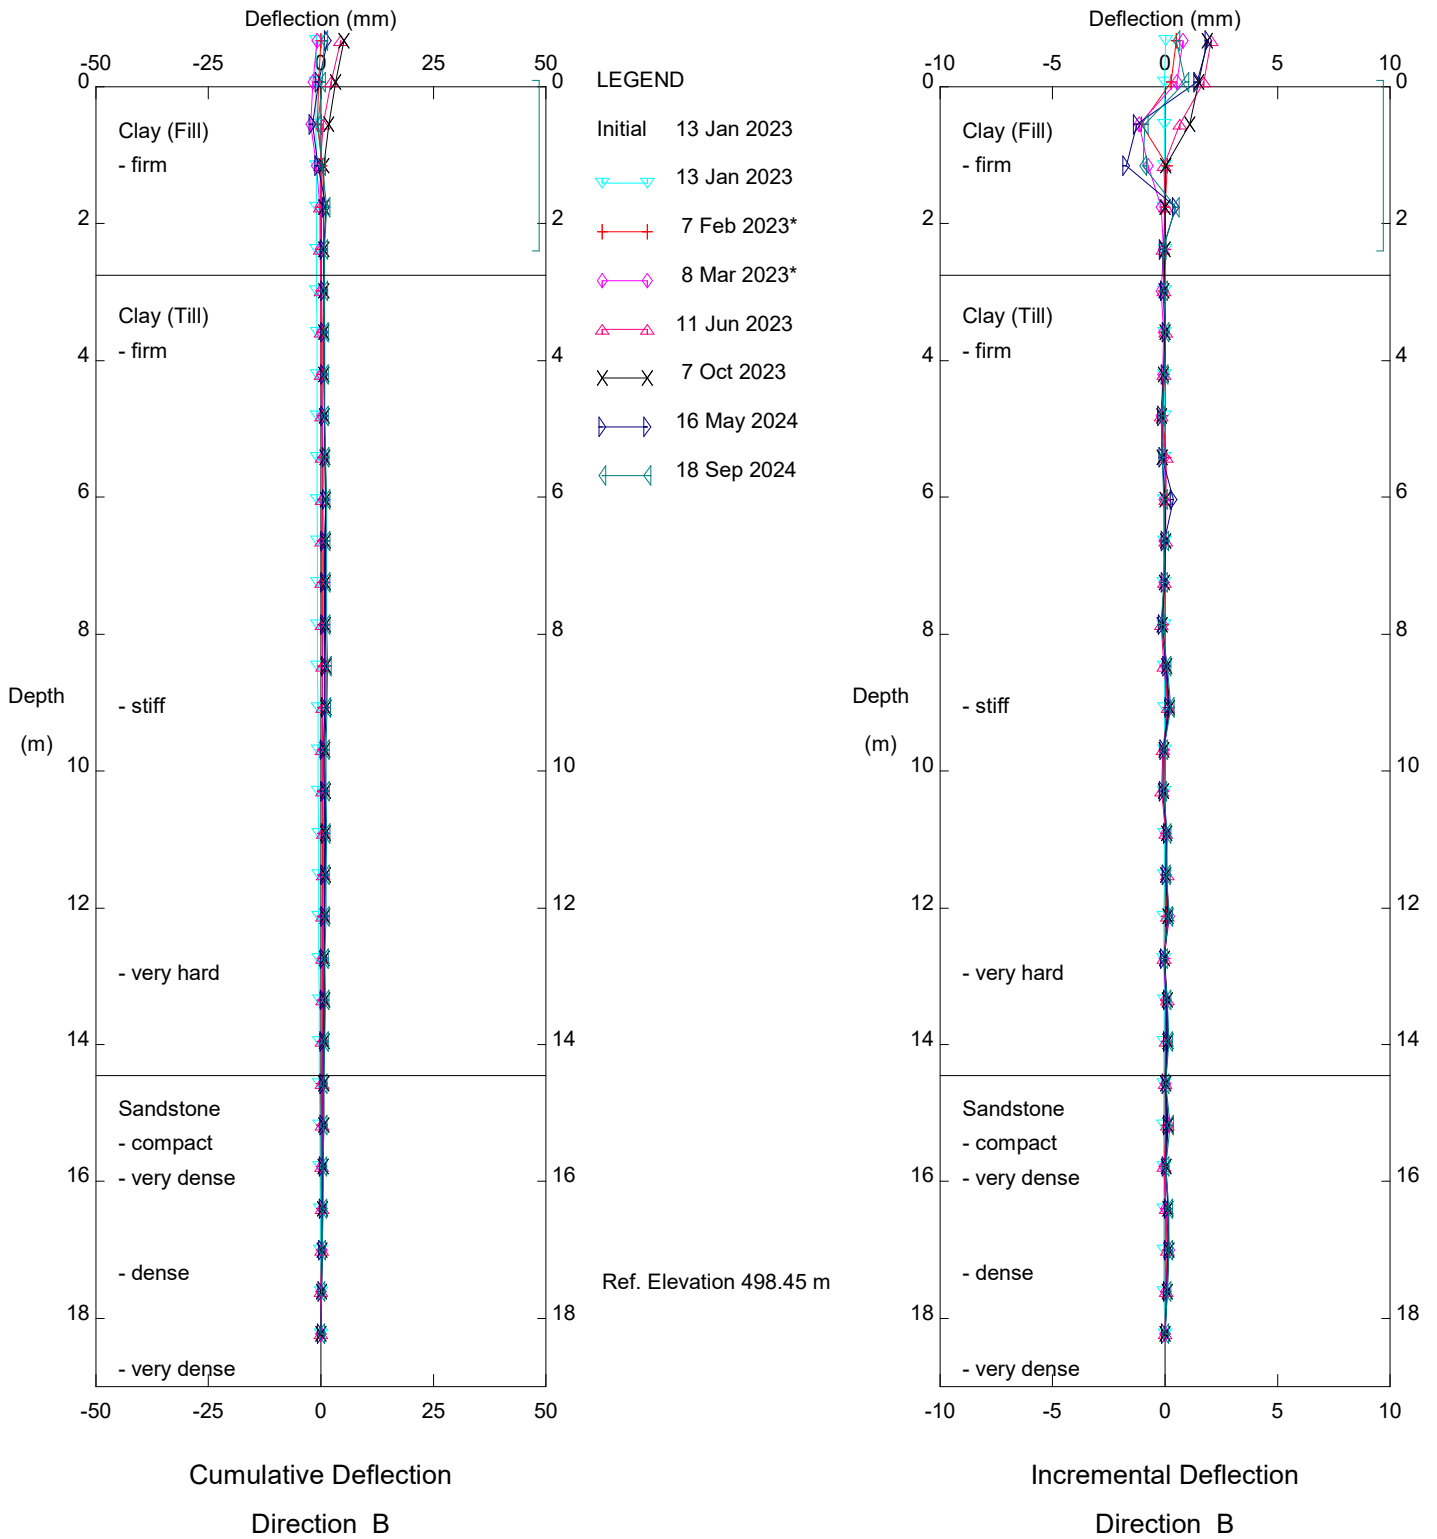
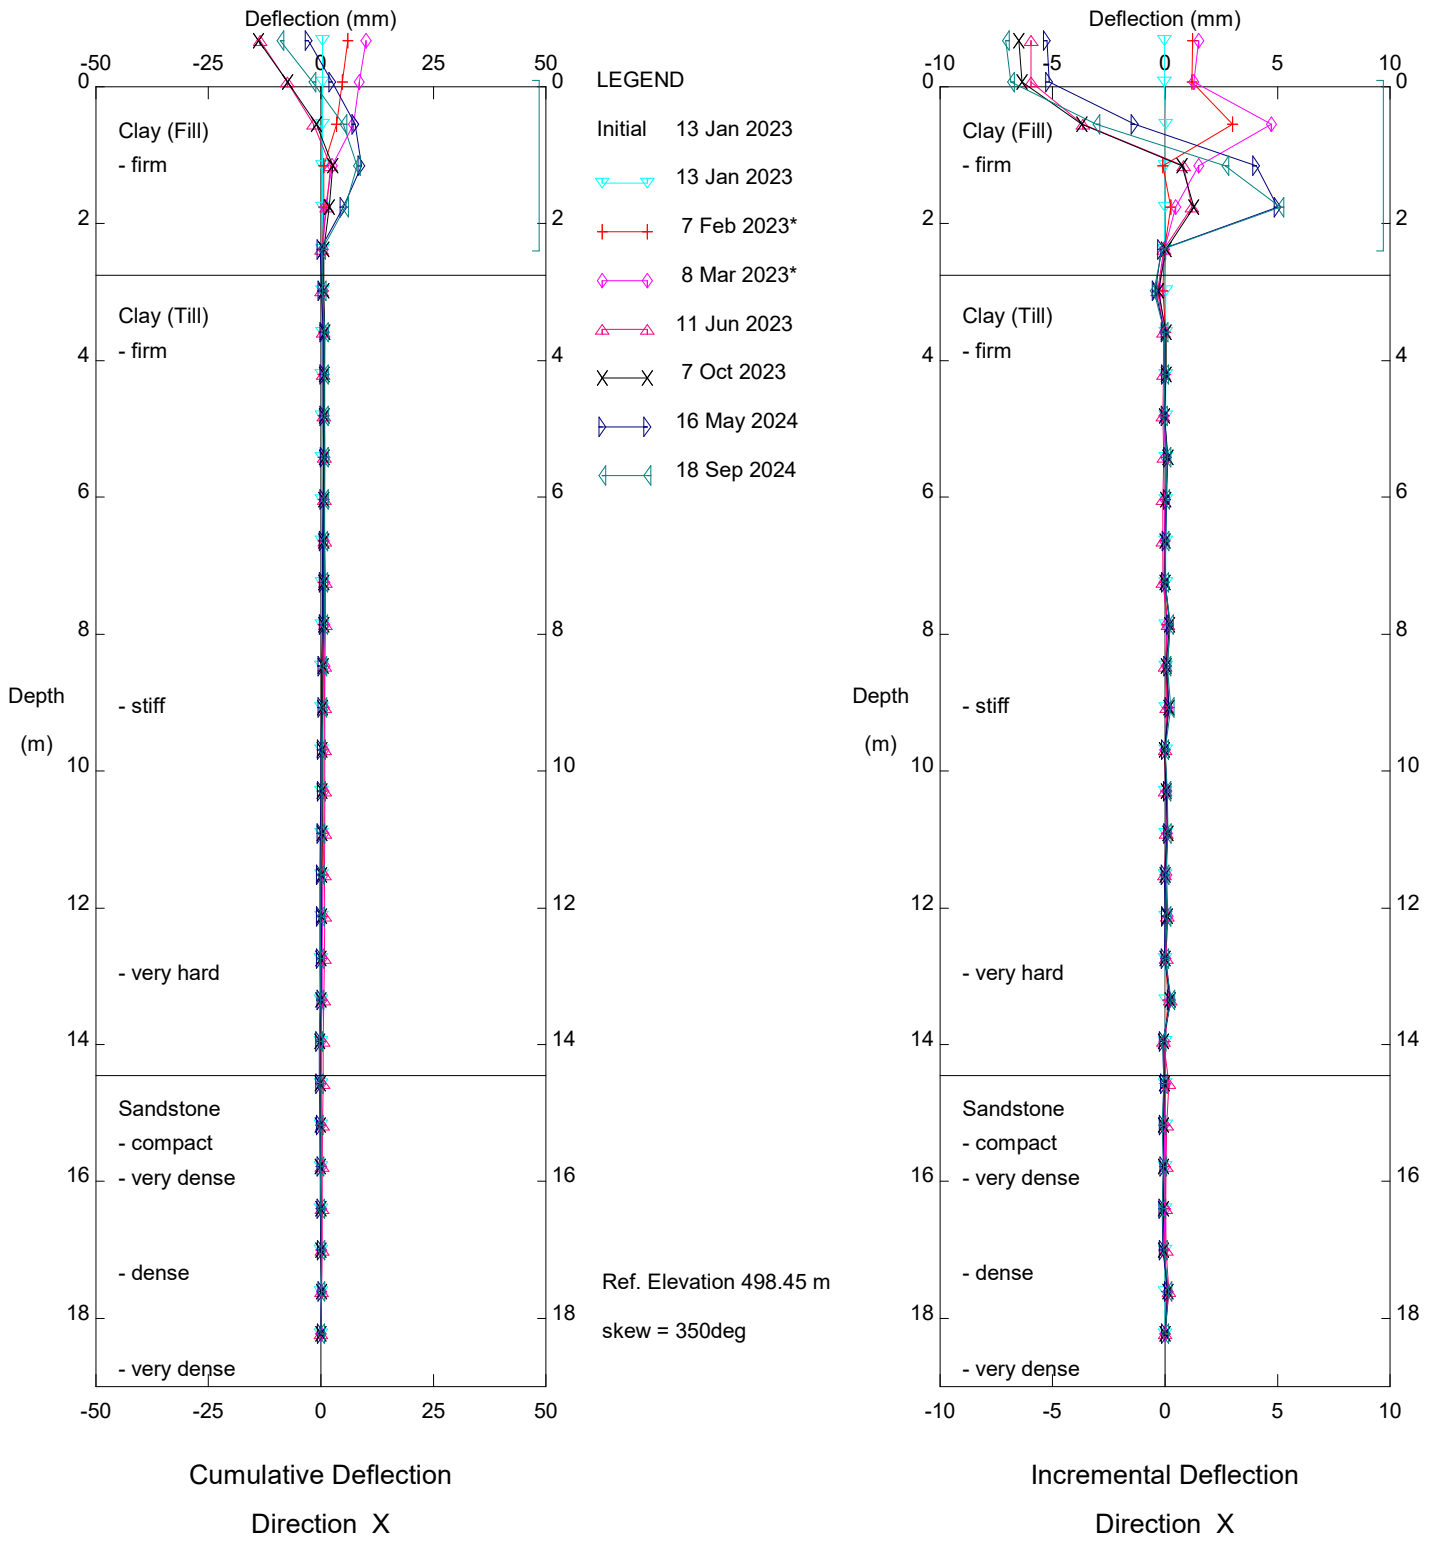
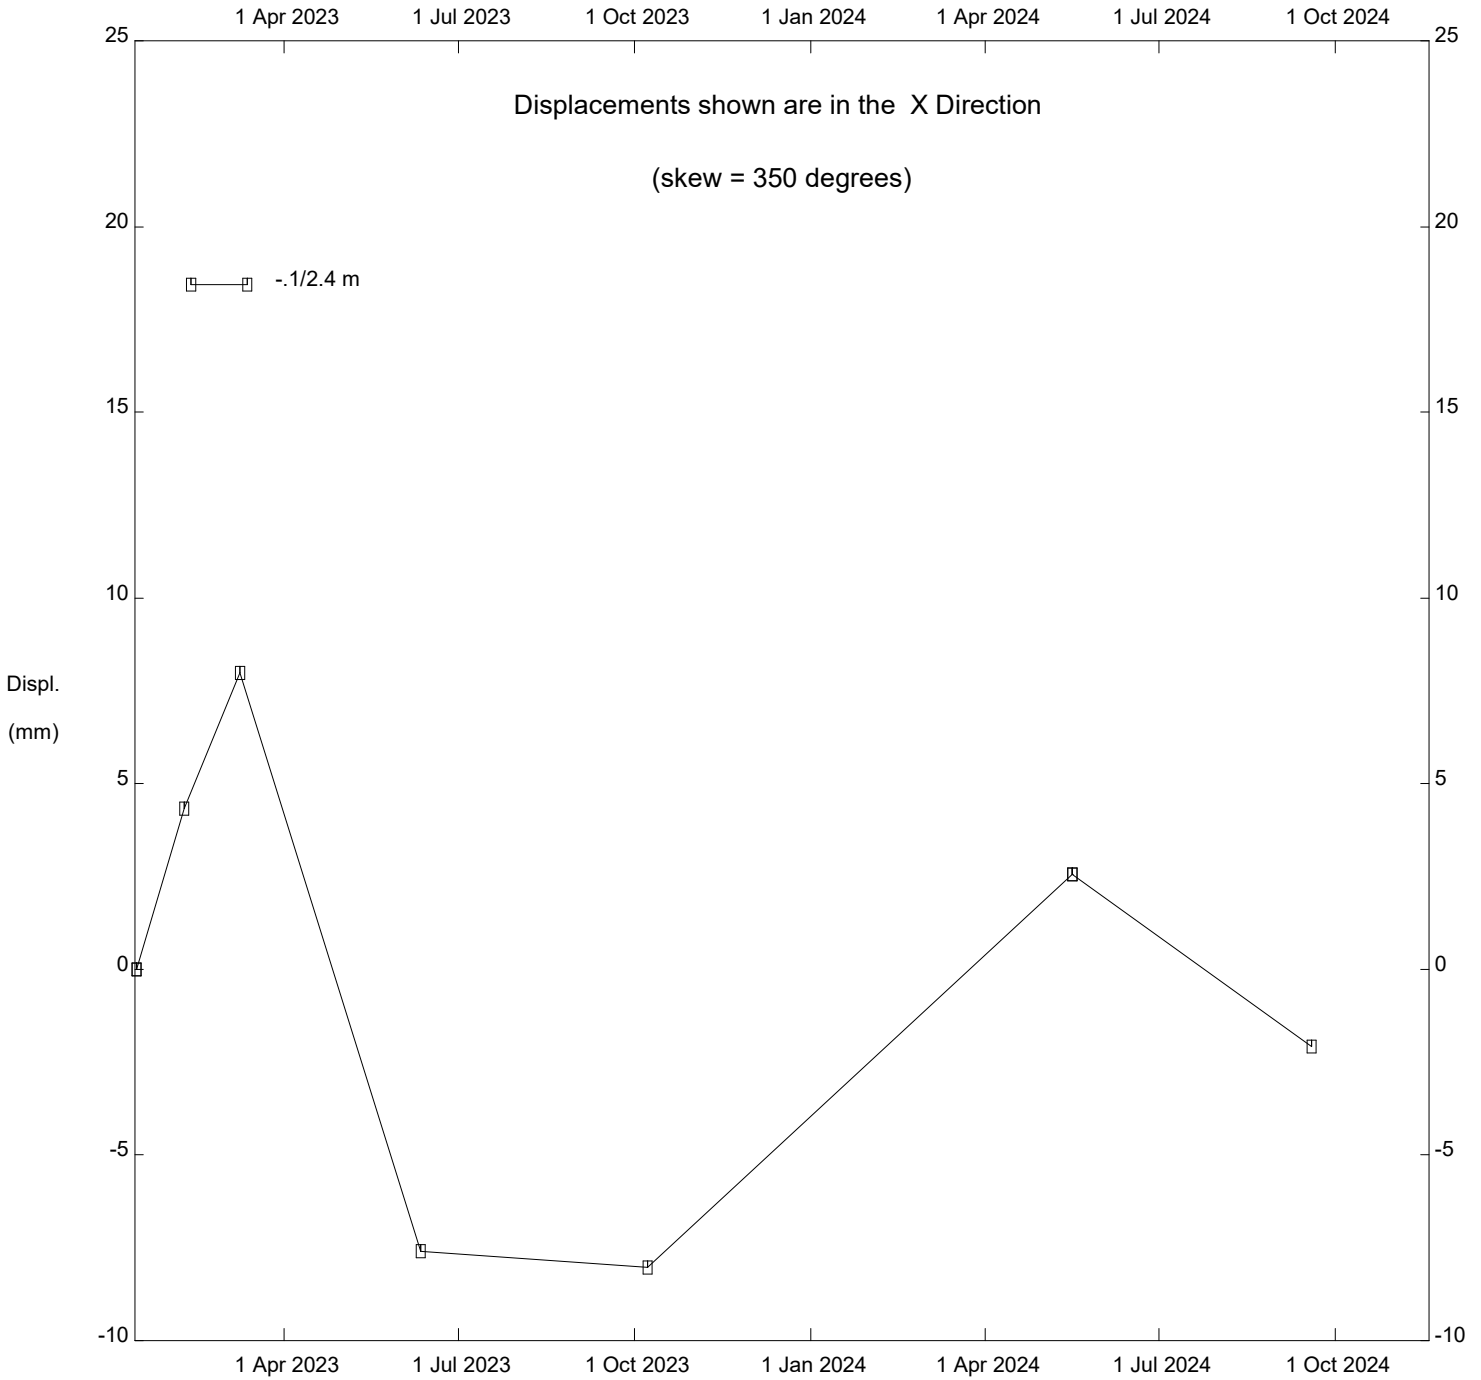
Hwy 750:02 (SH014) Salt Creek, Inclinometer SI23-1

Zones of New Movement:	
Interpretation of Monitoring Results:	<p>SI23-1 showed no discernible movement over 0 m to 2.4 m depth since the spring of 2024 readings. This SI has previously shown alternating movements in the upslope and downslope directions since it was initialized, which may be attributed either to frost action, poor grouting near the top of the SI, or some other disturbance near the top of the SI casing.</p> <p>Standpipe piezometer SP02-3 showed a decrease in groundwater level of 0.28 m since the fall of 2024 readings. The current water level in SP02-3 is 2.15 m below ground surface.</p>
Future Work:	The instruments should be read again in the spring of 2025. The movement zone in SI23-1 over 0 m to 2.4 m depth should be checked to confirm if it represents actual movement.
Instrumentation Repairs:	No instrument repairs are required at this time.
Additional Comments:

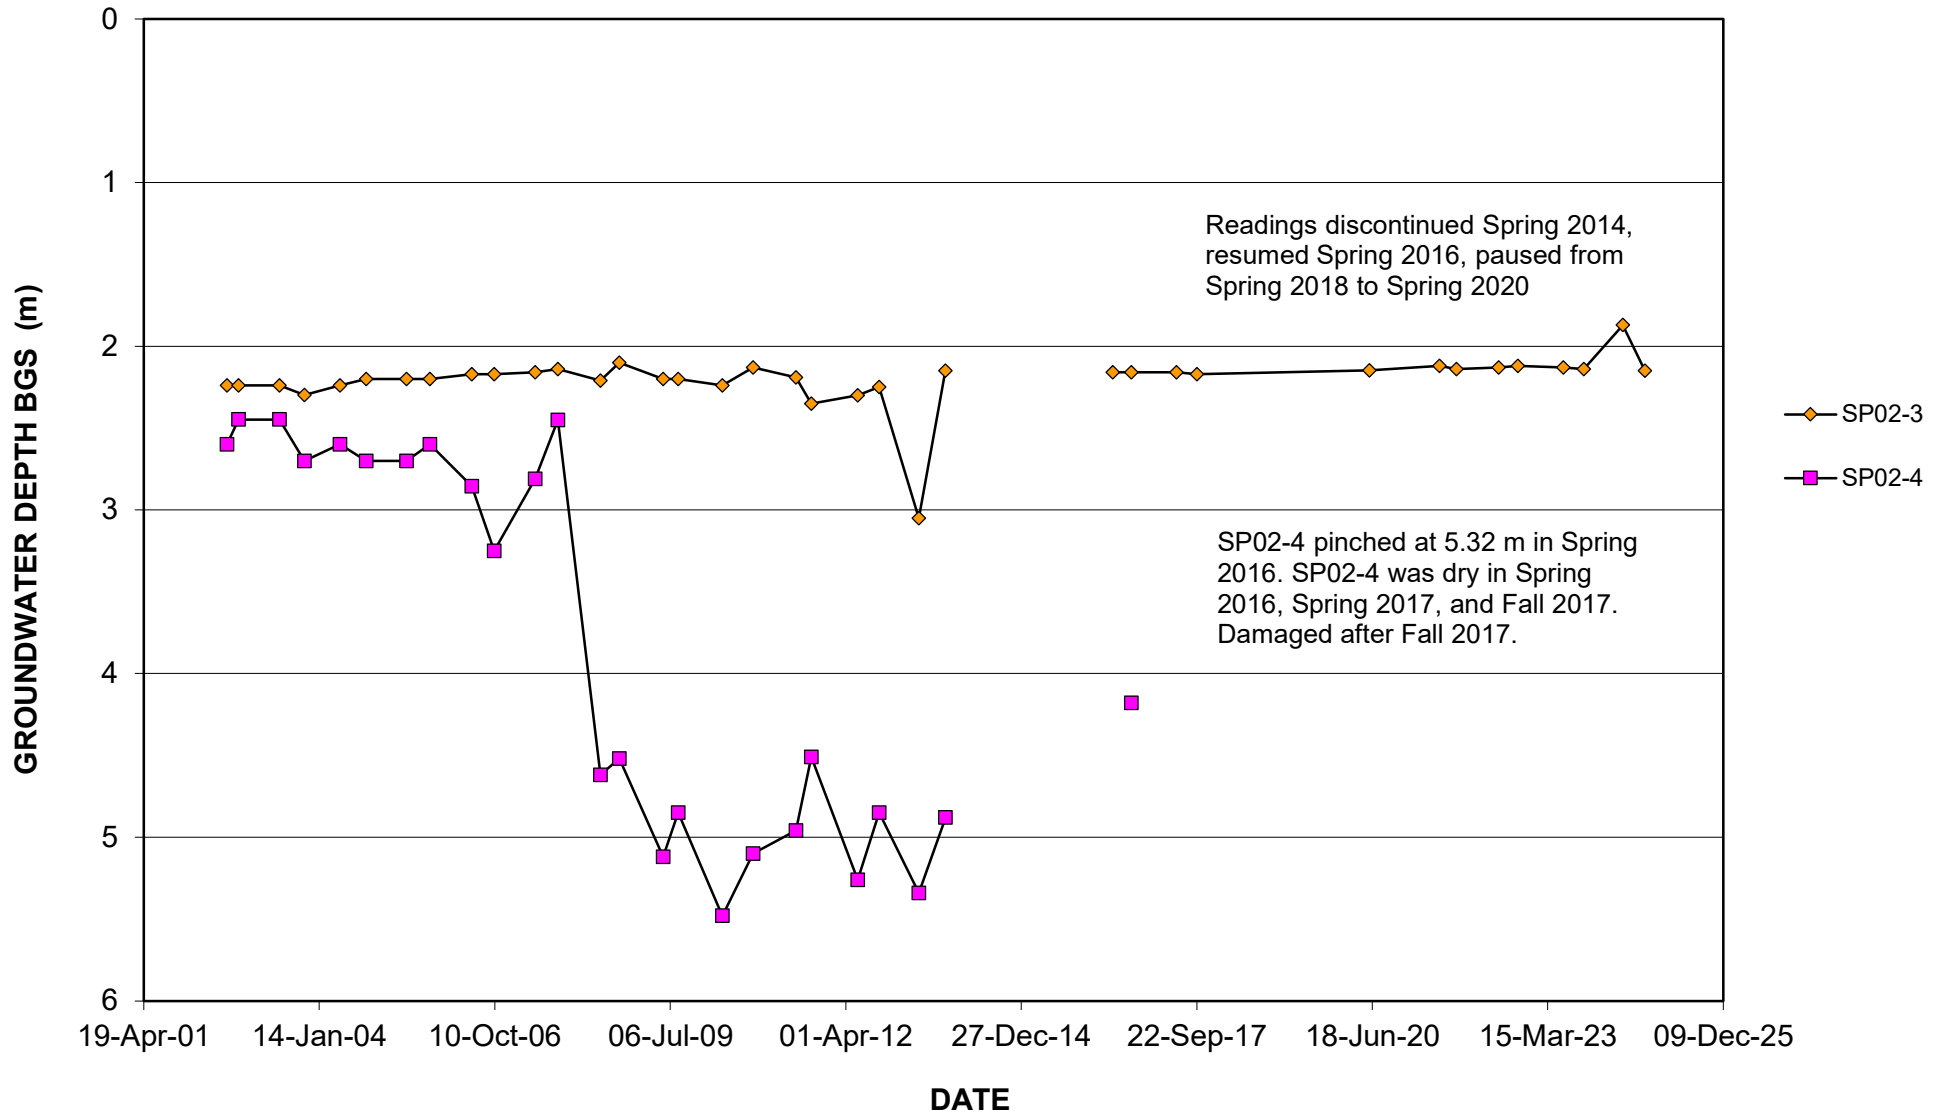
**FIGURE SH014-1
HWY 750:04 SALT CREEK STANDPIPE PIEZOMETER DATA**

INSTRUMENT #	DATE INITIALIZED	TIP DEPTH (m)	GROUND ELEV. (m)	CURRENT STATUS	HIGHEST RECORDED GROUNDWATER LEVEL (mBGS)	MEASURED WATER DEPTH (mBGS)	PREVIOUS WATER DEPTH (mBGS)	CHANGE IN WATER LEVEL SINCE PREVIOUS READING (m)
SP02-3	August 7, 2002	3.59	N/A	Operational	1.87 in May 2024	2.15	1.87	-0.28
SP02-4	August 7, 2002	8.38	N/A	Damaged	2.45 in October 2007	N/A	DRY (Sep. 22, 2017)	N/A
