Site Number	Location	Name	Hwy	km
SH014	HWY 750:02 C1 30.582	Salt Creek Slide	750:02	Km 30.6
Legal Description:		UTM Co-ordinates		
16-34-76-14 W5		11U E 558275	N	6165556

Current Monitoring:	16-May-2024	Previous Monitoring	07-Oct-2023
Instruments Read By:	Mr. Niraj Regmi, G.I.T., and Mr. Nixson Mationg, Thurber

**ALBERTA TRANSPORTATION AND ECONOMIC CORRIDORS GRMP (CON0022164)
PEACE REGION (PEACE RIVER DISTRICT)
INSTRUMENTATION MONITORING RESULTS**

SITE SH014: HWY 750:02 (SALT CREEK SLIDE)

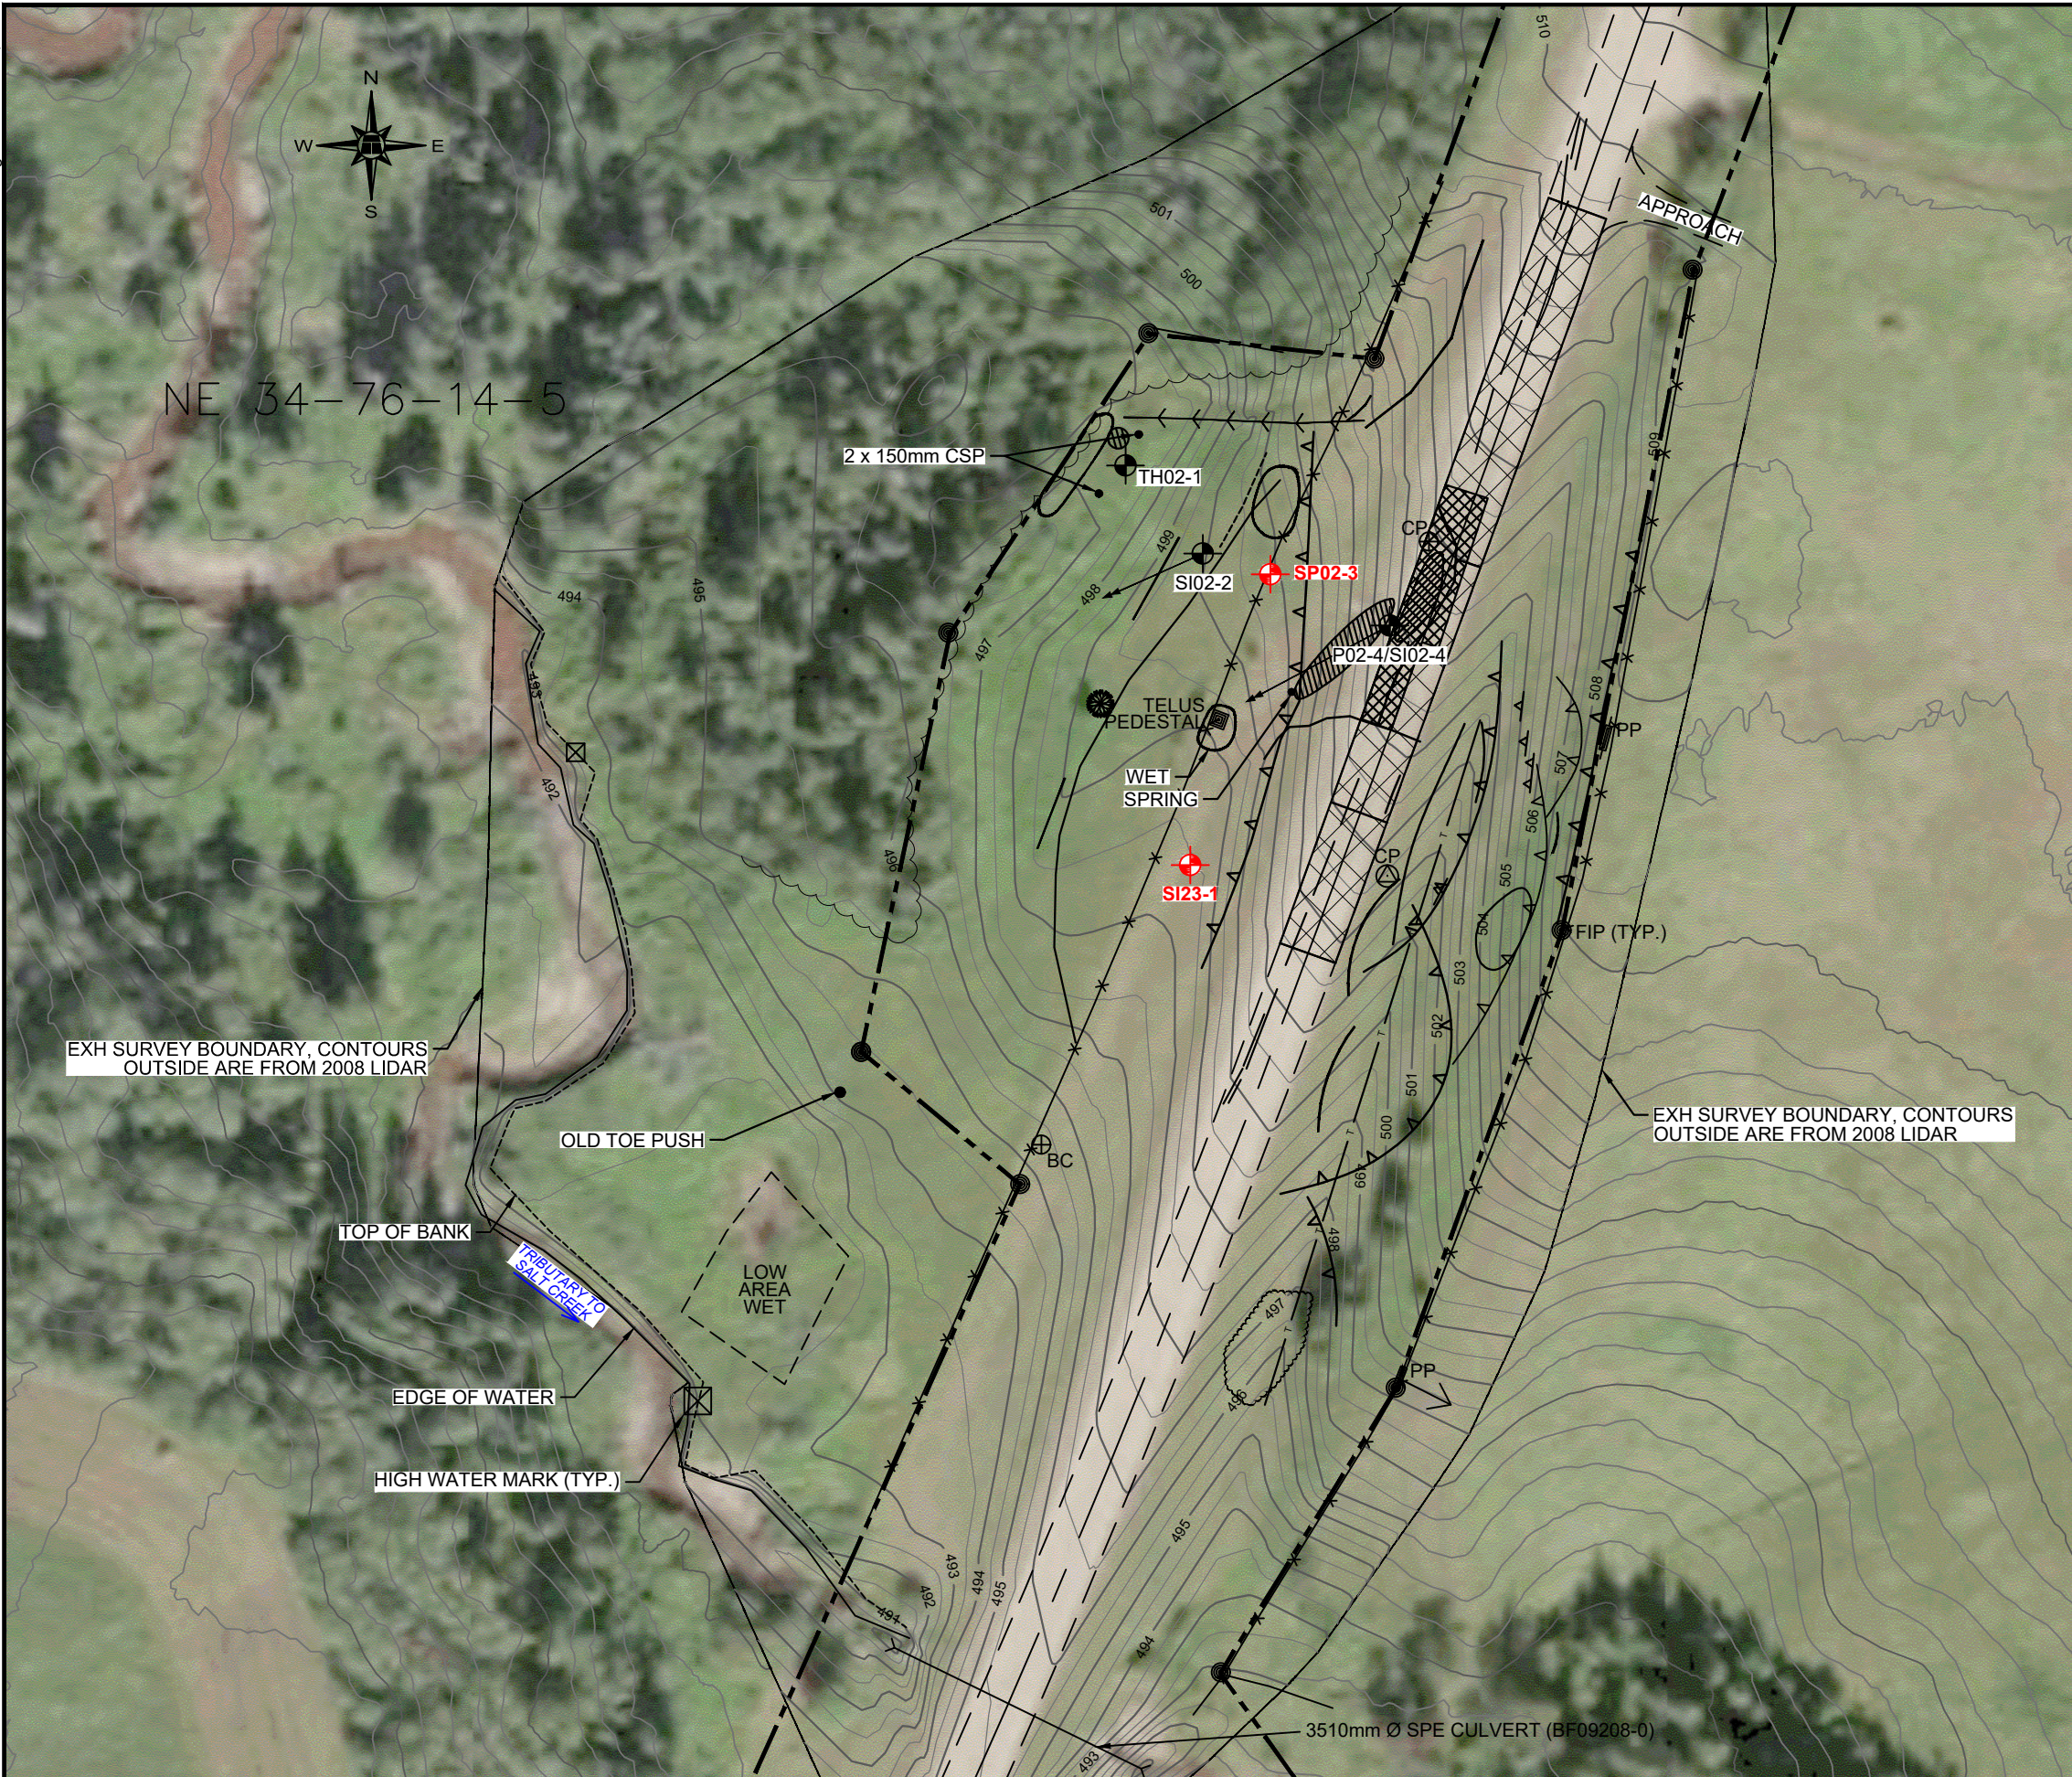
DWG NO. 32121-SH014-1

**SITE PLAN SHOWING APPROXIMATE
INSTRUMENT LOCATIONS**
