## Site 15 – Opal Ridge Rock Slide

PROJECT: HWY 40/HWY 541 GEOHAZARDS REVIEW				
	TITLE: OPAL RIDGE ROCK SLIDE				
CLIENT:	DATE: DECEMBER 2005	JOB No.: CG25211	CAD FILE: 25211N01.dwg	FIGURE No.: FIGURE E4	REV. A

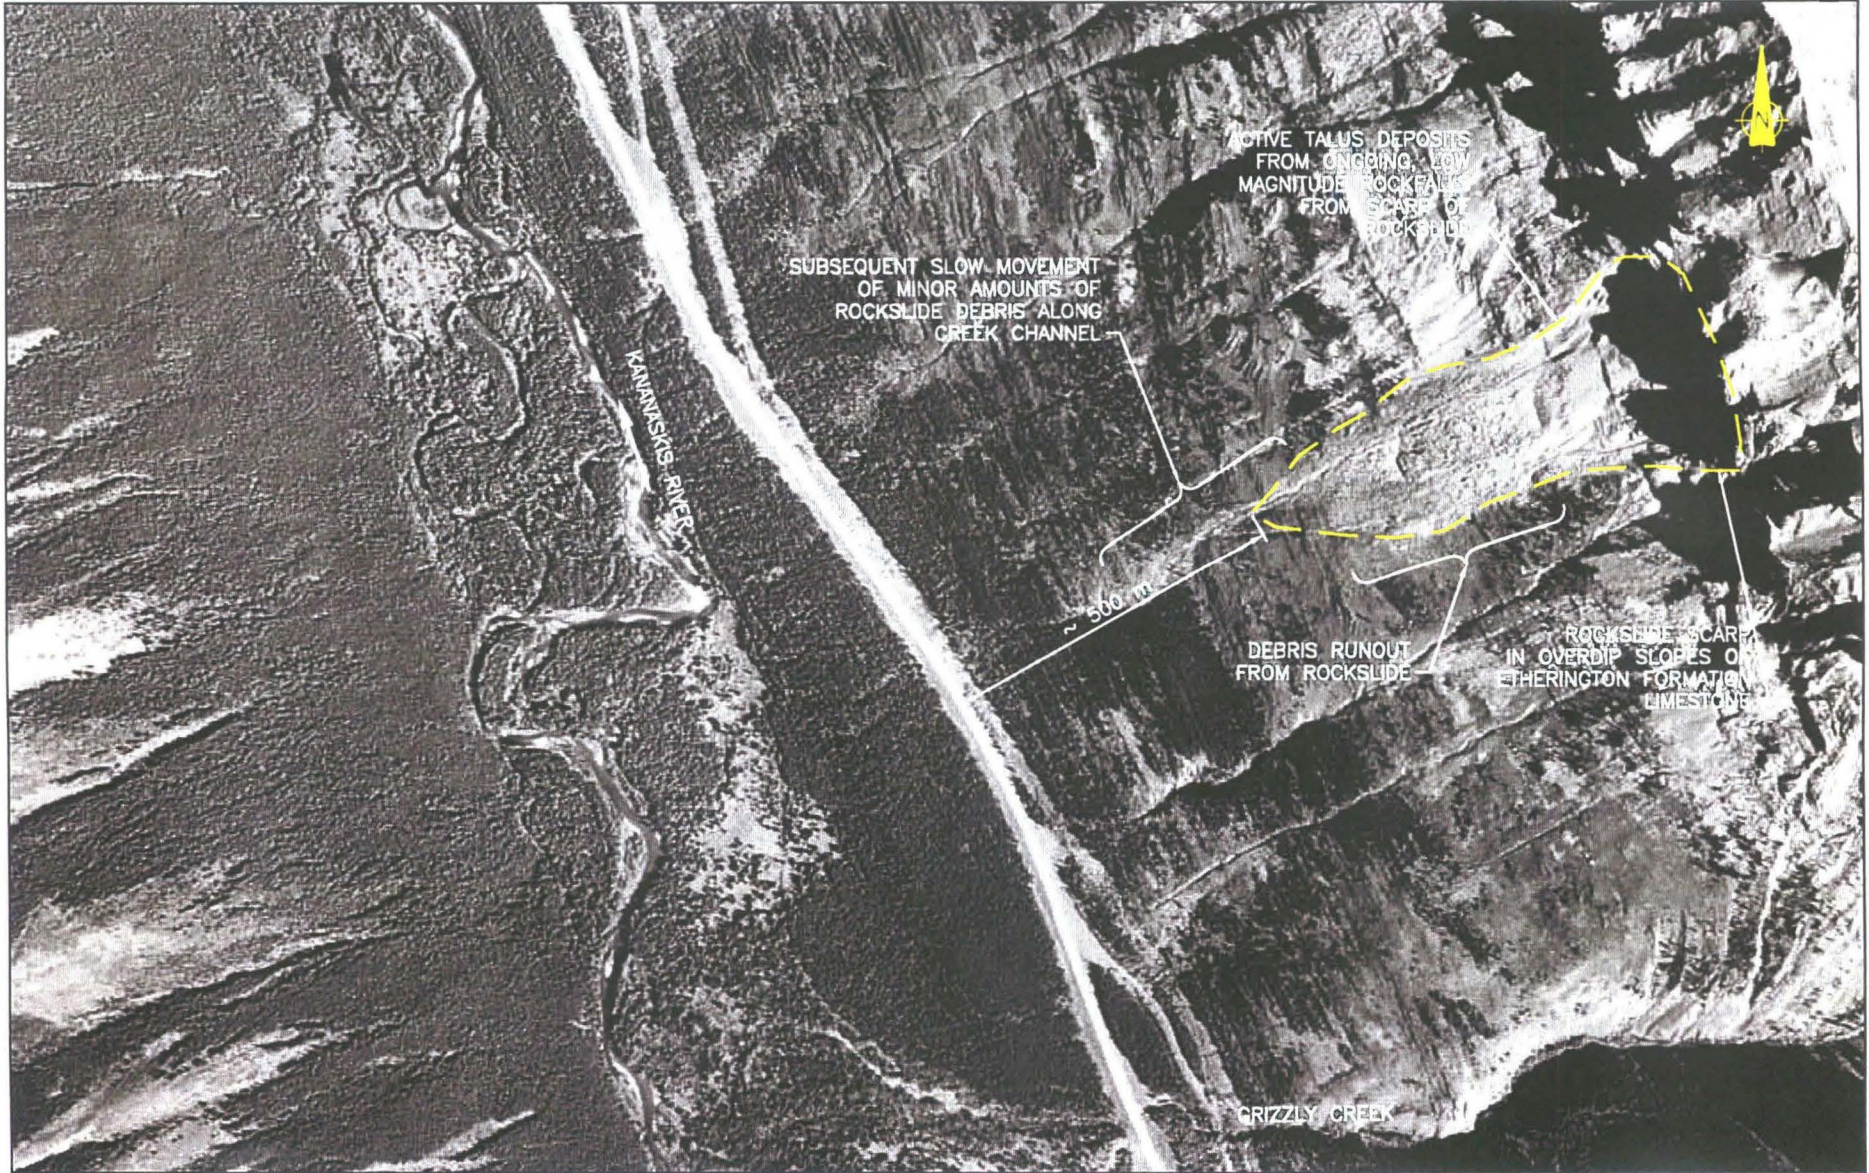
This site is located upslope of Highway 40 and approximately 1.7 km south of Fortress Junction. This segment of the highway parallels the northwest/southeast trending Opal Range. There is a deposit of rockslide debris on the upper half of the slope and approximately 500 m above the highway. This rockslide deposit was mapped by Cruden and Eaton (1985) on airphotos of the site that were taken in 1958. An annotated copy of a 1999 airphoto of the site is attached as Figure E4. The extent of the rockslide debris did not change significantly between the 1958 and 1999 airphotos.

The rockslide above the highway originated in the uppermost portion of the slope above the highway in an over dip<sup>1</sup> slope of Etherington Formation limestone. The middle and lower portions of the slope above the highway also expose Etherington Formation limestone, however the slope angle is less steep and these areas are under dip slopes. The debris from the rockslide ran downslope for a maximum distance of approximately 500 m and the downslope extent of the rockslide debris is approximately 500 m above the highway. The extent of the rockslide debris and its location relative to the highway is shown on Figure E4. It appears on both the 1958 and 1999 airphotos that small amounts of the rockslide debris have been moving further downslope along a small creek channel, likely transported by surface runoff, entrainment in snow avalanches and ongoing downslope creep due to gravity.

Cruden and Eaton (1985) mapped this rockslide as a low frequency/high magnitude event. The timing of the rockslide prior to the 1958 airphoto is not known, and it may have occurred hundreds, or even thousands, of years earlier because the majority of the debris is at or above treeline and the limestone debris would not readily weather into soils that could support vegetation. This rockslide illustrates the type of rock slope instability that could occur along the over dip bedrock slopes above this segment of the highway. However, the hazard to the highway from this type of rockslide is judged to be low based on the distance between the highway right-of-way and the over dip slopes on the upper portion of the slope above the highway that would be the source area of such a rockslide if one were to occur in the future.

Cruden and Eaton (1985) also showed an area of active talus deposits along the upslope edge of the rockslide debris. These talus deposits are generated by ongoing, high frequency/low magnitude rockfalls from the oversteepened cliffs around the scarp of the rockslide. These rockfalls are not a hazard to the highway.

Therefore, the recommended Risk Level for this site is 2.

No further work is recommended for this site.
