Highway 940 – Upper Wilkinson Creek Valley, Km 82.5 Gully Erosion

Alberta Transportation
Geohazards Review – Highway 940 Sites
Upper Wilkinson Creek Valley, Km 82.5 Gully Erosion
CG25262
April 2009

Hwy 940 – Upper Wilkinson Creek Valley Km 82.5 Gully Erosion

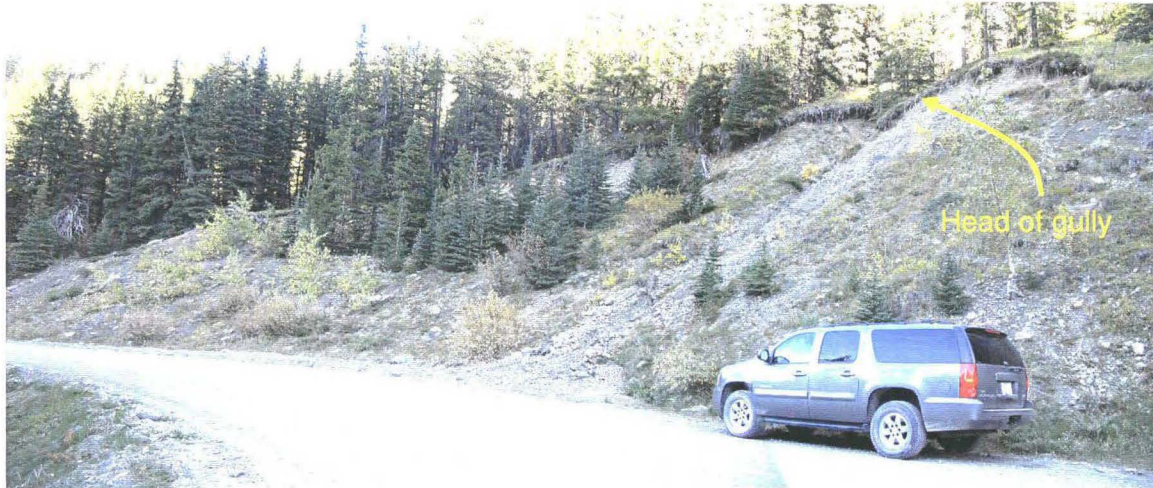
- The cutslope along the upslope edge of the road at this site is at approximately 30 to 32° inclination and exposes rocky soil with up to cobble and possibly even boulder-sized particles. Portions of the cut slope are treed, but the majority of the slope exposes rocky soil/colluvium. Photo 940-48 shows the cut slope.
- The road is approximately 9 m wide in this area.
- As shown in Photos 940-48 and 940-49, there is an erosion gully in the cutslope. The gully is greater than 20 m long, and extends for the length of the cutslope.
- There is a negligible to very small ditch along the toe of the cut slope. It appears that a debris lobe from the outlet of the gully encroached onto the road surface earlier in 2008. As shown in Photo 940-50, the portion of the debris lobe on the road surface had been graded clear earlier in 2008.

Photo 940-48 (top) – General view of the cut slope along the highway. Note that the gully headwall is around the crest of the cut slope, i.e. the gully runs the entire length of the cut slope.

It is recommended that AT continue to treat the debris from the gully as a maintenance issue, with any accumulated debris cleared from the road before it is opened to traffic

each year on May 1st and promptly if and when required to do so between May 1st and November 30th of each year.

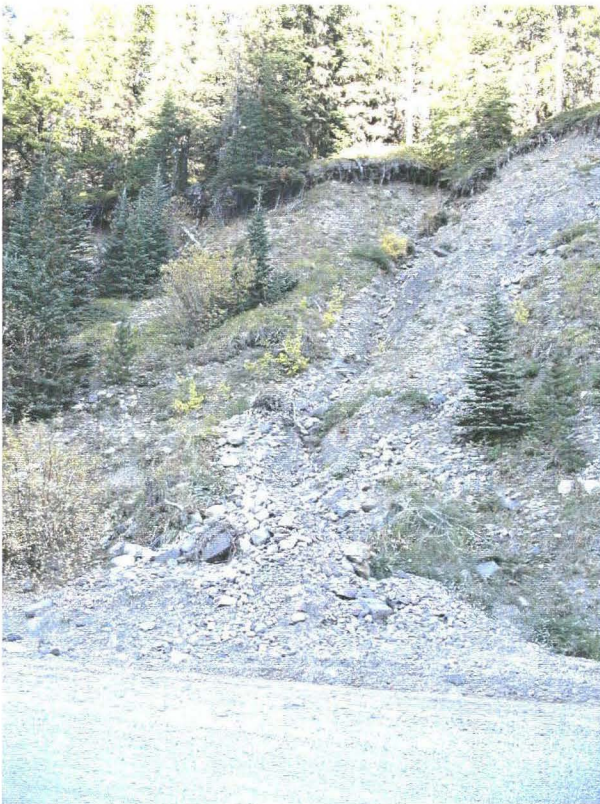
The ditch capacity at this site is very limited and debris from the gully is prone to filling the ditch and then spilling onto the upslope side of the road. Presumably, any debris that accumulates when the road is closed to traffic between December 1 and April 30 each year is removed from the road when it is regraded at the start of each season.

Photo 940-49 (bottom) – Closer view of the gully with the debris fan along the upslope edge of the road.

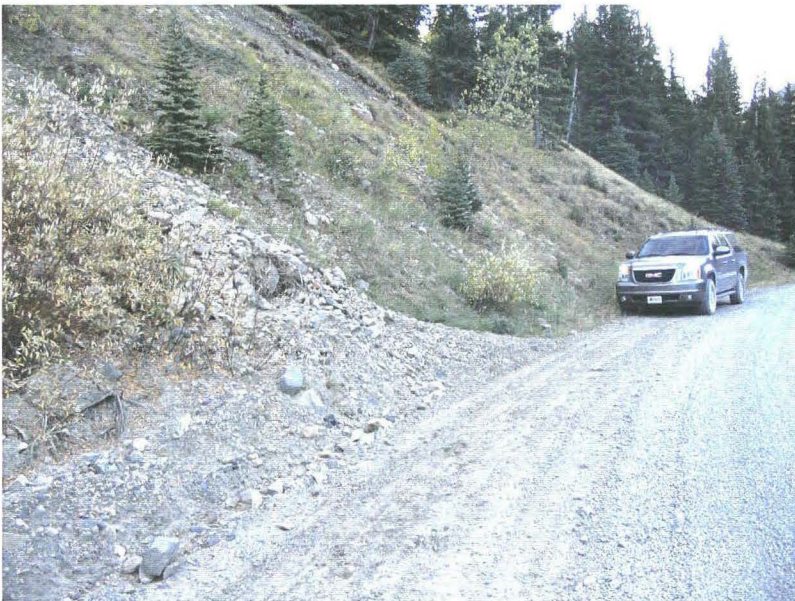
Photo 940-50 (top) – Facing northbound across the toe of the cut slope. Note how the debris from the gully extends to the upslope edge of the road and overflows from the negligible ditch. The lowermost portion of the fan had been graded out to clear the road earlier in 2008.
