Highway 940 – Dry Creek Colluvial Fan (Km 77.8)

Hwy 940 – Dry Creek Colluvial Fan (Km 77.8)

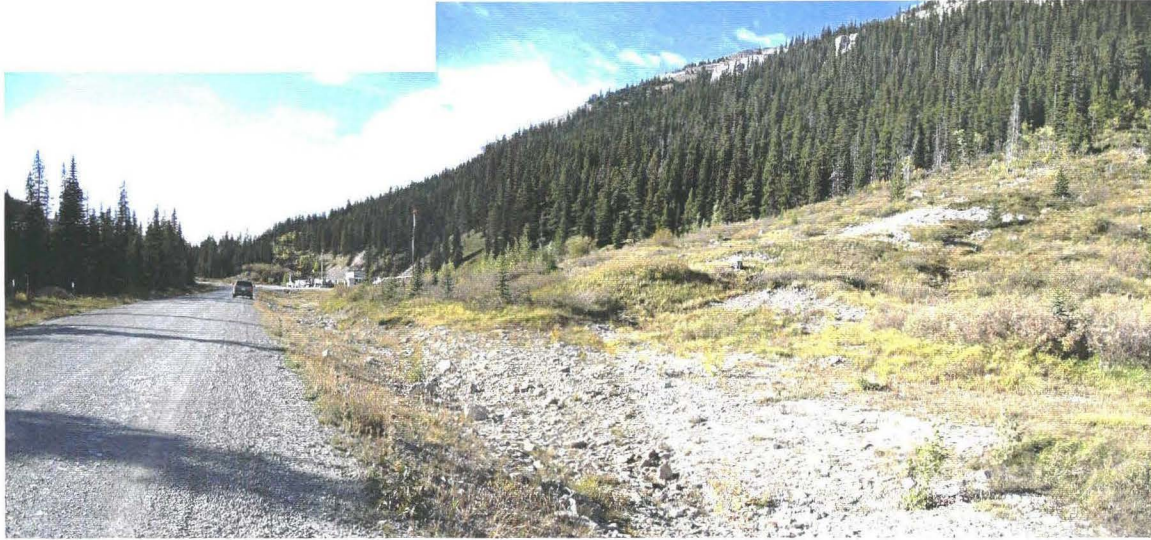
- The highway crosses the lowermost portion of a colluvial fan that has accumulated around the lower portion of a seasonal drainage channel on the south slope of Plateau Mountain. Photo 940-37 shows the relative locations of the lowermost portion of the fan and the road.

- The lower portion of the fan is at an angle of approximately 10° and is vegetated, with no active surface channel visible. As shown in Photo 940-37, it appears that the lowermost portion of the fan was graded flat for the road around the area where the original fan tapered out and blended into the Dry Creek valley floor.

Photo 940-37 (top) – Facing west/northbound across the lower portion of the fan which slopes at 10°. It appears that the lowermost portion of the fan was graded flat for the construction of the highway. There was no active surface creek channel visible on the fan at the time of the site inspection.

actively accumulating near the highway at this time. Based on the site appearance, the debris flow hazard at this site is judged to be very low.

No further work is recommended for this site.

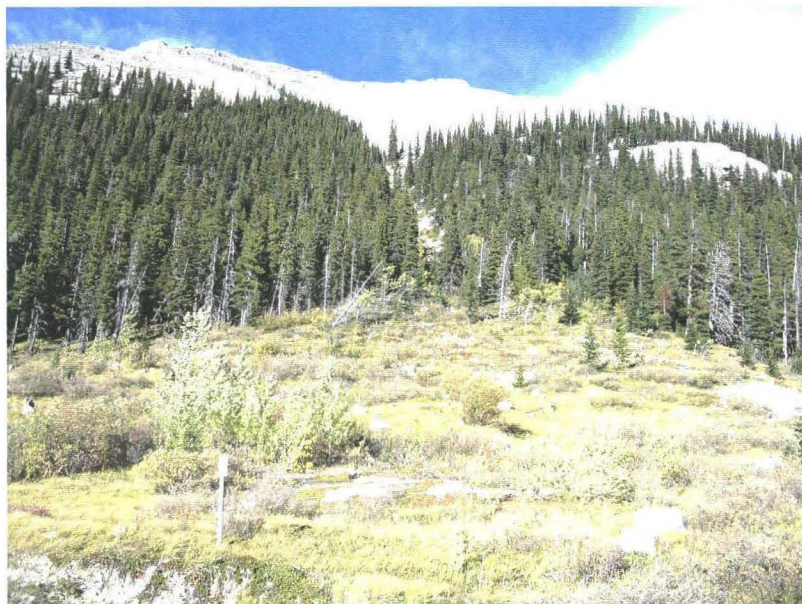
- The source of the debris in the fan is the exposed bedrock in the south slope of Plateau Mountain (see Photo 940-38). The bedrock exposed in the drainage basin visible above treeline appears to be nearly horizontally bedded, possibly with a very slight over-dip slope configuration (see Figure D1 in Appendix D for an illustration).

Photo 940-38 (bottom) – Facing upslope from the highway along the fan around the seasonal drainage channel. The exposed bedrock visible above the treeline is the south slope of Plateau Mountain.
