## **Highway 742 – Three Sisters Dam Fan**

## Hwy 742 – Three Sisters Dam Fan

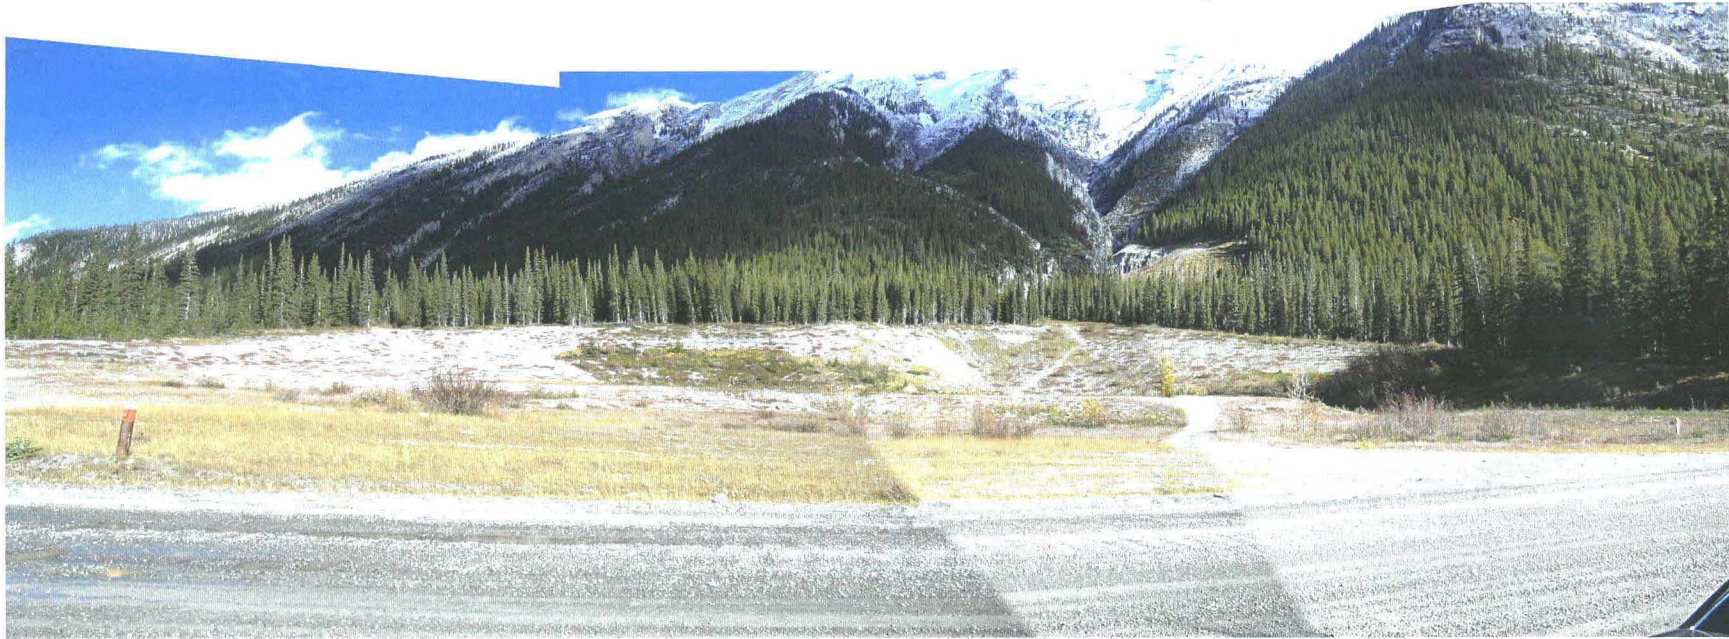
- As shown in Photo 742-45, the highway crosses the lowermost portion of a fluvial/colluvial fan at this site. This fan has been deposited below a drainage basin in the southwest slope of the Three Sisters peaks and above the Spray River channel (now the Spray Lakes Reservoir) and has developed over time since the last glaciation.

- It appears that an approximately 50 m wide area along the highway right-of-way and across the lowermost portion of the fan was excavated and leveled during highway construction and that no new debris has been deposited in that area during subsequent years.

- Portions of the fan have been excavated in recent years for use as construction material. The excavated face in the face exposes up to boulder-sized rocks. The portions of the fan that have been excavated have become partially revegetated.

- There is no creek channel visible in the surface of the fan above the highway. It appears that any flow coming from the drainage basin above the highway percolates down into the granular fan material in the area upslope of the highway.

**Photo 742-45** – Facing upstream along the fan from the highway, with the lower slopes of the Three Sisters Peaks visible in the background.

There appears to be very little to no risk to the highway from debris flows along the creek channel. It does not appear that significant amounts of debris have been deposited on the fan in proximity to the highway in recent years, nor is there an active creek channel incised into the surface of the fan around the highway.

- Probability Factor of 2 to reflect the apparently inactive debris deposition on the fan around the highway in recent years and allowing for a very low to low probability of the fan becoming active again around the highway elevation in the future.
- Consequence Factor of 1.

Therefore, the recommended Risk Level for this site is 2.

No further assessment or monitoring work is recommended for this site.
