Site 9 – Limestone Mountain Cut Slope

| | | PROJECT: HWY 40/HWY 541 GEOHAZARDS REVIEW | | | |
| CLIENT: Alberta INFRASTRUCTURE AND TRANSPORTATION | | TITLE: LIMESTONE MOUNTAIN CUT SLOPE CONCRETE BUTTRESS BLOCK DRAWINGS (JANUARY 1974) FROM AIT FILES | | | |

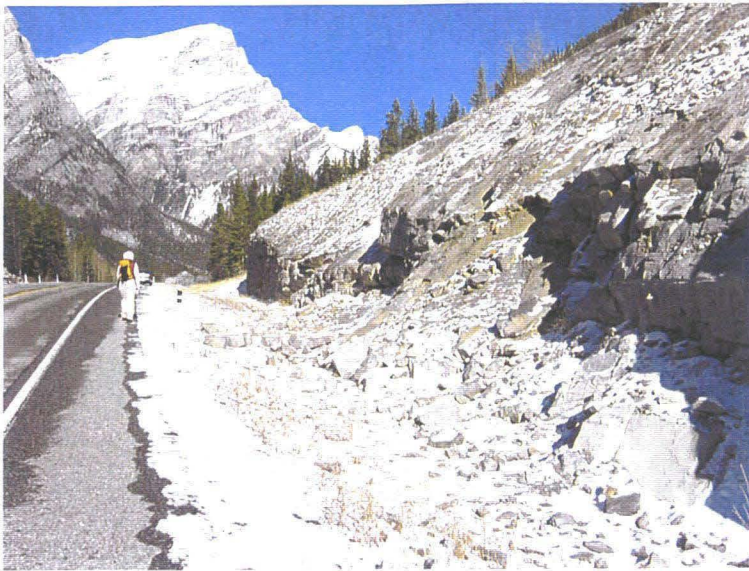
The cut slope along the east side of the highway exposes bedrock with bedding planes dipping down towards the road at approximately 45°, similar to the nearby Galatea Creek Through-Cut site. Along some segments of the cut slope the entire cut face consists of an exposed bedding plane (Photo 1). Along other segments, the lower portion of the cut slope is vertical and the upper portion exposes a bedding plane and/or rocky soil at around 45° inclination. The height of the cut slope varies between about 4 and 8 m.

Photo 1 (top) – Facing north along Highway 40 at the Limestone Mountain Cut Slope site. The area in the foreground illustrates how the bedding of the rock dips down towards the highway in this area and in some areas boulder-sized rocks break off and slide down the bedding plane. The debris is contained within the existing ditch.

It is recommended that the accumulated rockfall debris in the ditch be cleaned out to restore the maximum ditch capacity and reduce the Consequence Factor to 1. The ditch should be cleaned as necessary in the future to maintain the catchment capacity. The timing and frequency of ditch cleaning will depend on the volume of future rockfall debris, and it appears that cleaning will be required at least annually.

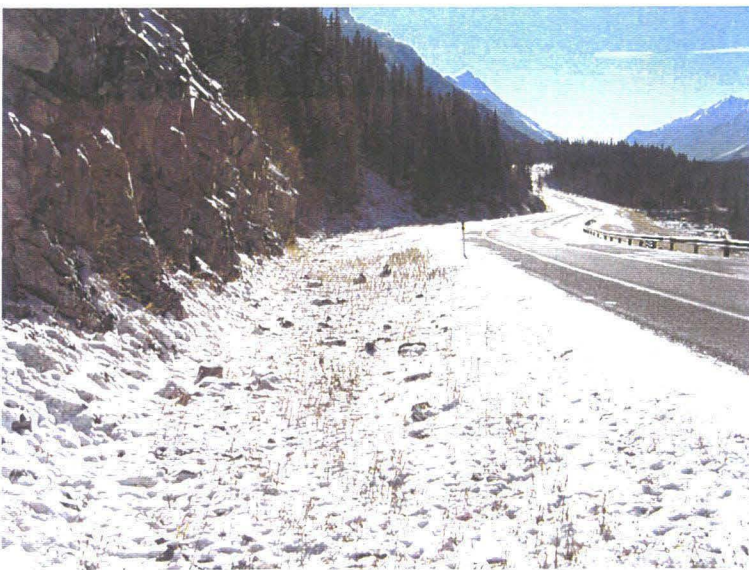
The rockfall debris is contained within the existing ditch (Photos 1 and 2). There were no rocks on the road at the time of the site inspection in October 2005 and there were no signs of damage to the pavement from previous rockfall.

Photo 2 (bottom) – Facing south along Highway 40 at the Limestone Mountain Cut Slope site. Some segments of the cut slope at this site experience rockfall originating from the steep soil/rock slope above the crest of the near-vertical, lower cut slope. As shown in this photo, the rockfall debris is contained within the existing ditch.

This segment of the cut slope is adjacent to the area shown in Photo 1.

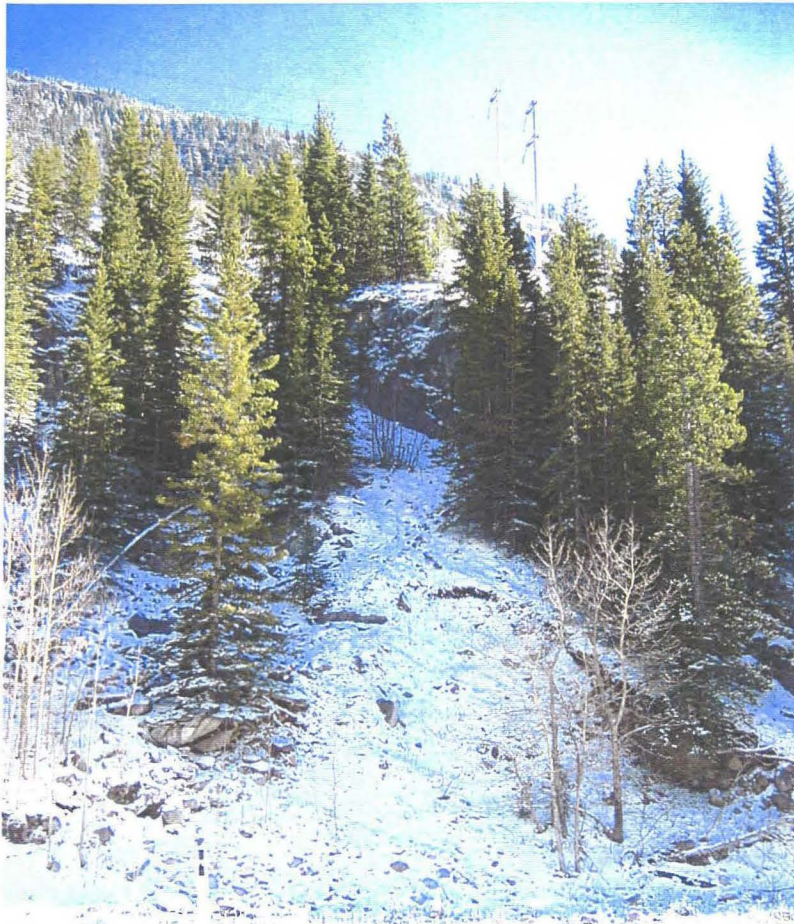
- A lower colluvium slope at approximately 35° with the toe along the east ditch of the road. This colluvium slope is approximately 15 m high.
- An upper slope of exposed bedrock at approximately 45°. This rock slope extends for a considerable distance above the highway. As with the nearby cut slope along the highway, the bedrock in the upper slope has bedding planes dipping down towards the highway at approximately 45°.

Portions of the colluvium slope are treed and most of these trees have curved trunks, which indicates that there is ongoing creep movement of the colluvium down towards the highway. There is a hazard of rockfall debris from the upper bedrock slope rolling down the colluvium and into the ditch.

The width of the ditch between the toe of the colluvium slope and the east edge of the highway is typically around 14 m and it was clear of debris at the time of the field inspection in October 2005.

Photo 3 (top) – Colluvium slope above Highway 40 and adjacent to the south end of the cut slope shown in Photos 1 and 2. The vertical height of this colluvium slope is approximately 15 m and it is inclined at approximately 35°. Most of the trees growing out of the colluvium slope have curved trunks which indicates that there is ongoing creep movement of the colluvium down towards the highway. The rock slope above the colluvium slope is at approximately 45°. There is a hazard of rockfall from the bedrock slope rolling down the colluvium and into the ditch. The width of the ditch is typically around 14 m and it was clear of debris at the time of the field inspection.

The rock slope with the concrete buttress blocks shown in Photo 4 is just off the upper left edge of this photo.

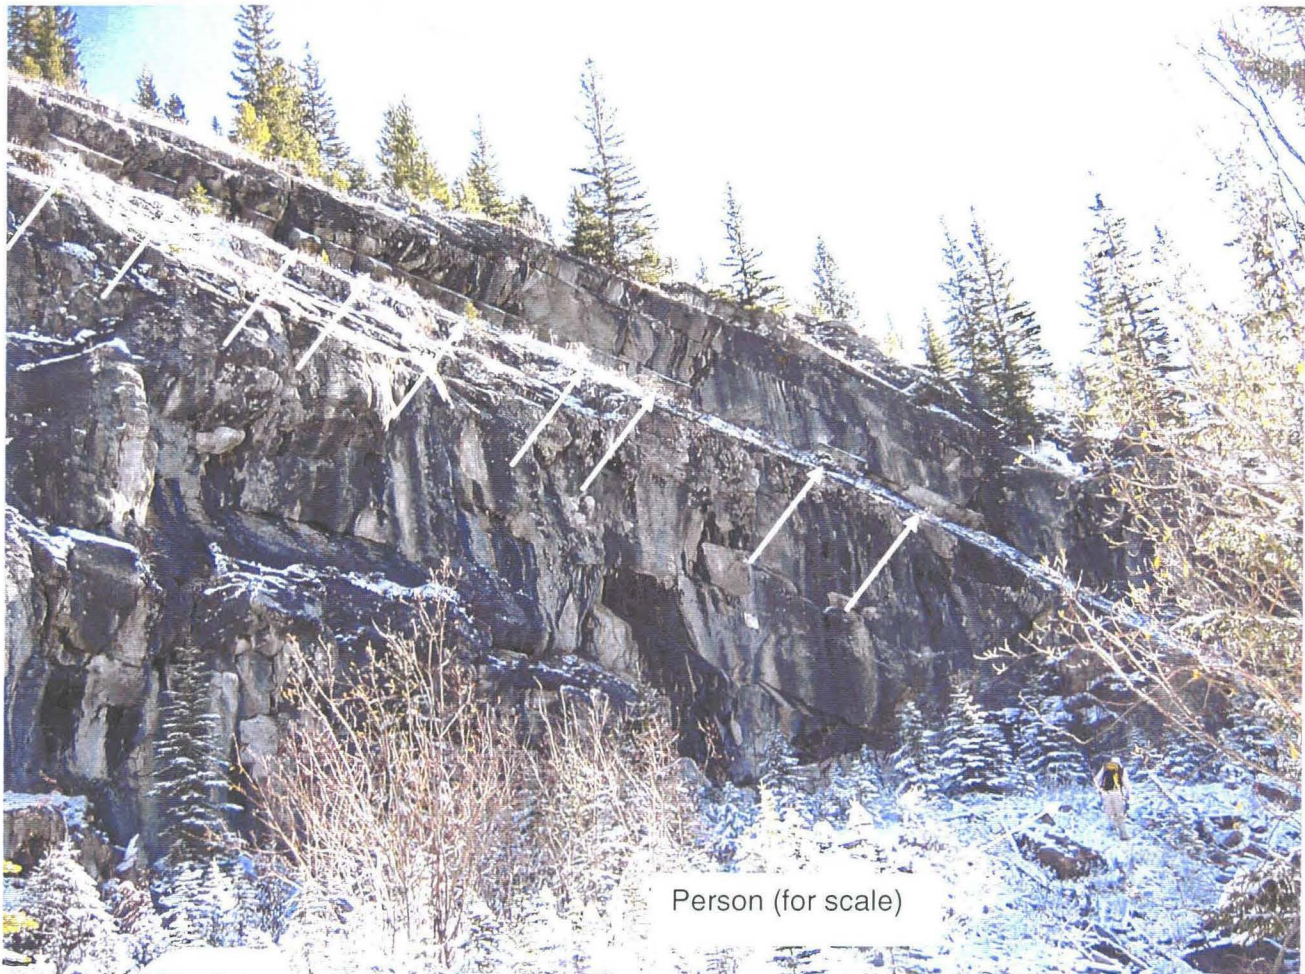
Also, a series of concrete buttress blocks were noted on a portion of the upper bedrock slope and they appear to correspond to some design drawings for bedrock slope stabilization measures that were found during a review of AIT's files. Copies of the design drawings, which are dated from 1974, are attached as Figure E2. These drawings show reinforced and dowel-anchored concrete blocks to be installed to prevent

rock detachment and sliding along a bedding plane dipping towards the highway. No other design or construction documentation was reviewed. During the October 2005 site inspection it was noted that these stabilization measures are located a considerable distance from the highway. It is judged that even if they were not in place the rockfall hazard to the highway from this portion of the rock slope would be relatively low to negligible. It was not possible to safely access the concrete blocks to inspect their condition.

Photo 4 (bottom) – Concrete buttress blocks installed along a bedding dip slope above Highway 40. (Locations of blocks marked with white arrows.) Note the person in the lower right hand corner of the photo for scale. Please also see Figure D2 for an illustration of how the buttress blocks were constructed.

These blocks were installed approximately 30 m above Highway 40 in order to stabilize potential rock detachment and sliding along the bedding plane. Given the offset from the highway, it is judged that even without these buttress blocks in place the hazard to the highway from this slope would be very low.
