SITE NUMBER AND NAME: S012 Spray Lakes Road		HIGHWAY & KM: 742:02, 4.319	PREVIOUS INSPECTION DATE: July 6, 2020	INSPECTION DATE: May 8, 2023
LEGAL DESCRIPTION 11-29-024-10 W5M	NAD 83 COORDINATES: UTM Northing Easting 11 5659724 614296		RISK ASSESMENT: PF: 3 CF: 5 TOTAL: 15	
AVERAGE ANNUAL DAILY TRAFFIC (AADT): 1063 (north); 1056 (south), (Ref. No. 67429980)			CONTRACTOR MAINTENANCE AREA (CMA): 28

PROJECT SOUTHERN REGION GEOHAZARD RISK MANAGEMENT PROGRAM		
TITLE Site Plan S012 - Spray Lakes Road Hwy 742:02, km 4.319		
SCALE 1:1,000	PROJECT No. A05116A03	FIG No. 1

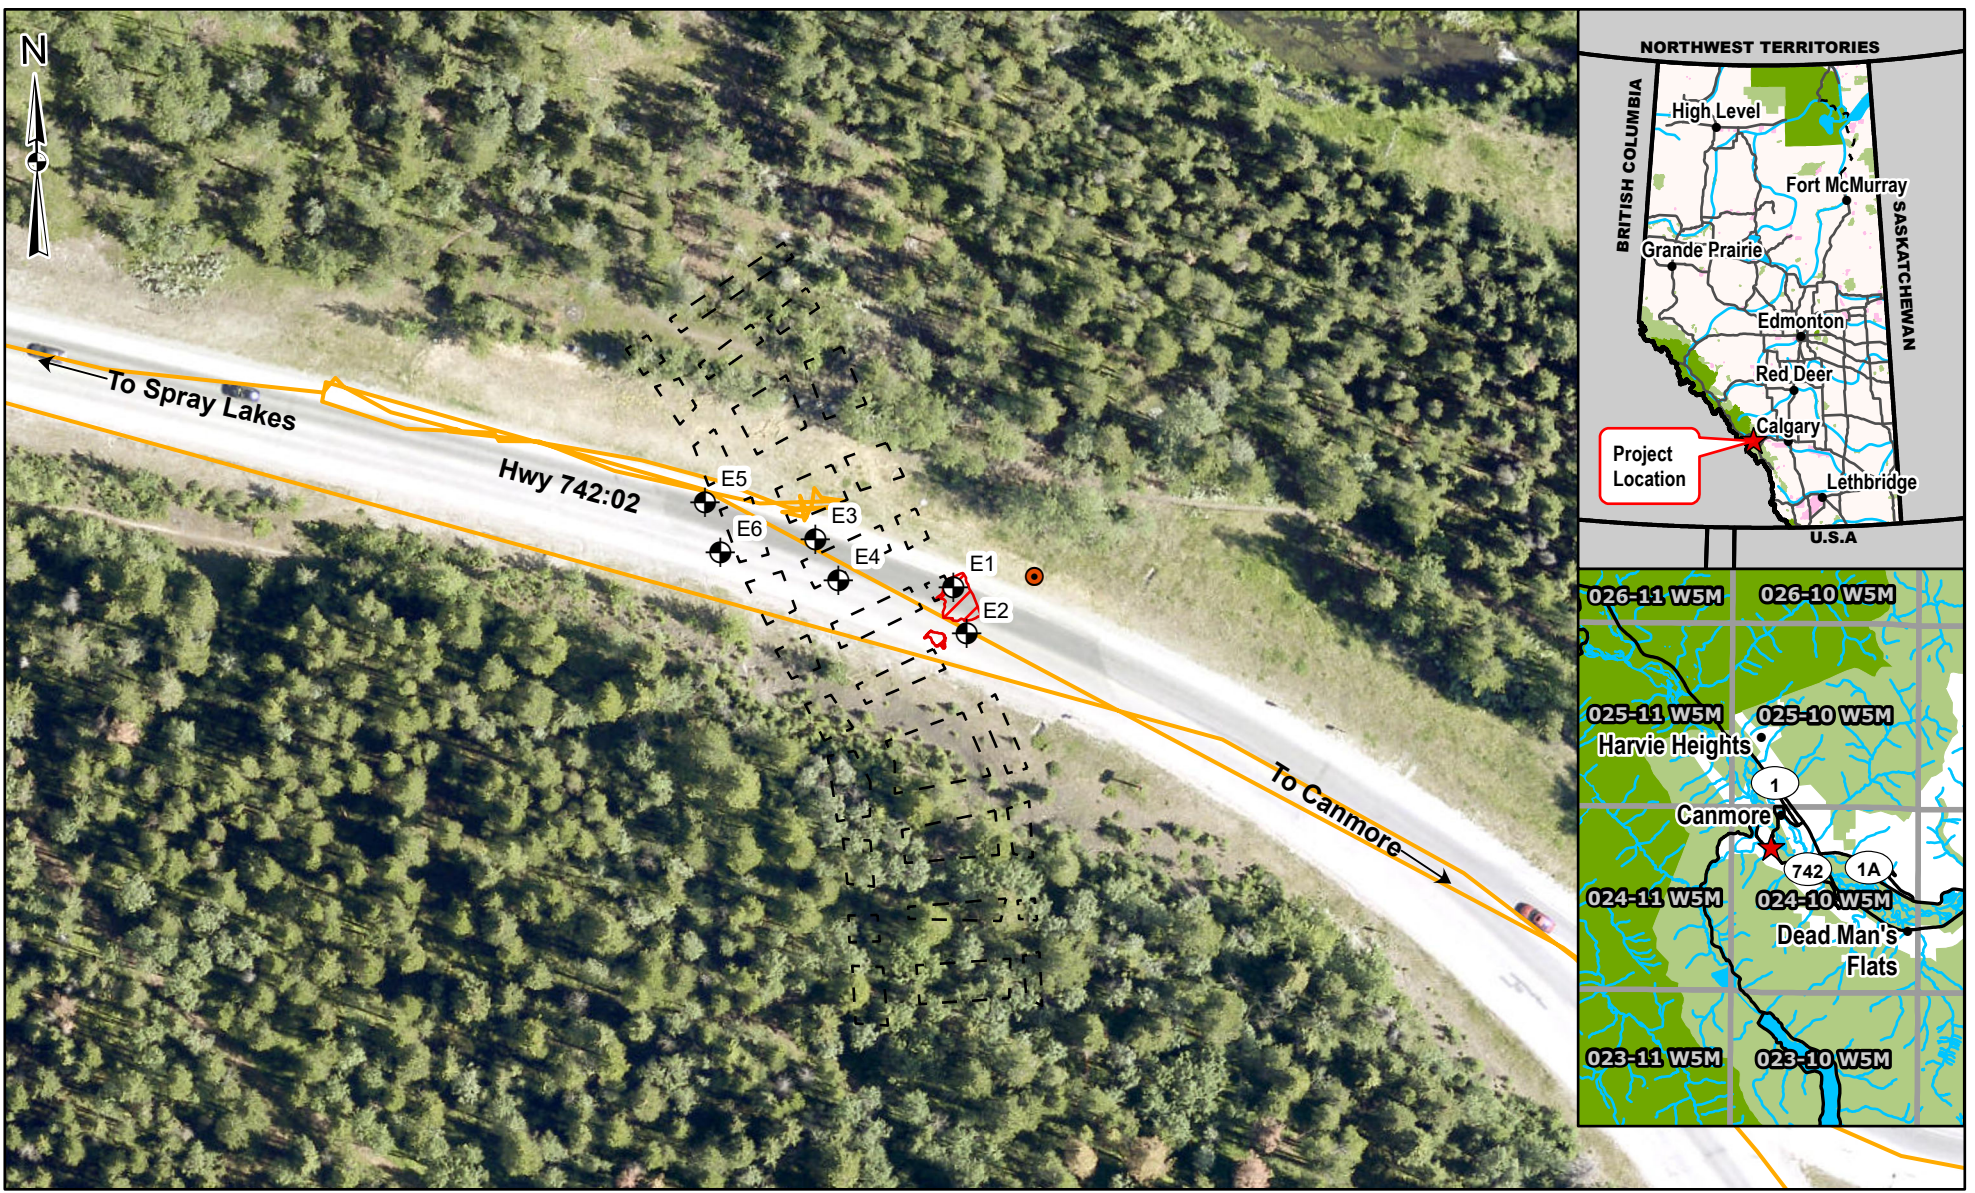
- Vibrating Wire Inline Extensometer
- Readout Location (Concrete Vault)
- GPS Track (May 8, 2023)
- Approximate Location of Coal Mine Shafts
- Approximate Extent of Voids

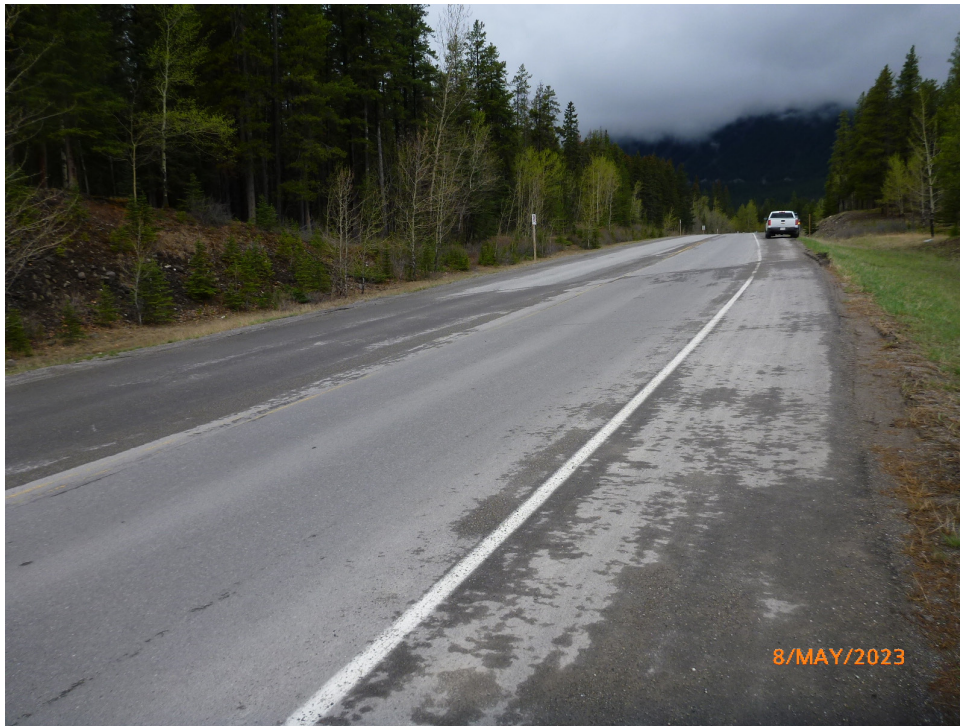
Photo 1 Highway surface above where coal mine voids were filled. Photo was taken facing west on May 8, 2023.

COMMENTS
No observable changes to the site when compared to 2020 inspection.
Pavement surface has some subtle depressions, indicating movement of subgrade. Bedrock is exposed to the south of the subject site. Subtle depression noted at outlet of culvert to east of site, may indicate infiltration of culvert discharge into an underlying void.

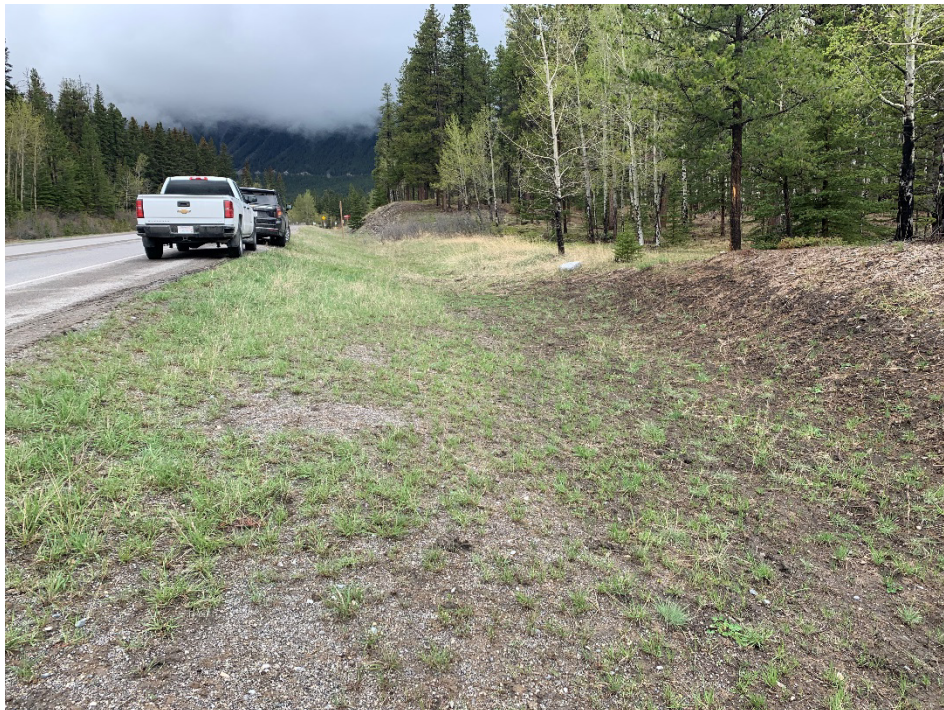
Photo 2 North ditch. Photo taken facing west on May 8, 2023.

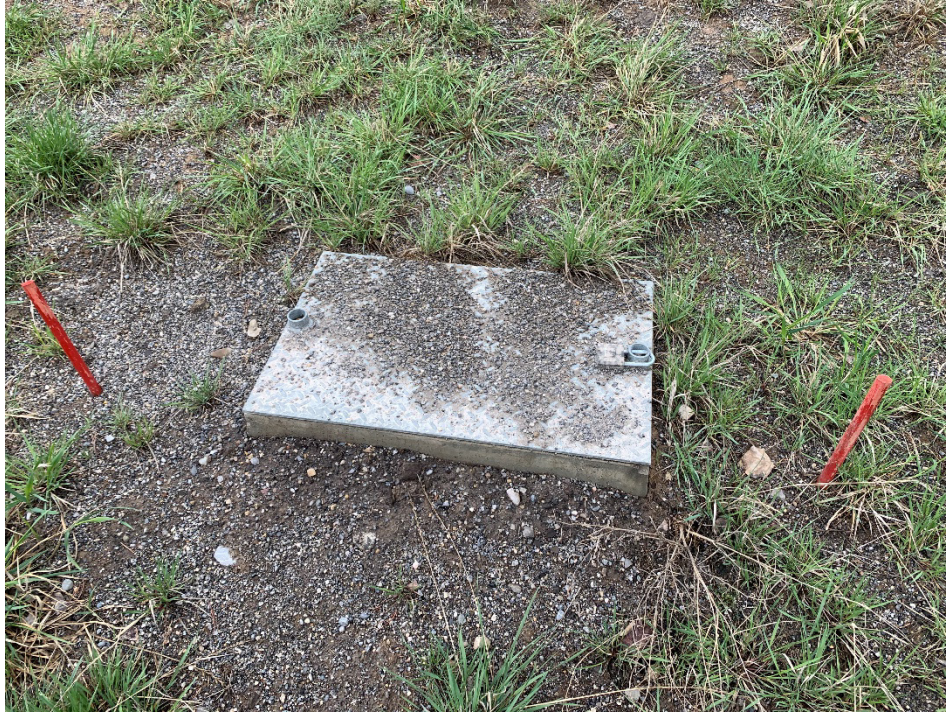
Photo 3 **Headbox for Data Logger. Photo taken on north side of highway on May 8, 2023.**
