NORTH CENTRAL REGION (ATHABASCA AREA)
2019 GEOHAZARD ASSESSMENT

NC014-1: HWY 661:02 FORT ASSINIBOINE (km 1.8)
SITE PLAN SHOWING EXISTING FEATURES

NC014-1: HWY 661: 02 FORT ASSINIBOINE (km 1.8)
SITE PLAN SHOWING MID-HILL LANDSLIDE AREA

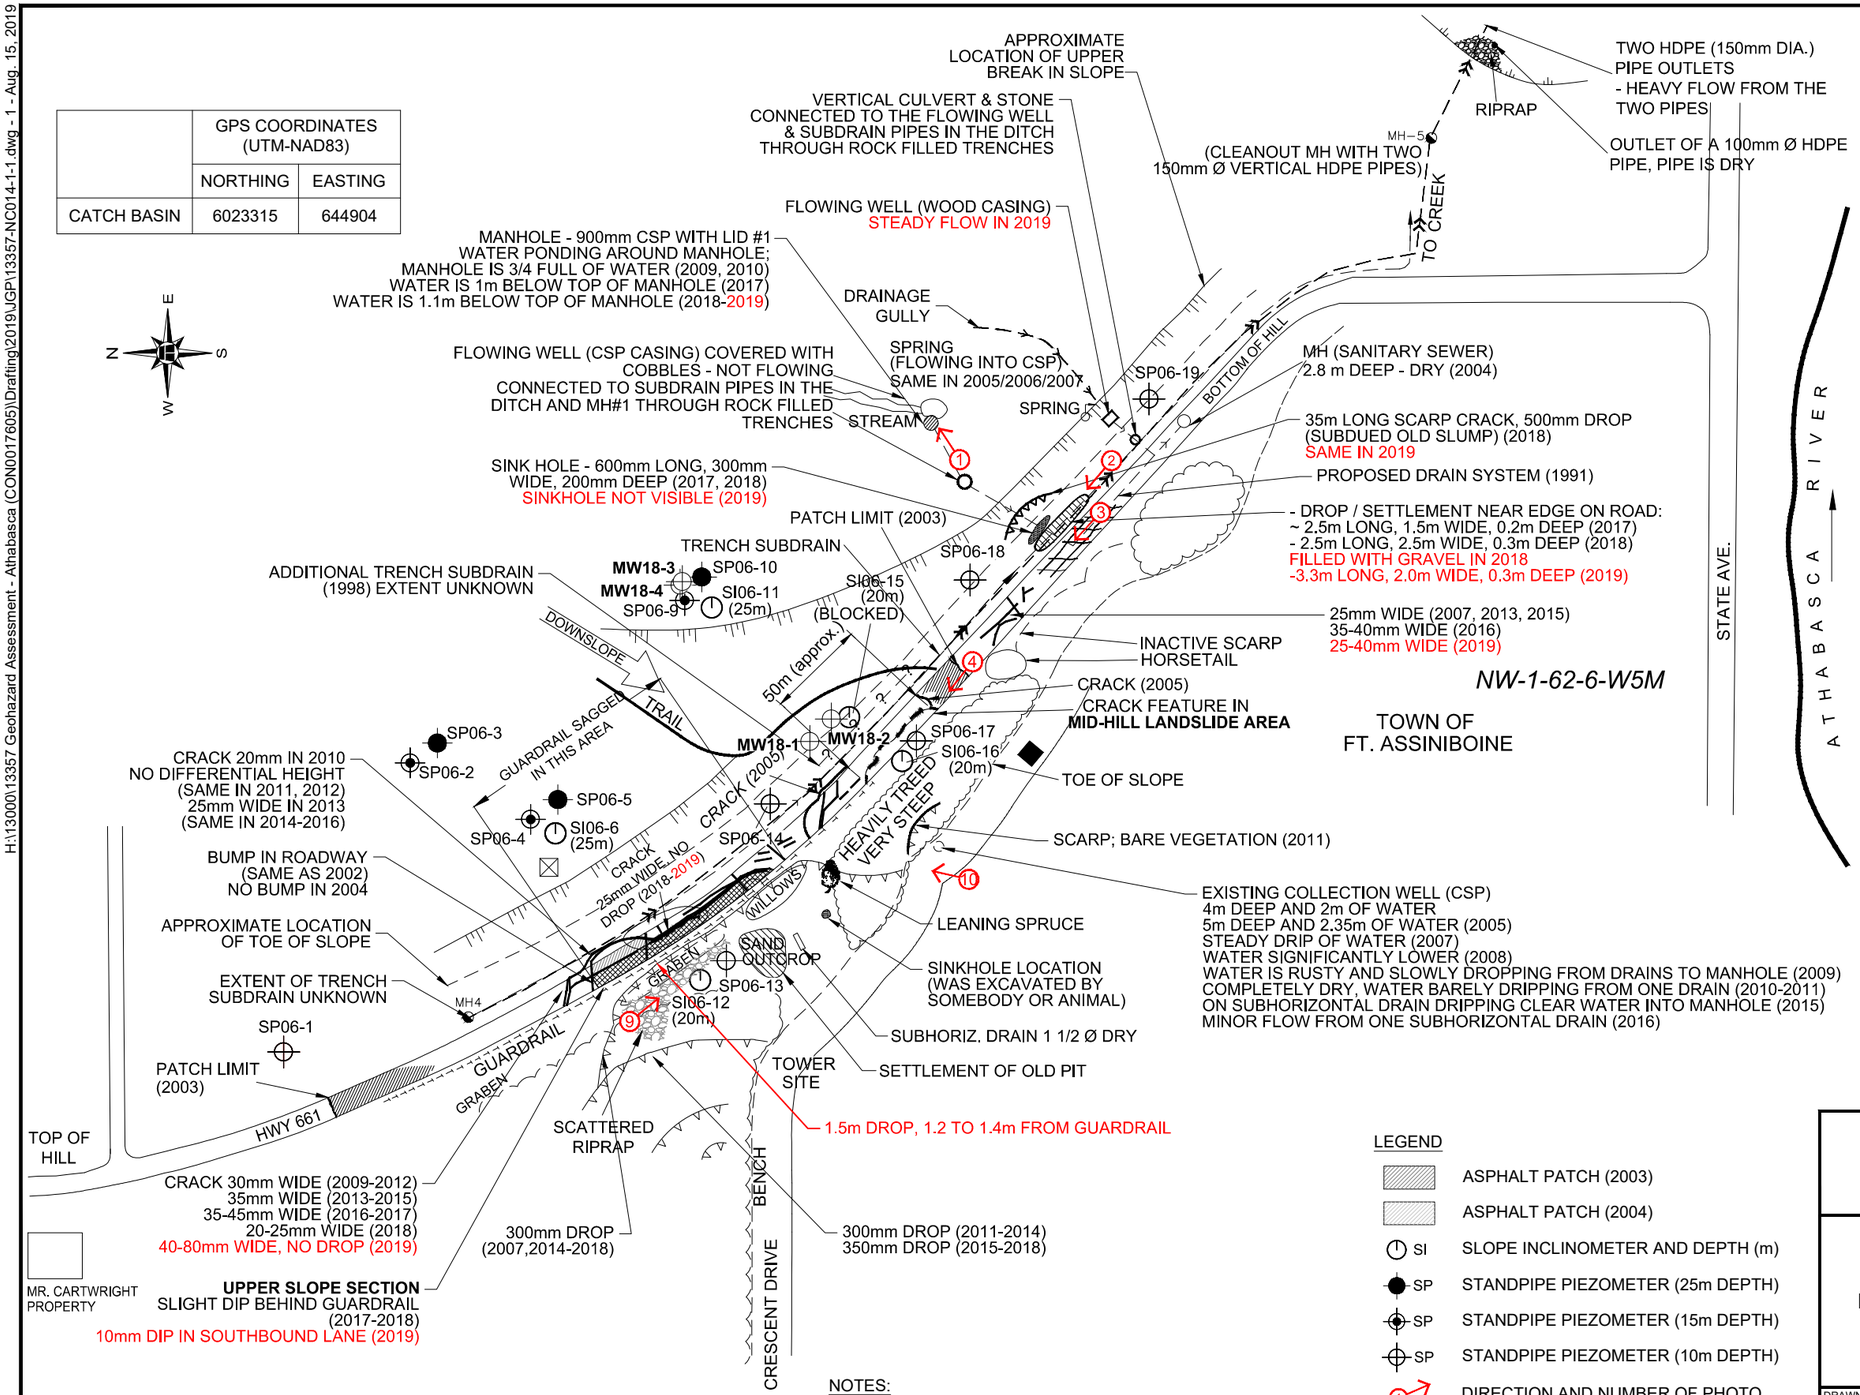
DWG NO. NC014-1-1

NOTES:
1. FEATURE LOCATIONS ARE APPROXIMATE
2. PREVIOUS OBSERVATIONS SHOWN IN BLACK
3. THREE LEVEL LOGGERS WERE INSTALLED IN SP06-2, SP06-3, AND SP06-13 AND TWO VIBRATING WIRE PIEZOMETERS WERE INSTALLED IN SP06-4 AND SP06-5.
4. JUNE 10, 2019 OBSERVATIONS ARE SHOWN IN RED

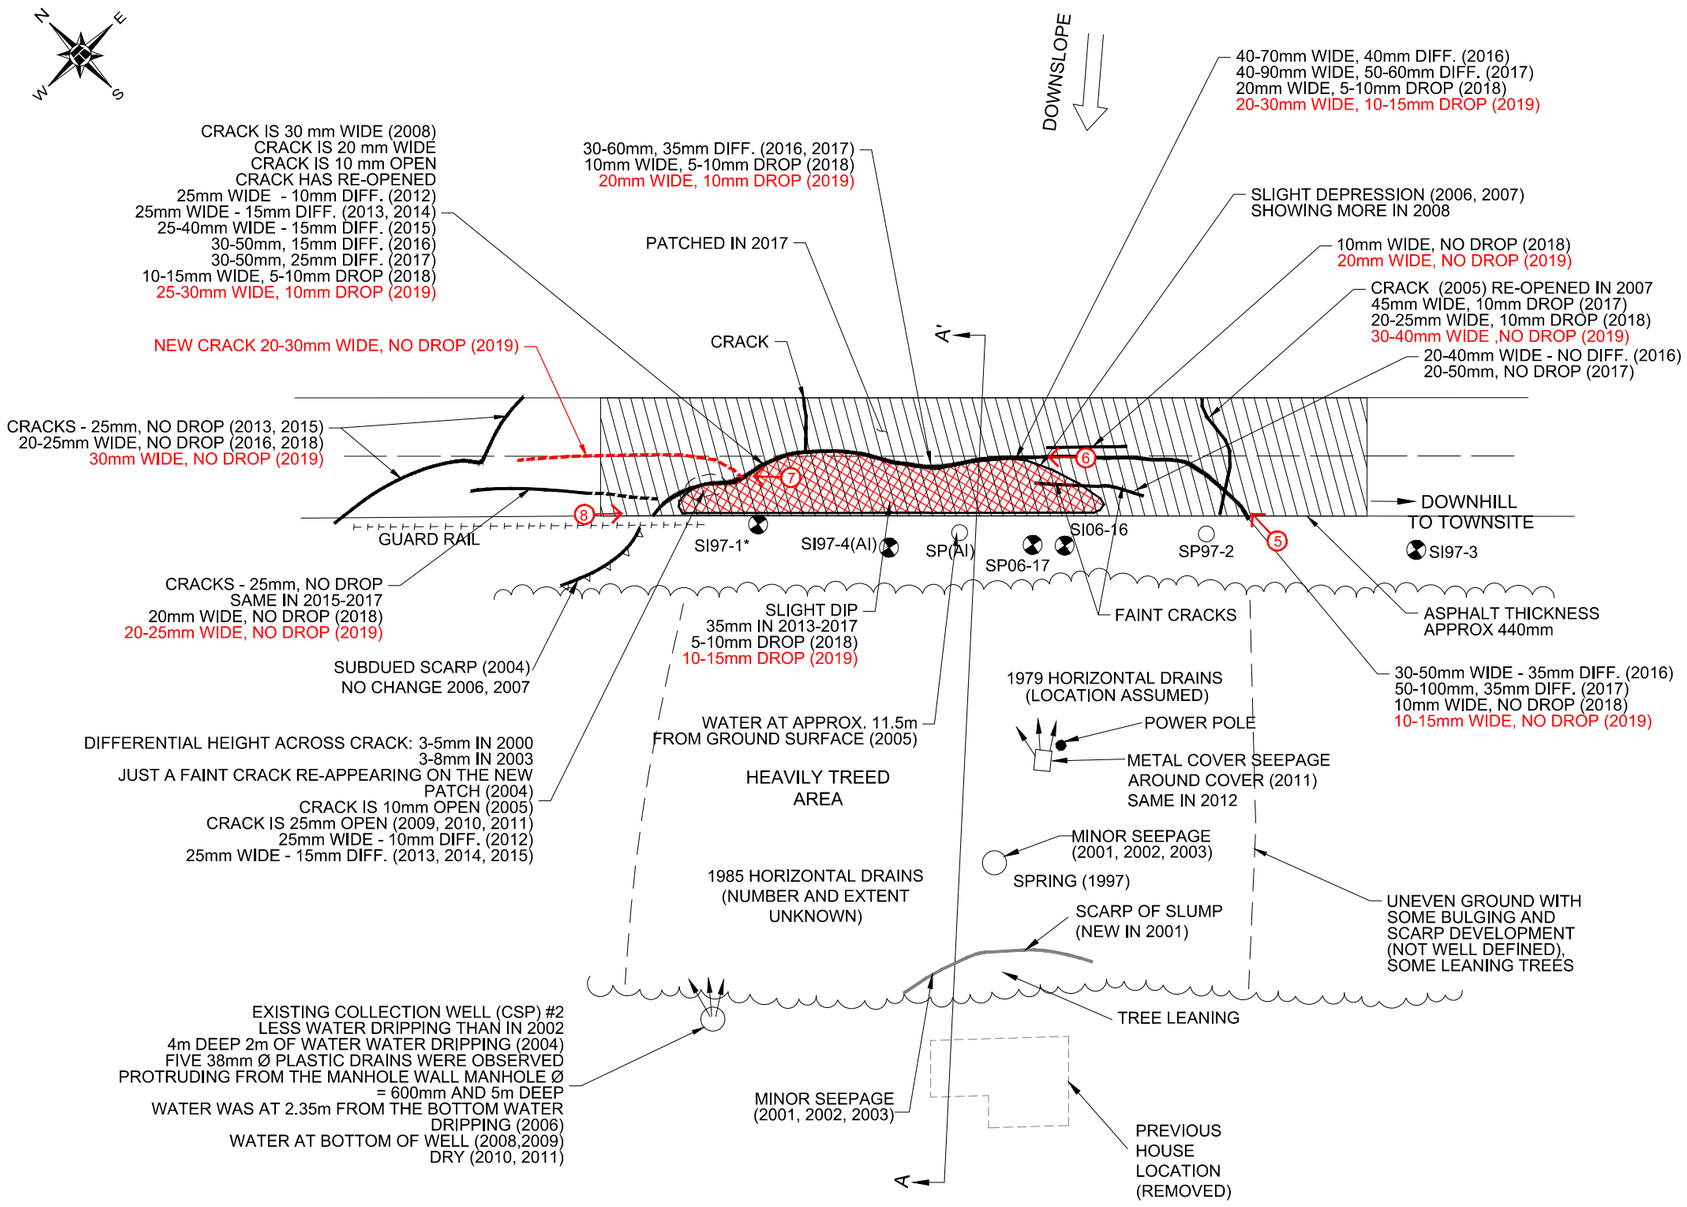
DWG NO. NC014-1-2

1. FEATURE LOCATIONS ARE APPROXIMATE.
2. PREVIOUS OBSERVATIONS SHOWN IN BLACK
3. PREVIOUS CRACK PATTERN WAS COVERED BY NEW (2004) ASPHALT PATCH
4. JUNE 10, 2019 OBSERVATIONS ARE SHOWN IN RED

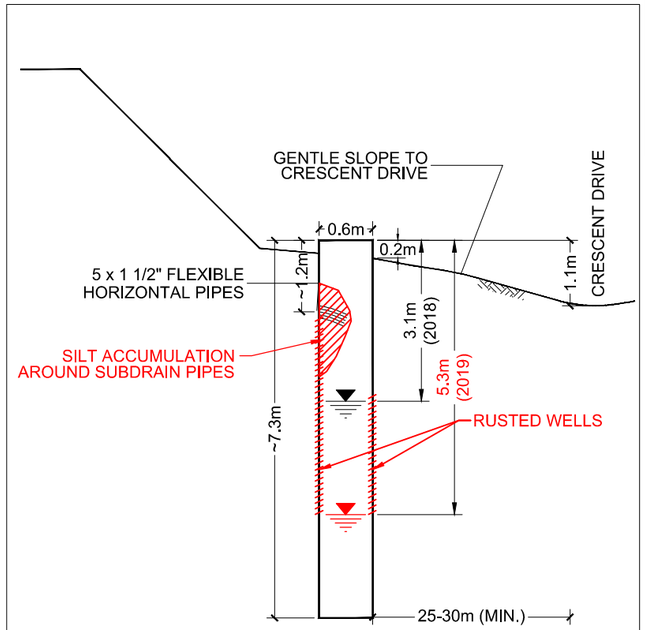
MANHOLE #2 DETAILS (2014)

1. MH #2 HAS NO OUTFLOW PIPE - WATER IS LIKELY PERCOLATING INTO GROUND (2015)
2. MINOR FLOW FROM ONE OF SUBHORIZONTAL DRAINS IN 2016
3. ONE OF THE SUBHORIZONTAL DRAINS IS DRIPPING WATER
4. ONE OF THE DRAINS IS FLOWING. MORE WATER NOTED IN 2018
5. STEADY FLOW FROM ONE OF THE DRAINS; HEAVIEST FLOW SINCE OBSERVED
