ALBERTA TRANSPORTATION AND ECONOMIC CORRIDORS GRMP
PEACE REGION – (PEACE RIVER DISTRICT)
FALL 2024

Site Number	Location	Name	Hwy	km
PH033	HWY 744:04 C1 59.451	CNR Slide- Judah Hill	744:04	Km 59.5
Legal Description: 2-29-83-21 W5		**UTM Co-ordinates**		
		11U E 482662.27	N 6231329.62

ALBERTA TRANSPORTATION AND ECONOMIC CORRIDORS GRMP (CON0022164)
PEACE REGION (PEACE RIVER DISTRICT)
INSTRUMENTATION MONITORING RESULTS

SITE PH033-1: HWY 744:04, JUDAH HILL (CNR SLIDE)

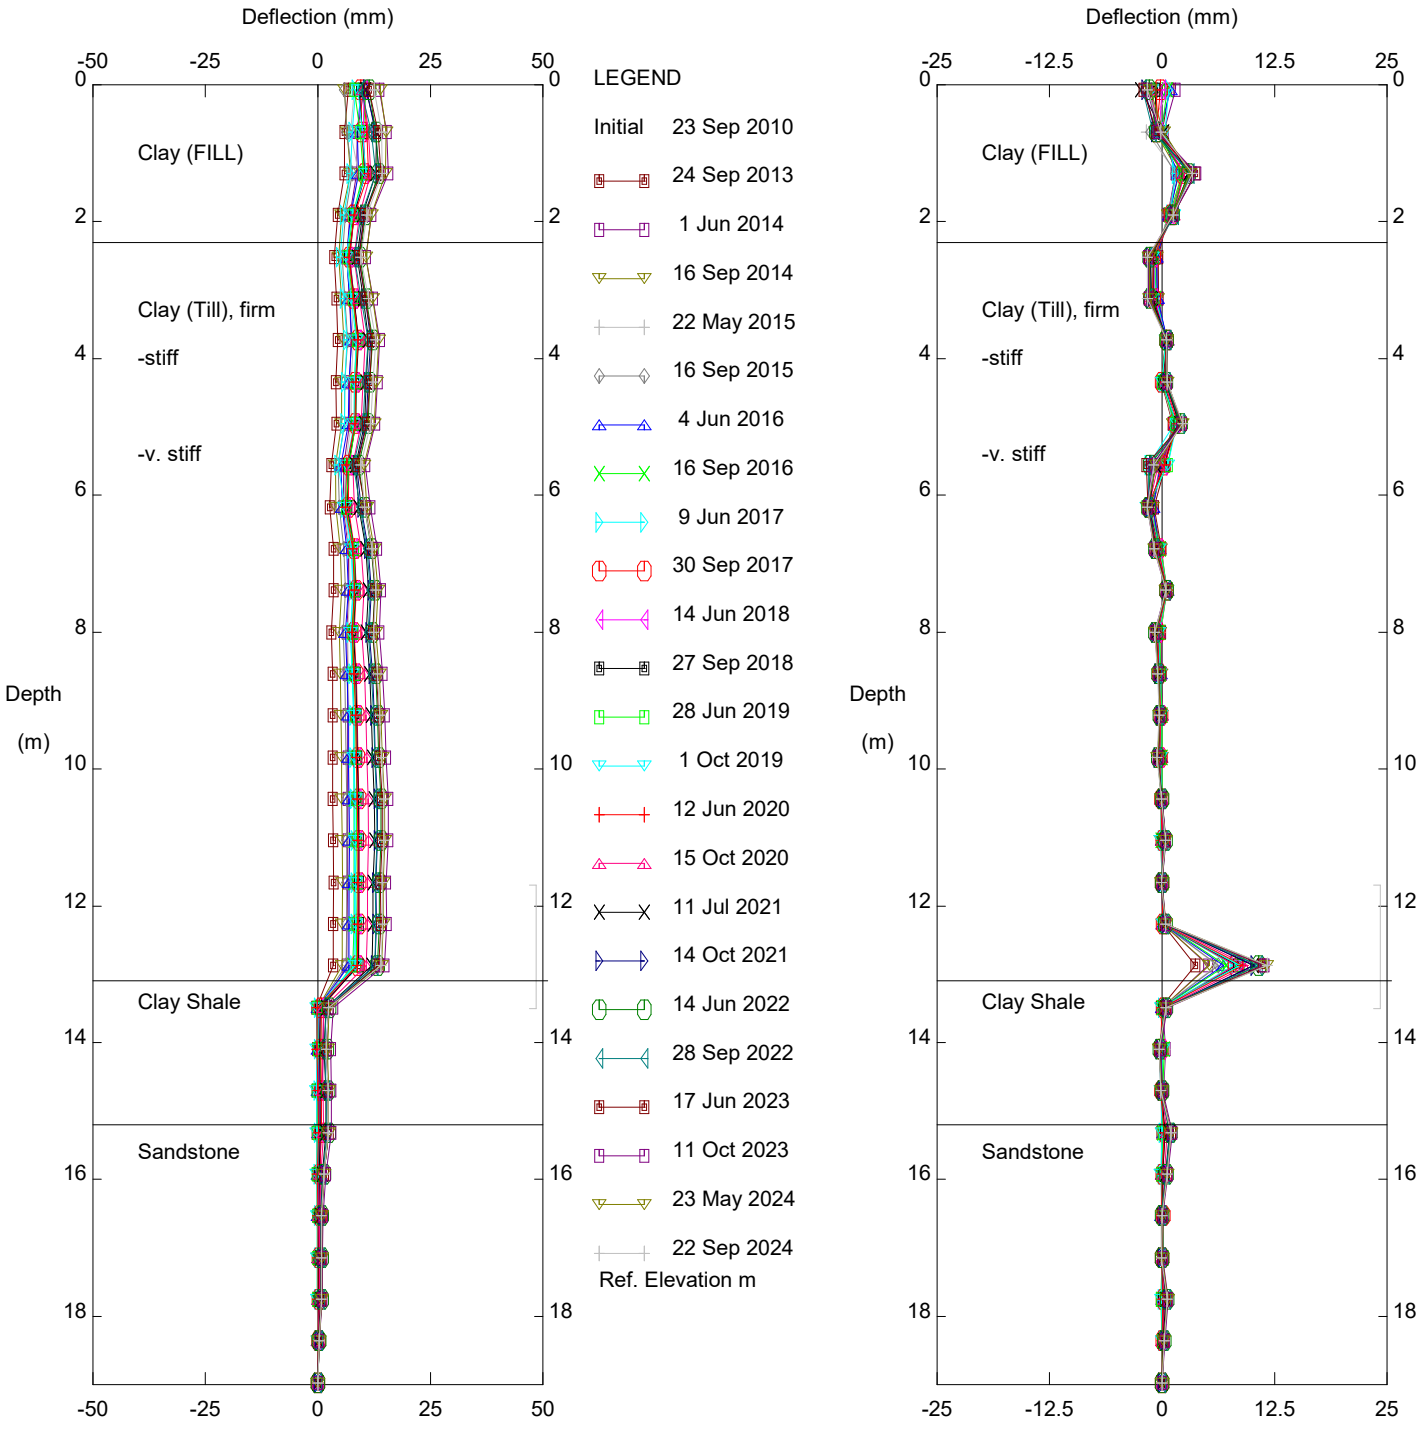
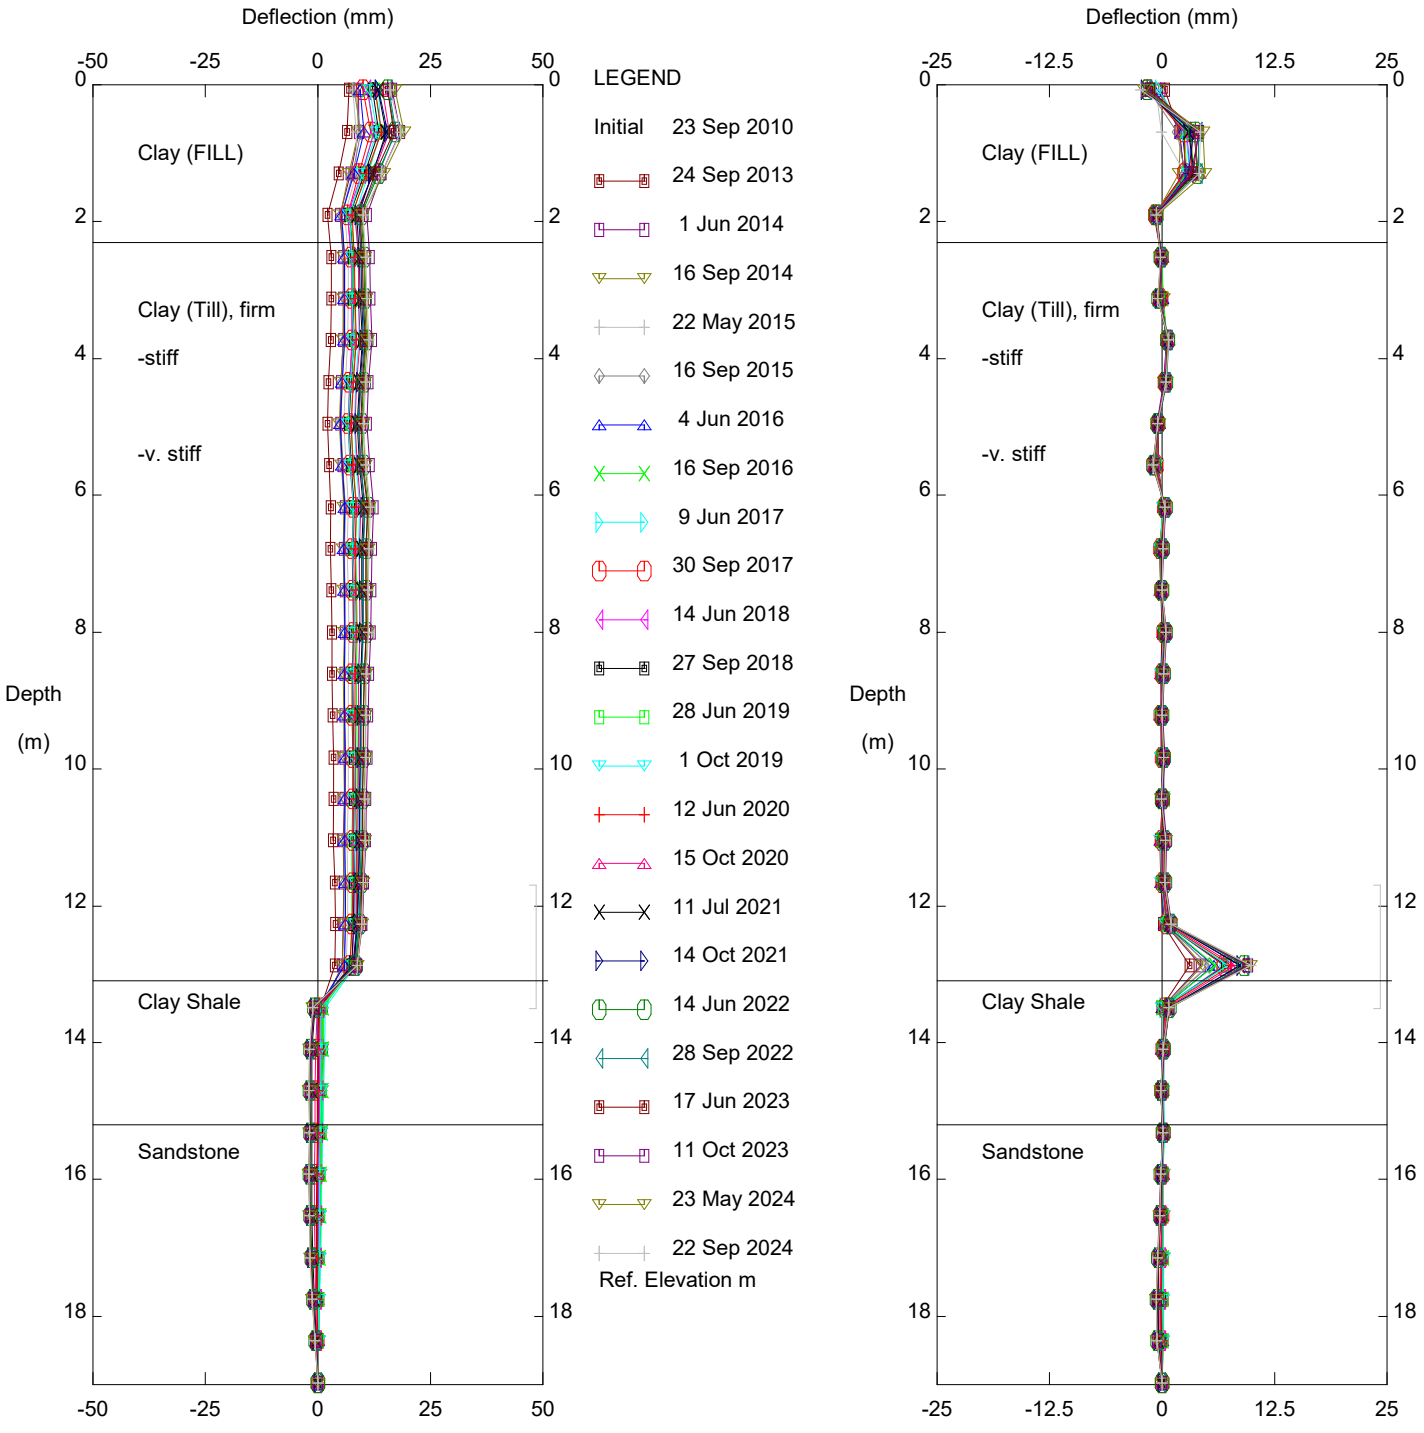
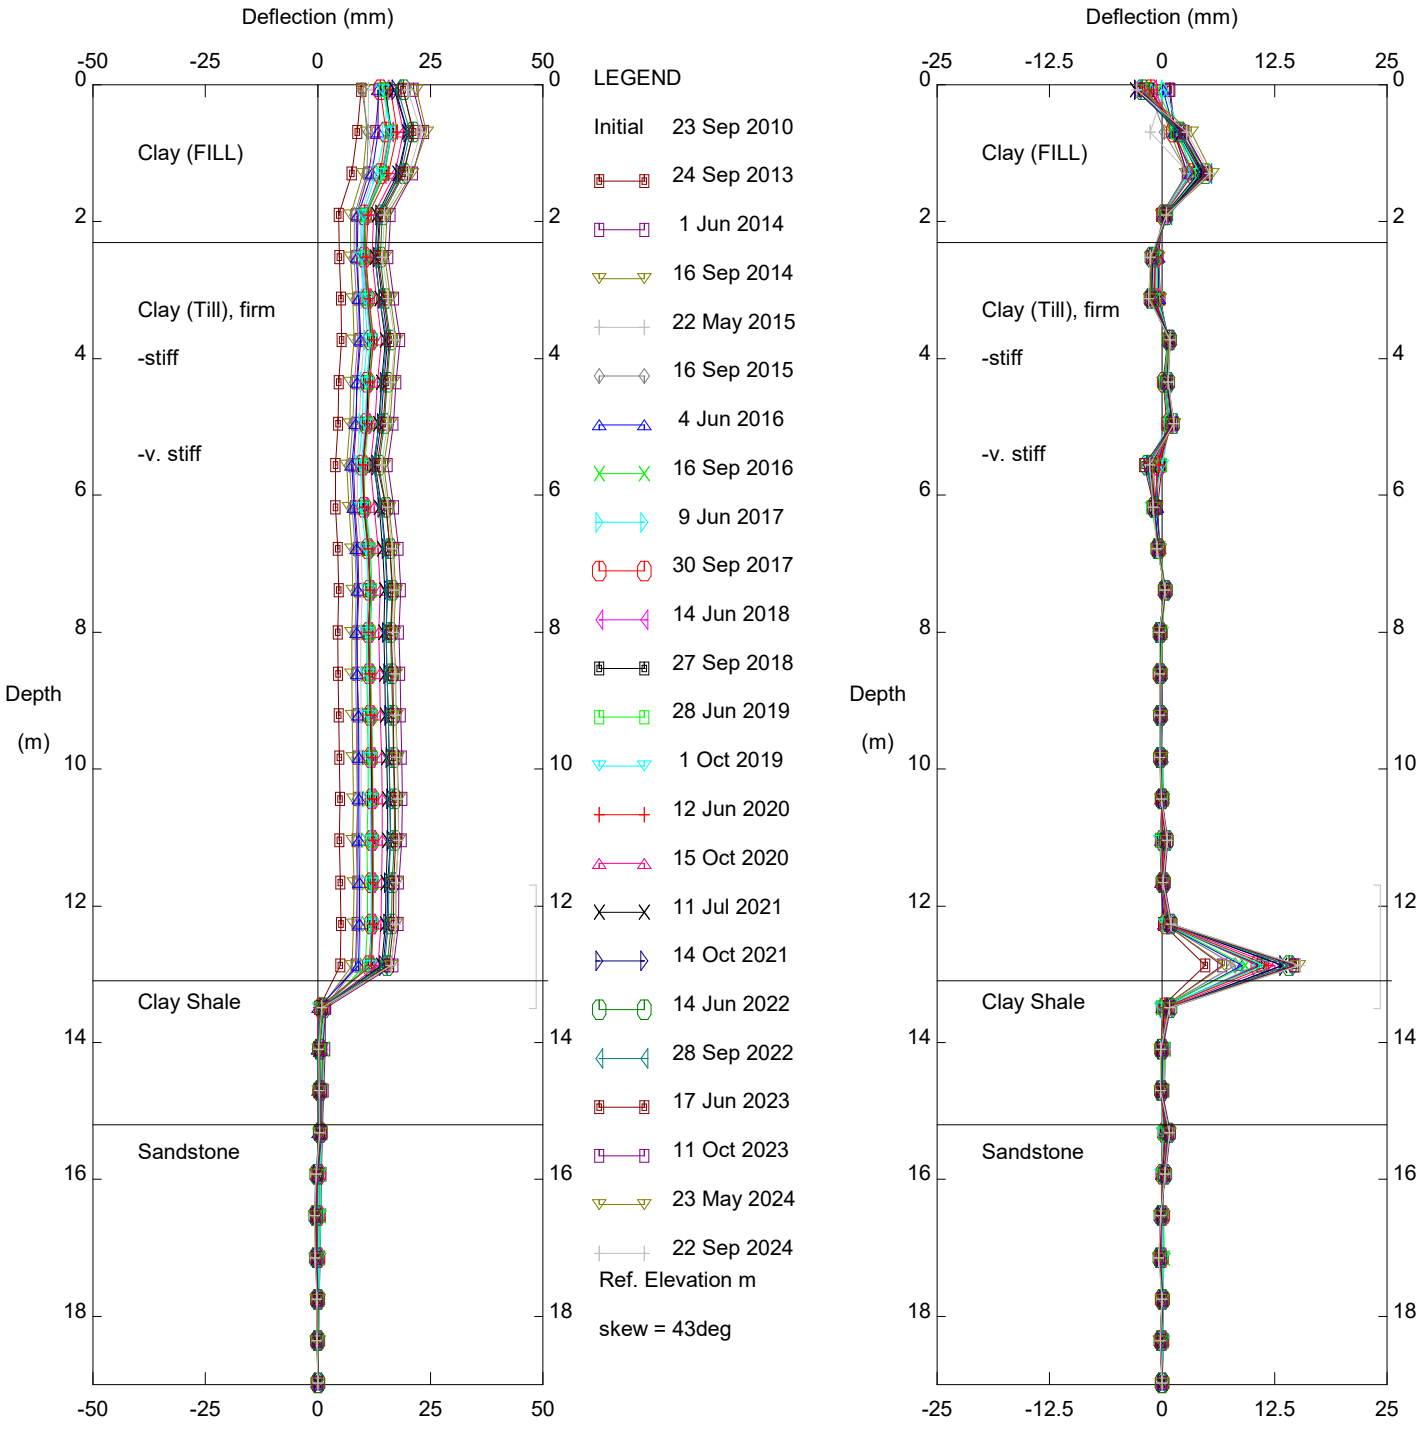
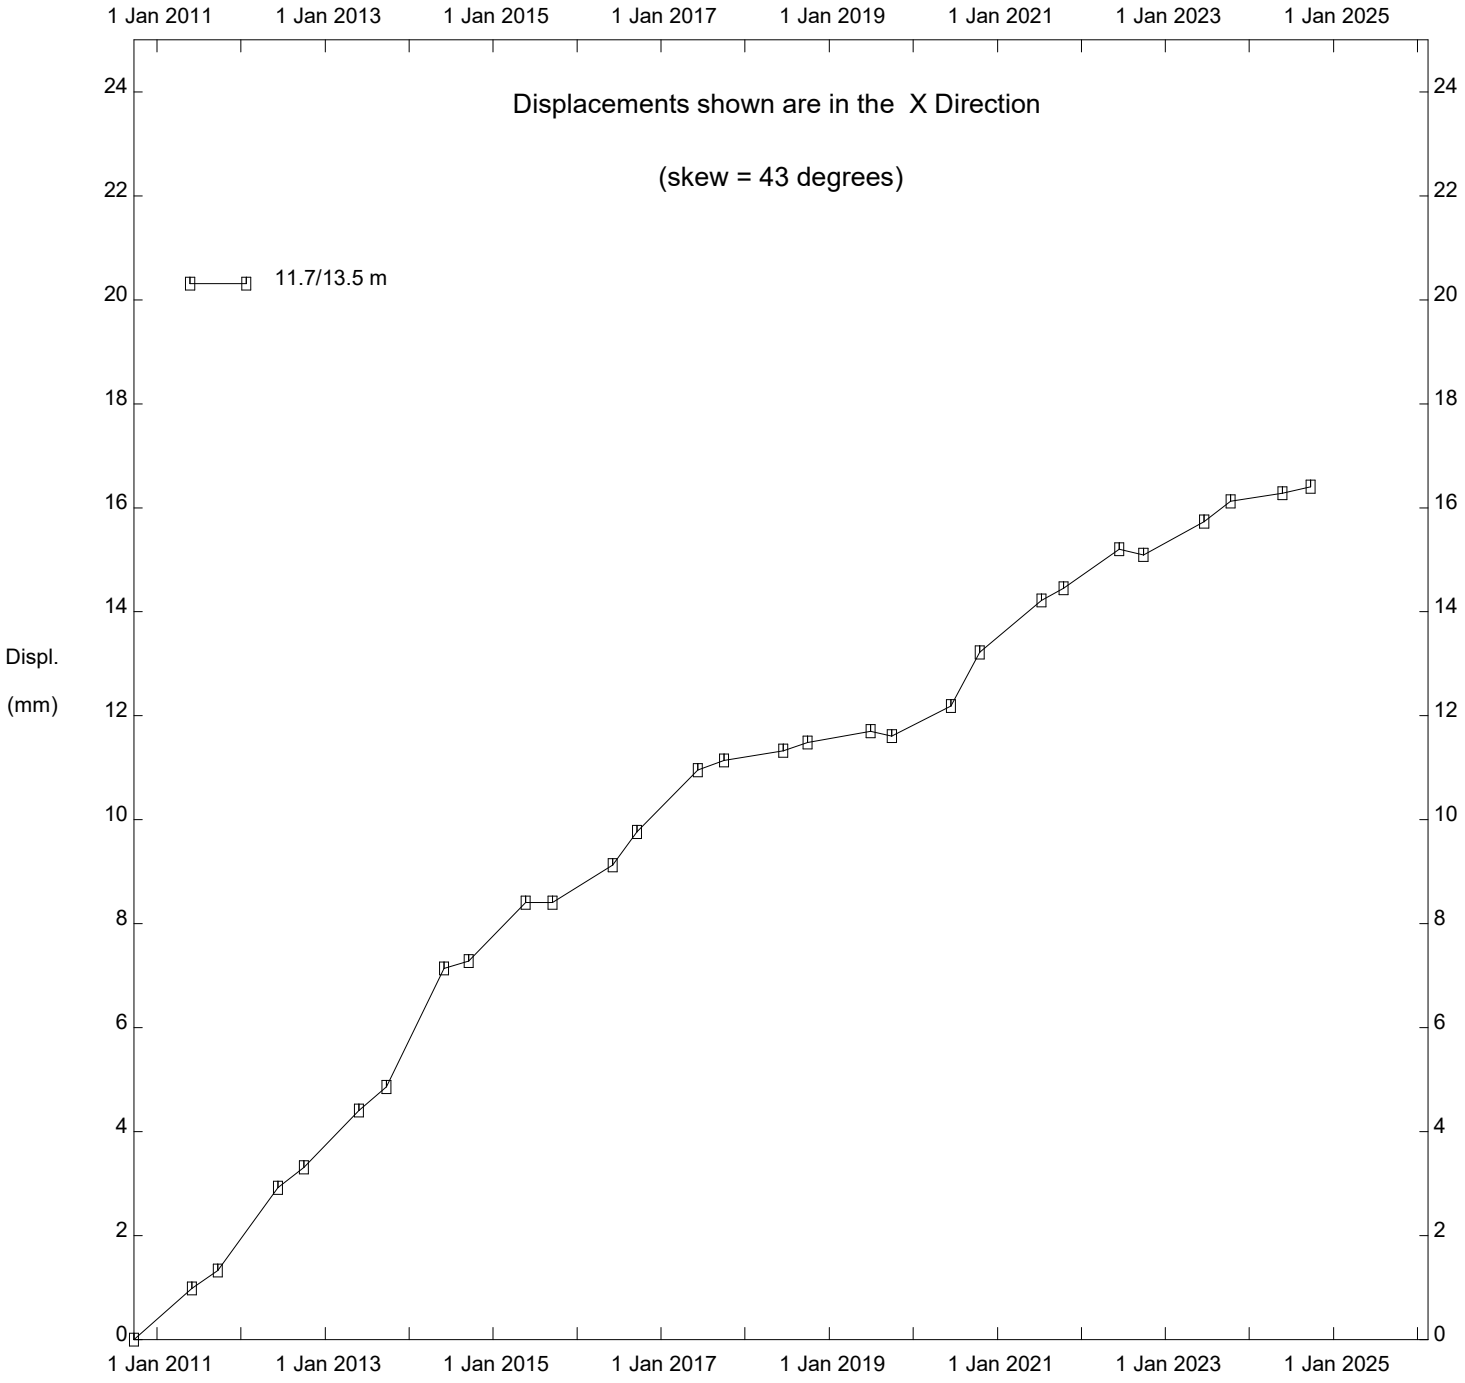
PH033-1 Judah Hill CNR Slide, Inclinometer SI10-16

Discussion	
Zones of New Movement:	None
Interpretation of Monitoring Results:	SI10-16 showed a rate of movement of 0.1 mm/yr over 11.7 m to 13.5 m depth since the spring of 2024 readings. SI10-17 showed no discernible movement over 9.5 m to 11.3 m depth since the spring of 2024 readings. Si10-16 and SI10-17 are both shearing within a stiff clay strata just above a clay shale strata. Pneumatic piezometer PN10-16 showed a decrease in groundwater level of 0.09 m since the spring of 2024 readings.
Future Work:	The instruments should be read again in the Spring of 2025.
Instrumentation Repairs:	No instrument repairs are required at this time.
Additional Comments:
