May 4, 2010

File:15-16-224

**NORTH CENTRAL REGION – ATHABASCA AREA – GEOHAZARD
ASSESSMENT (CE102/2008)
CALL-OUT FOR EMBANKMENT DISTRESS
ON HWY 813:02 (KM 0.5)**

SITE SKETCH PLAN SHOWING APPROXIMATE CONDITIONS DURING CALLOUT ON MARCH 31, 2010

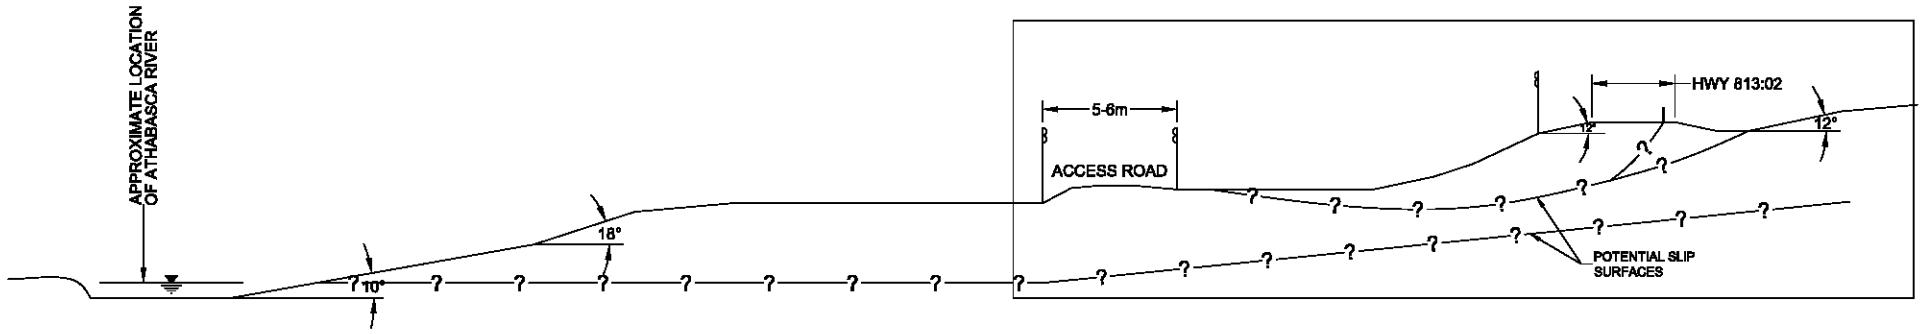
CROSS-SECTION A-A' IS BASED ON APPROXIMATE FIELD MEASUREMENTS AND MAY NOT REPRESENT THE ACTUAL PROFILE THROUGHOUT THE SLIDE AREA ALONG THE HIGHWAY.
