GEOHAZARD ASSESSMENT PROGRAM
NORTH CENTRAL REGION – ATHABASCA
2017 INSPECTION

Site Number	Location	Hwy	Km
NC 004-1	Town of Athabasca	55:10 and 813:02 Intersection	Hwy 55:10: km 0.34 to 0.84 Hwy 813:02: km 0.00 to 1.97
Legal Description		UTM Co-ordinates (NAD 83)	
21-066-22 W4M		12 E 6066180	N 353385

Date	PF	CF	Total
Previous Inspection:	May 18, 2016	12	4	48
Current Inspection:	May 17, 2017	12	4	48
Road AADT:	9100		Year:	2016
Inspected By:	Tarek Abdelaziz, José Pineda (Thurber) Roger Skirrow, Arthur Kavulok, Ron Hilligas, Paula Campbell (TRANS)			
Report Attachments:	<input checked="" type="checkbox"/> Photographs <input checked="" type="checkbox"/> Plans <input checked="" type="checkbox"/> Maintenance Items

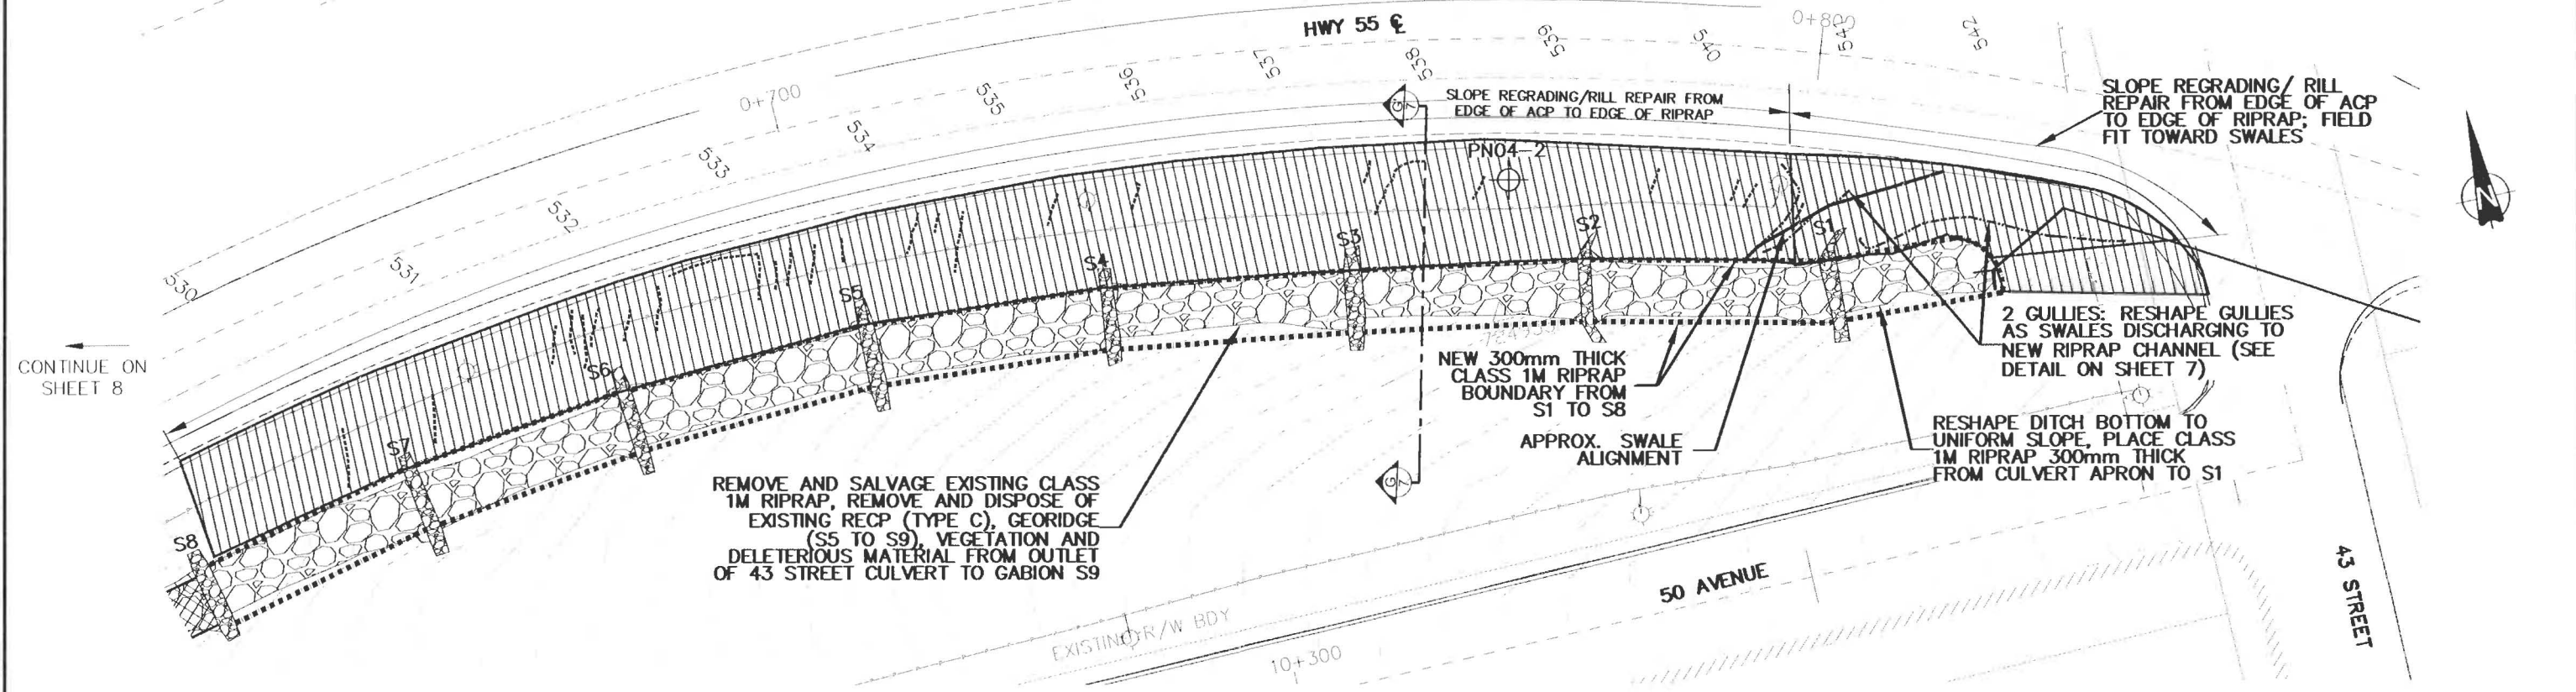
DETAIL SITE PLAN-REPAIR AREA 5 SCALE: 1:300

NOTES:
 EXISTING CLASS 1M RIPRAP APPROXIMATE 200mm THICK BETWEEN CULVERT OUTLET AND S4 AND 150mm THICK BETWEEN S4 AND S9.
