**ALBERTA TRANSPORTATION AND ECONOMIC CORRIDORS  
GEOHAZARD ASSESSMENT PROGRAM  
NORTH CENTRAL REGION – ATHABASCA &  
FORT MCMURRAY DISTRICTS  
2023 SITE INSPECTION**

Site Number	Location	Name	Hwy	km
NC103-2	Approximately 7.9 km north of Hwy 29 (North of Elk Point)	<b>KEHIWIN LAKE</b>	41:23	7.9
<b>Legal Description</b>		<b>UTM Co-ordinates (NAD 83)</b>		
9-25-58-07 W4		12 N 5988463.22	E	506745.73

**NC103-2: HWY41:23 KEHIWIN LAKE WEST SIDE  
SLOPE SLUMP (km 7.9)**

**FIGURE 1**

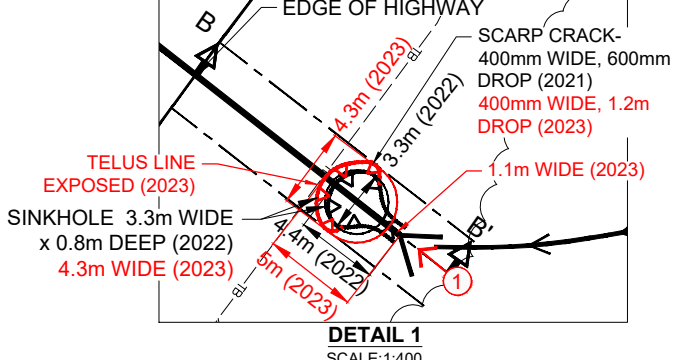
**DETAIL 1**  
SCALE:1:400

- NOTES:**
- MAY 18, 2023 OBSERVATIONS ARE SHOWN IN RED.
  - CROSS - SECTION A - A' IS BASED ON APPROXIMATE FIELD MEASUREMENTS, MAY NOT REPRESENT THE ACTUAL PROFILE.
  - CULVERT IS LOCATED BETWEEN PILES P60 AND P61. THE CENTER TO CENTER SPACING BETWEEN THE CULVERT AND EACH OF THE PILES IS 1.5m.
