**ALBERTA TRANSPORTATION AND  
ECONOMIC CORRIDORS GRMP  
NORTH CENTRAL (ATHABASCA AND FORT  
McMURRAY DISTRICTS)  
INSTRUMENTATION MONITORING- SPRING 2024**

Site Number	Location	Name	Hwy	km
NC104 (NC024-4)	HWY 41:23 C1 7.66	Kehiwin Lake	41:23	Km 7.7
<b>Legal Description:</b> 9-25-58-7 W4		<b>UTM Co-ordinates</b>		
		12U E 506556	N	5988265

<b>Current Monitoring:</b>	6-June-2024	<b>Previous Monitoring</b>	25-May-2023
<b>Instruments Read By:</b>	Mr. Niraj Regmi, G.I.T and Mr. Nixson Mationg, of Thurber

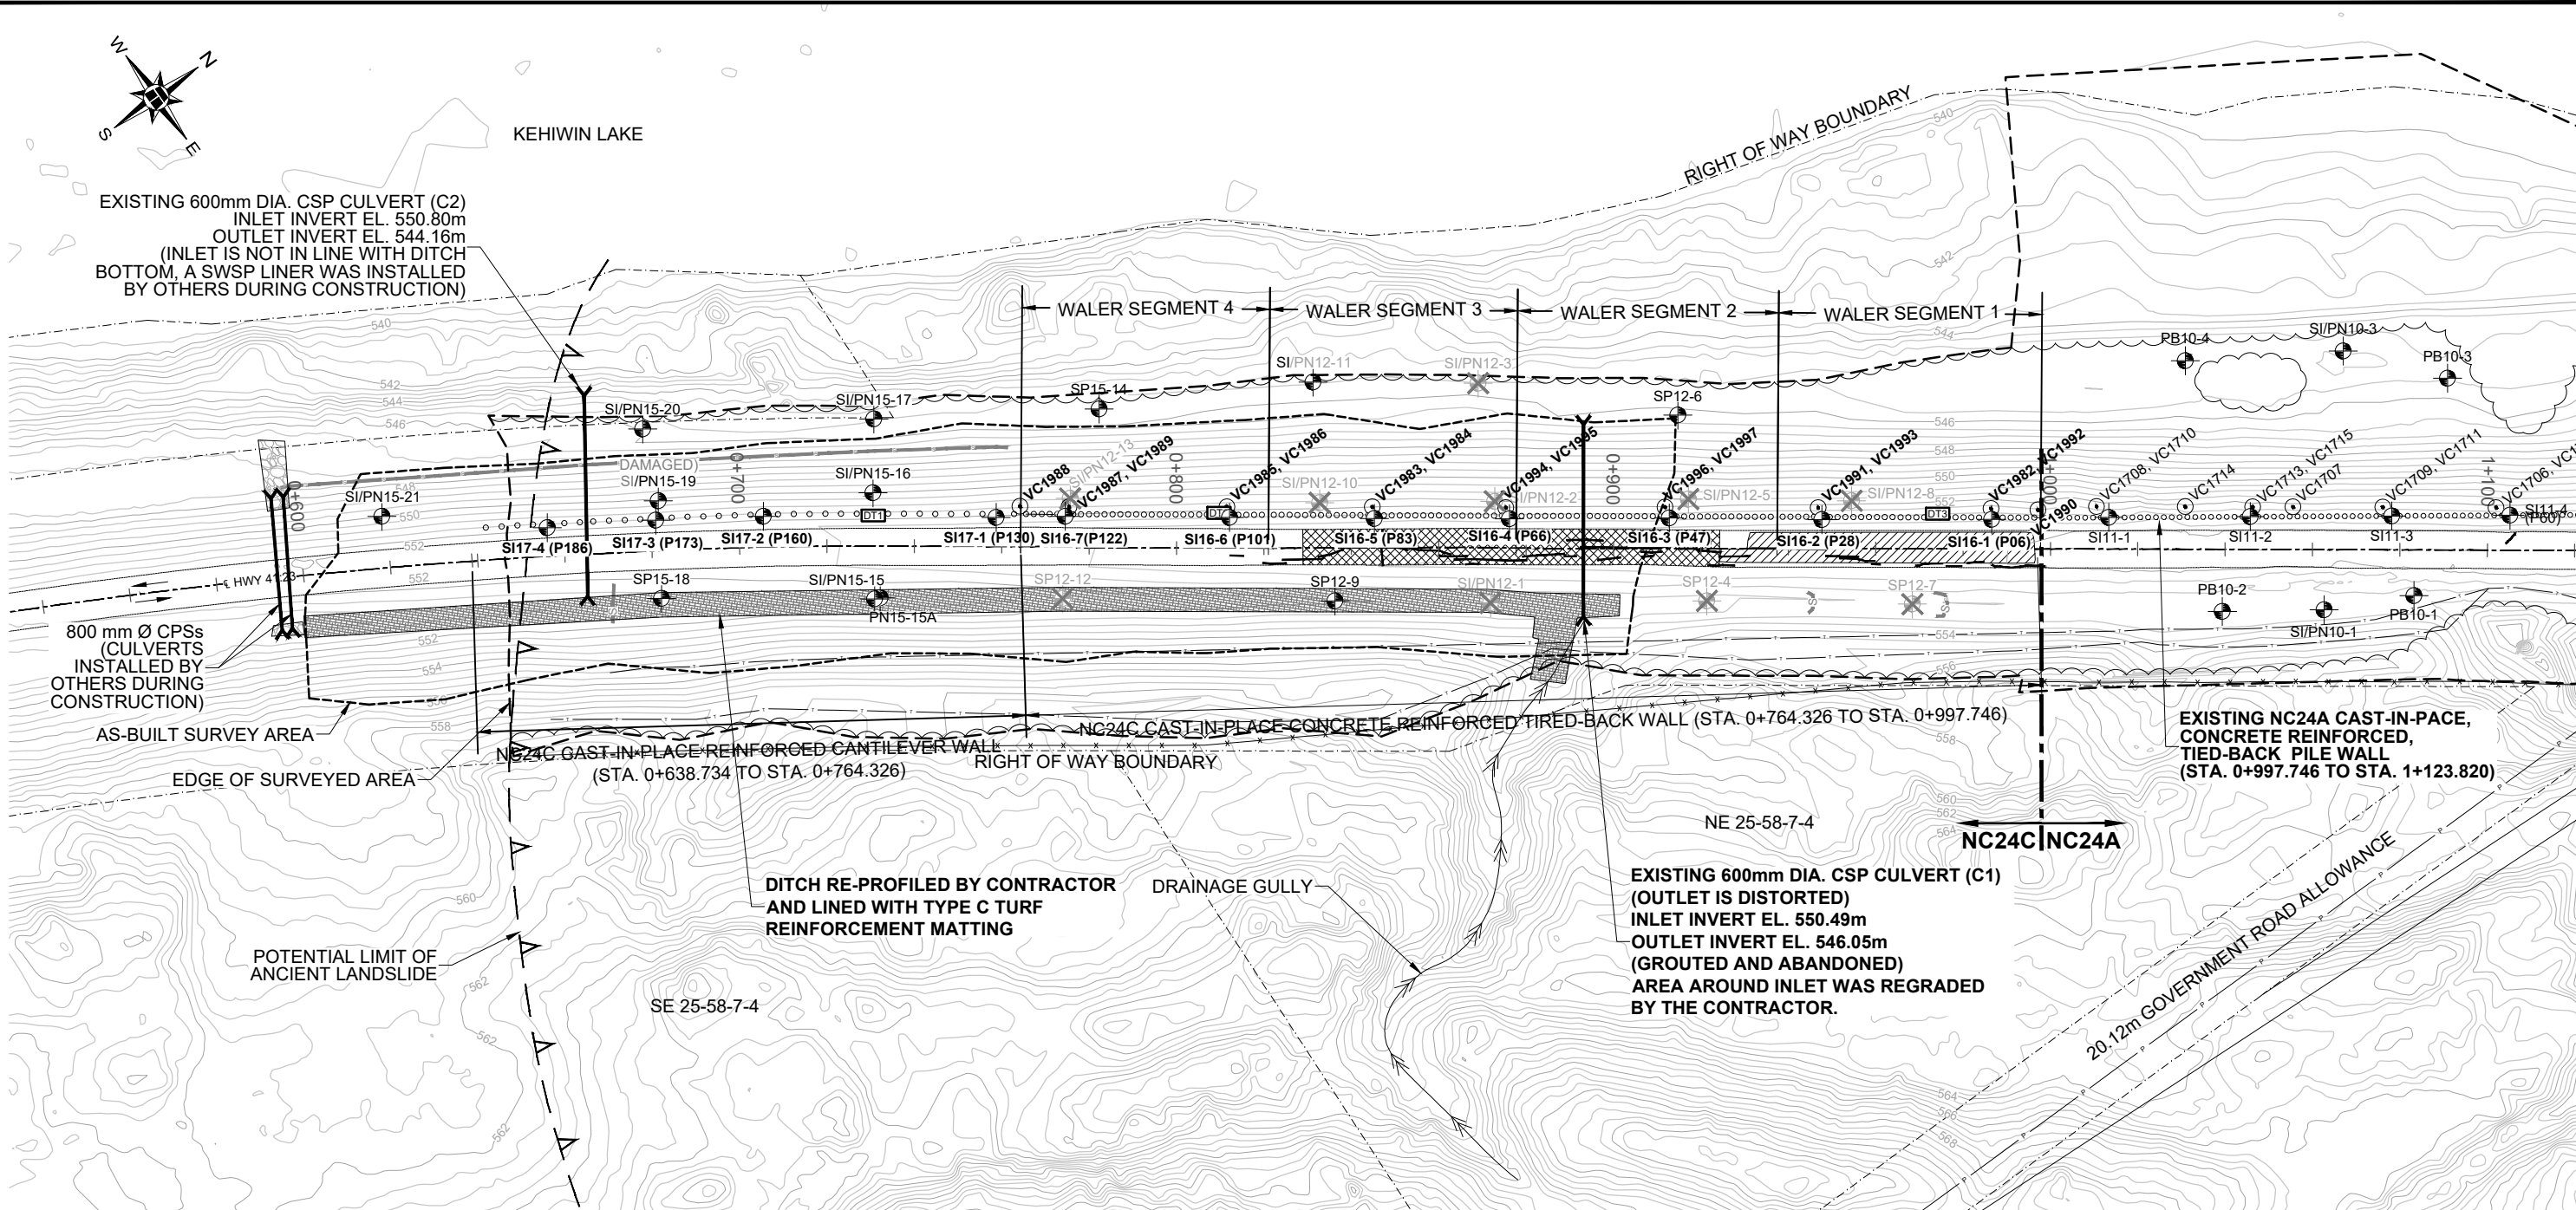
**\*\* Rundown by Lawn mower, stickup protector sunk 4 ft in the ground and bent at top. IF repair needed, will need mechanical excavation.**
