ALBERTA TRANSPORTATION AND
ECONOMIC CORRIDORS GRMP
NORTH CENTRAL (ATHABASCA AND FORT
McMURRAY DISTRICTS)
INSTRUMENTATION MONITORING- SPRING 2024

Site Number	Location	Name	Hwy	km
NC069	HWY 63:02 L1 32.020	South of Wandering River	63:02	Km 32
Legal Description: 3-27-70-17 W4		UTM Co-ordinates		
		12U E 403599	N	6105301

Current Monitoring:	13-June-2024	Previous Monitoring	Between 27-May-2023 and 02-Jun-2023
Instruments Read By:	Mr. Niraj Regmi, G.I.T and Mr. Nixon Mationg, of Thurber

SITE NC069: HWY 63:02 SLOPE REPAIR SOUTH OF WANDERING RIVER

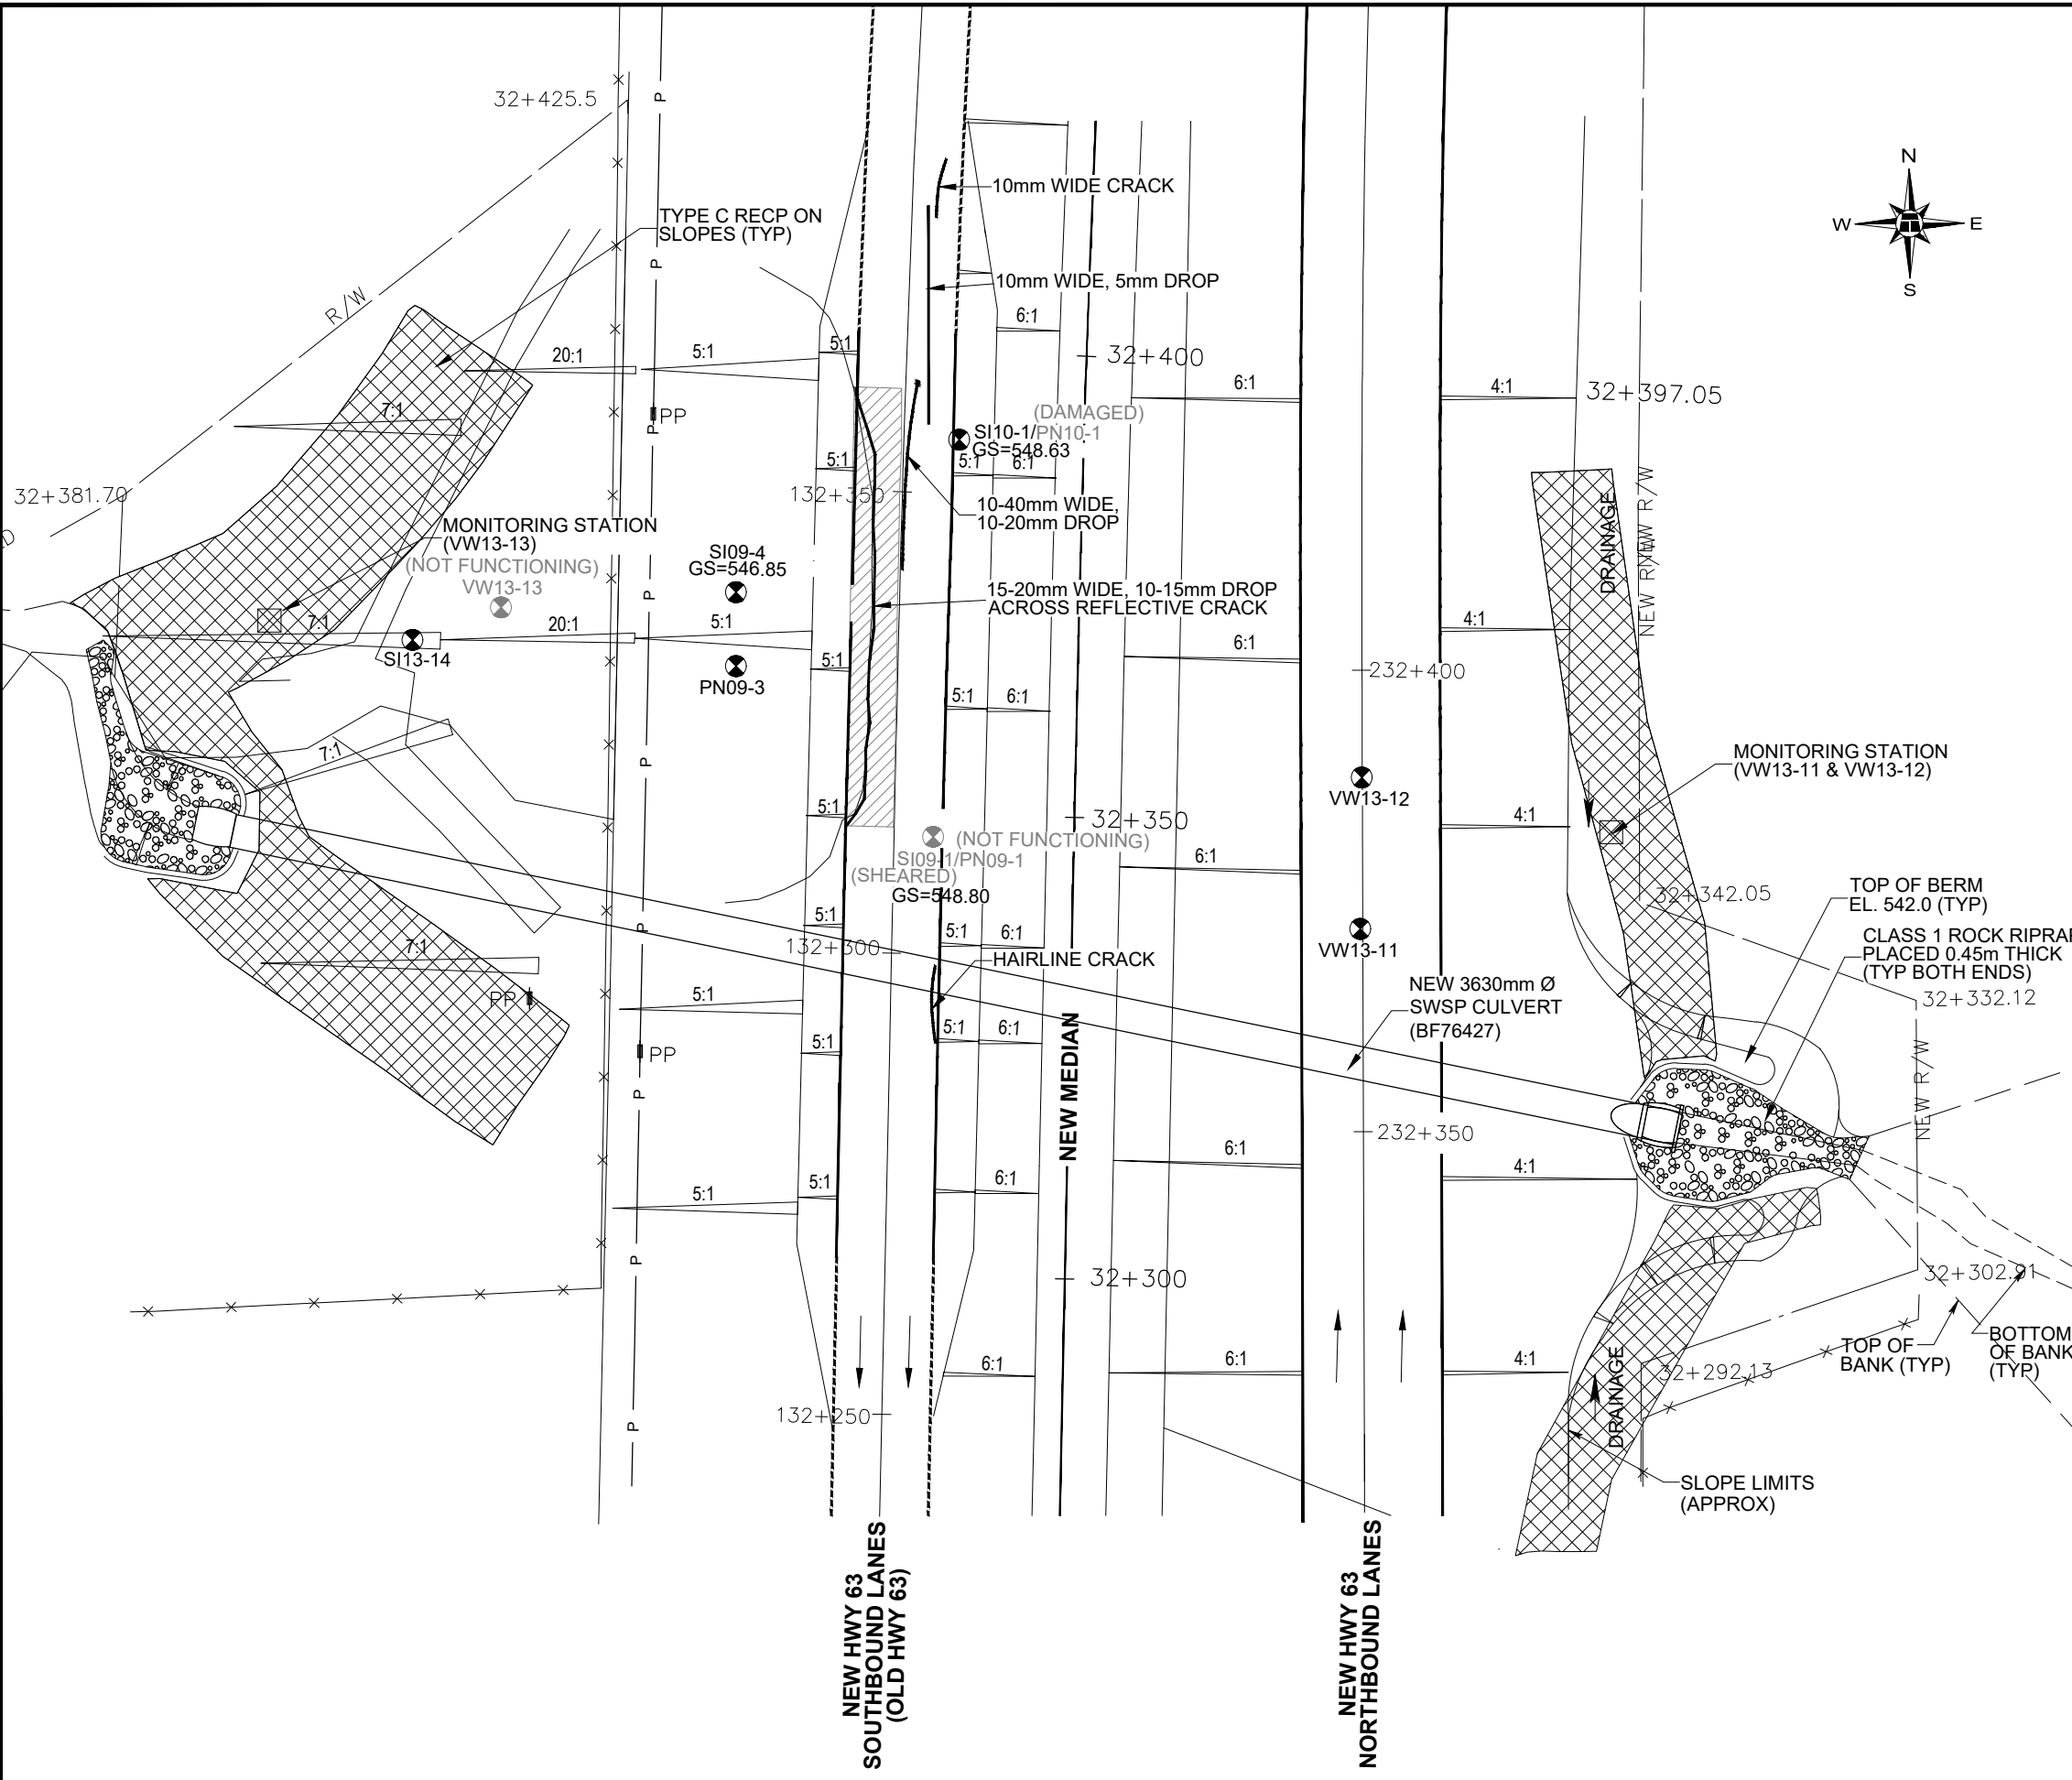
SI09-4 was installed on November 17, 2009 to replace SI09-3. It has a red stick-up protector in the west ditch.
SI10-1 casing breaking apart @ 10 ft. use dummy probe/ camera for next reading.
Confirm if PN09-1 functioning
PN10-1 cut off damaged, requires mechanical excavation
