**ALBERTA TRANSPORTATION  
GEOHAZARD ASSESSMENT PROGRAM  
NORTH CENTRAL REGION – ATHABASCA  
2020 INSPECTION**

Site Number	Location	Name	Hwy	km
NC070-1	Approximately 2 km northeast of Hangingstone River and 40 km south of Fort McMurray	Truck Staging Area	63:10	18.8
<b>Legal Description</b>		<b>UTM Co-ordinates (NAD 83)</b>		
SE ¼ and SW¼ -3-86-9-W4M		12 N 6253630	E 478921

**NORTH CENTRAL REGION (ATHABASCA AREA)**  
**2020 GEOHAZARD ASSESSMENT**  
**NC070-1: HWY 63:10 TRUCK STAGING AREA**  
**SITE PLAN**

**NC070-1: HWY 63:10 TRUCK STAGING AREA SITE PLAN SHOWING EXISTING INSTRUMENT LOCATIONS**

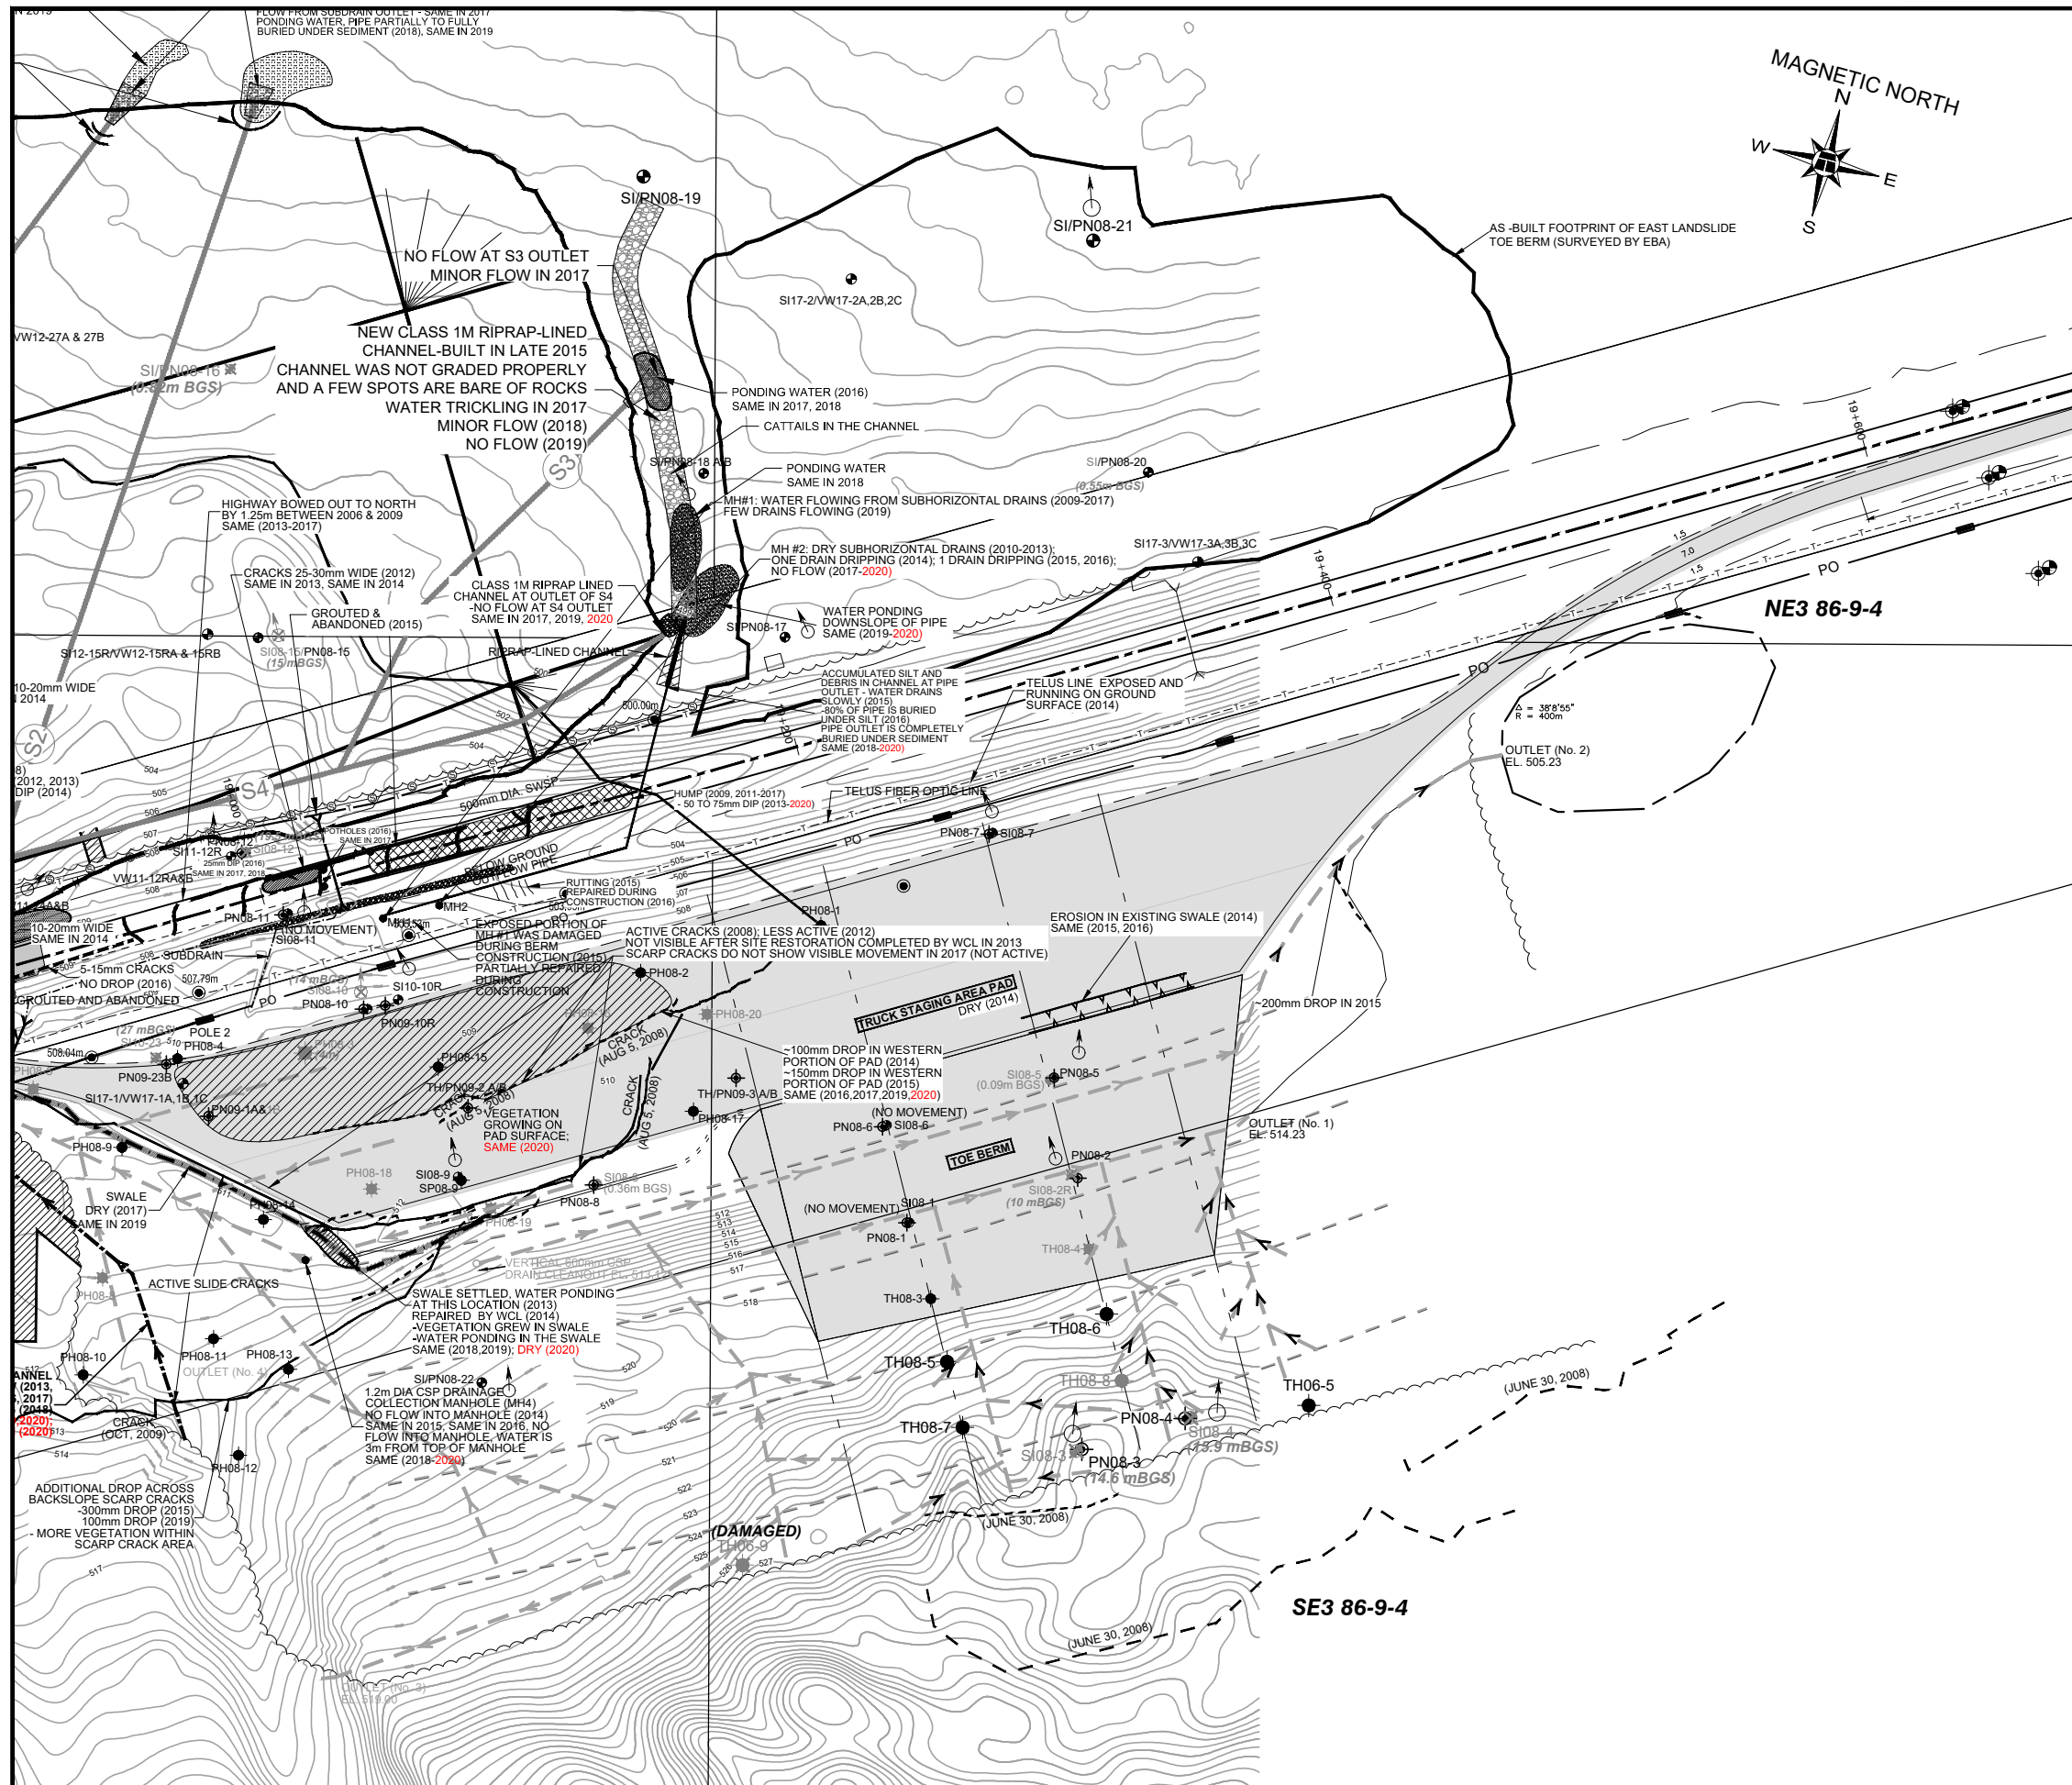
1. IN 2012, TELUS INSTALLED A 7m DEEP CABLE BETWEEN PEDESTALS 17A & 17B AND ABANDONED THE EXISTING BURIED CABLE ONLY BETWEEN THESE LOCATIONS.
2. IN 2012, SHAW INSTALLED A 7m DEEP CABLE IN THE NORTH DITCH, BETWEEN STATIONS 18+660 AND 19+210, AND ABANDONED THE EXISTING ABOVE GROUND CABLE FOR A DISTANCE OF ABOUT 550m ALONG THE HIGHWAY ALIGNMENT.
3. SUBDRAINS S1 TO S4 ARE 200mm Ø PERFORATED PIPES AND WERE INSTALLED DURING BERM CONSTRUCTION IN 2015.
4. CRACKS ON HIGHWAY SURFACE WERE SEALED DURING WEST BERM CONSTRUCTION IN 2015.
5. THE HIGHWAY NEW SOUTHBOUND LANES WERE CONSTRUCTED IN 2015 TO THE NORTH OF THE TOE OF THE WEST LANDSLIDE. FORMER HIGHWAY LANES PRIOR TO CONSTRUCTION ARE CURRENTLY THE HIGHWAY NORTHBOUND LANES.
6. JUNE 24, 2020 OBSERVATIONS ARE SHOWN IN RED.
