NORTH CENTRAL REGION (ATHABASCA AREA)
- 2013 GEOHAZARD ASSESSMENT

NC14: HWY 661:02 FORT ASSINIBOINE (km 1.8)
SITE PLAN SHOWING EXISTING FEATURES

**NC14: HWY 661: 02 FORT ASSINIBOINE (km 1.8)
 SITE PLAN SHOWING MID-HILL SLIDE AREA**

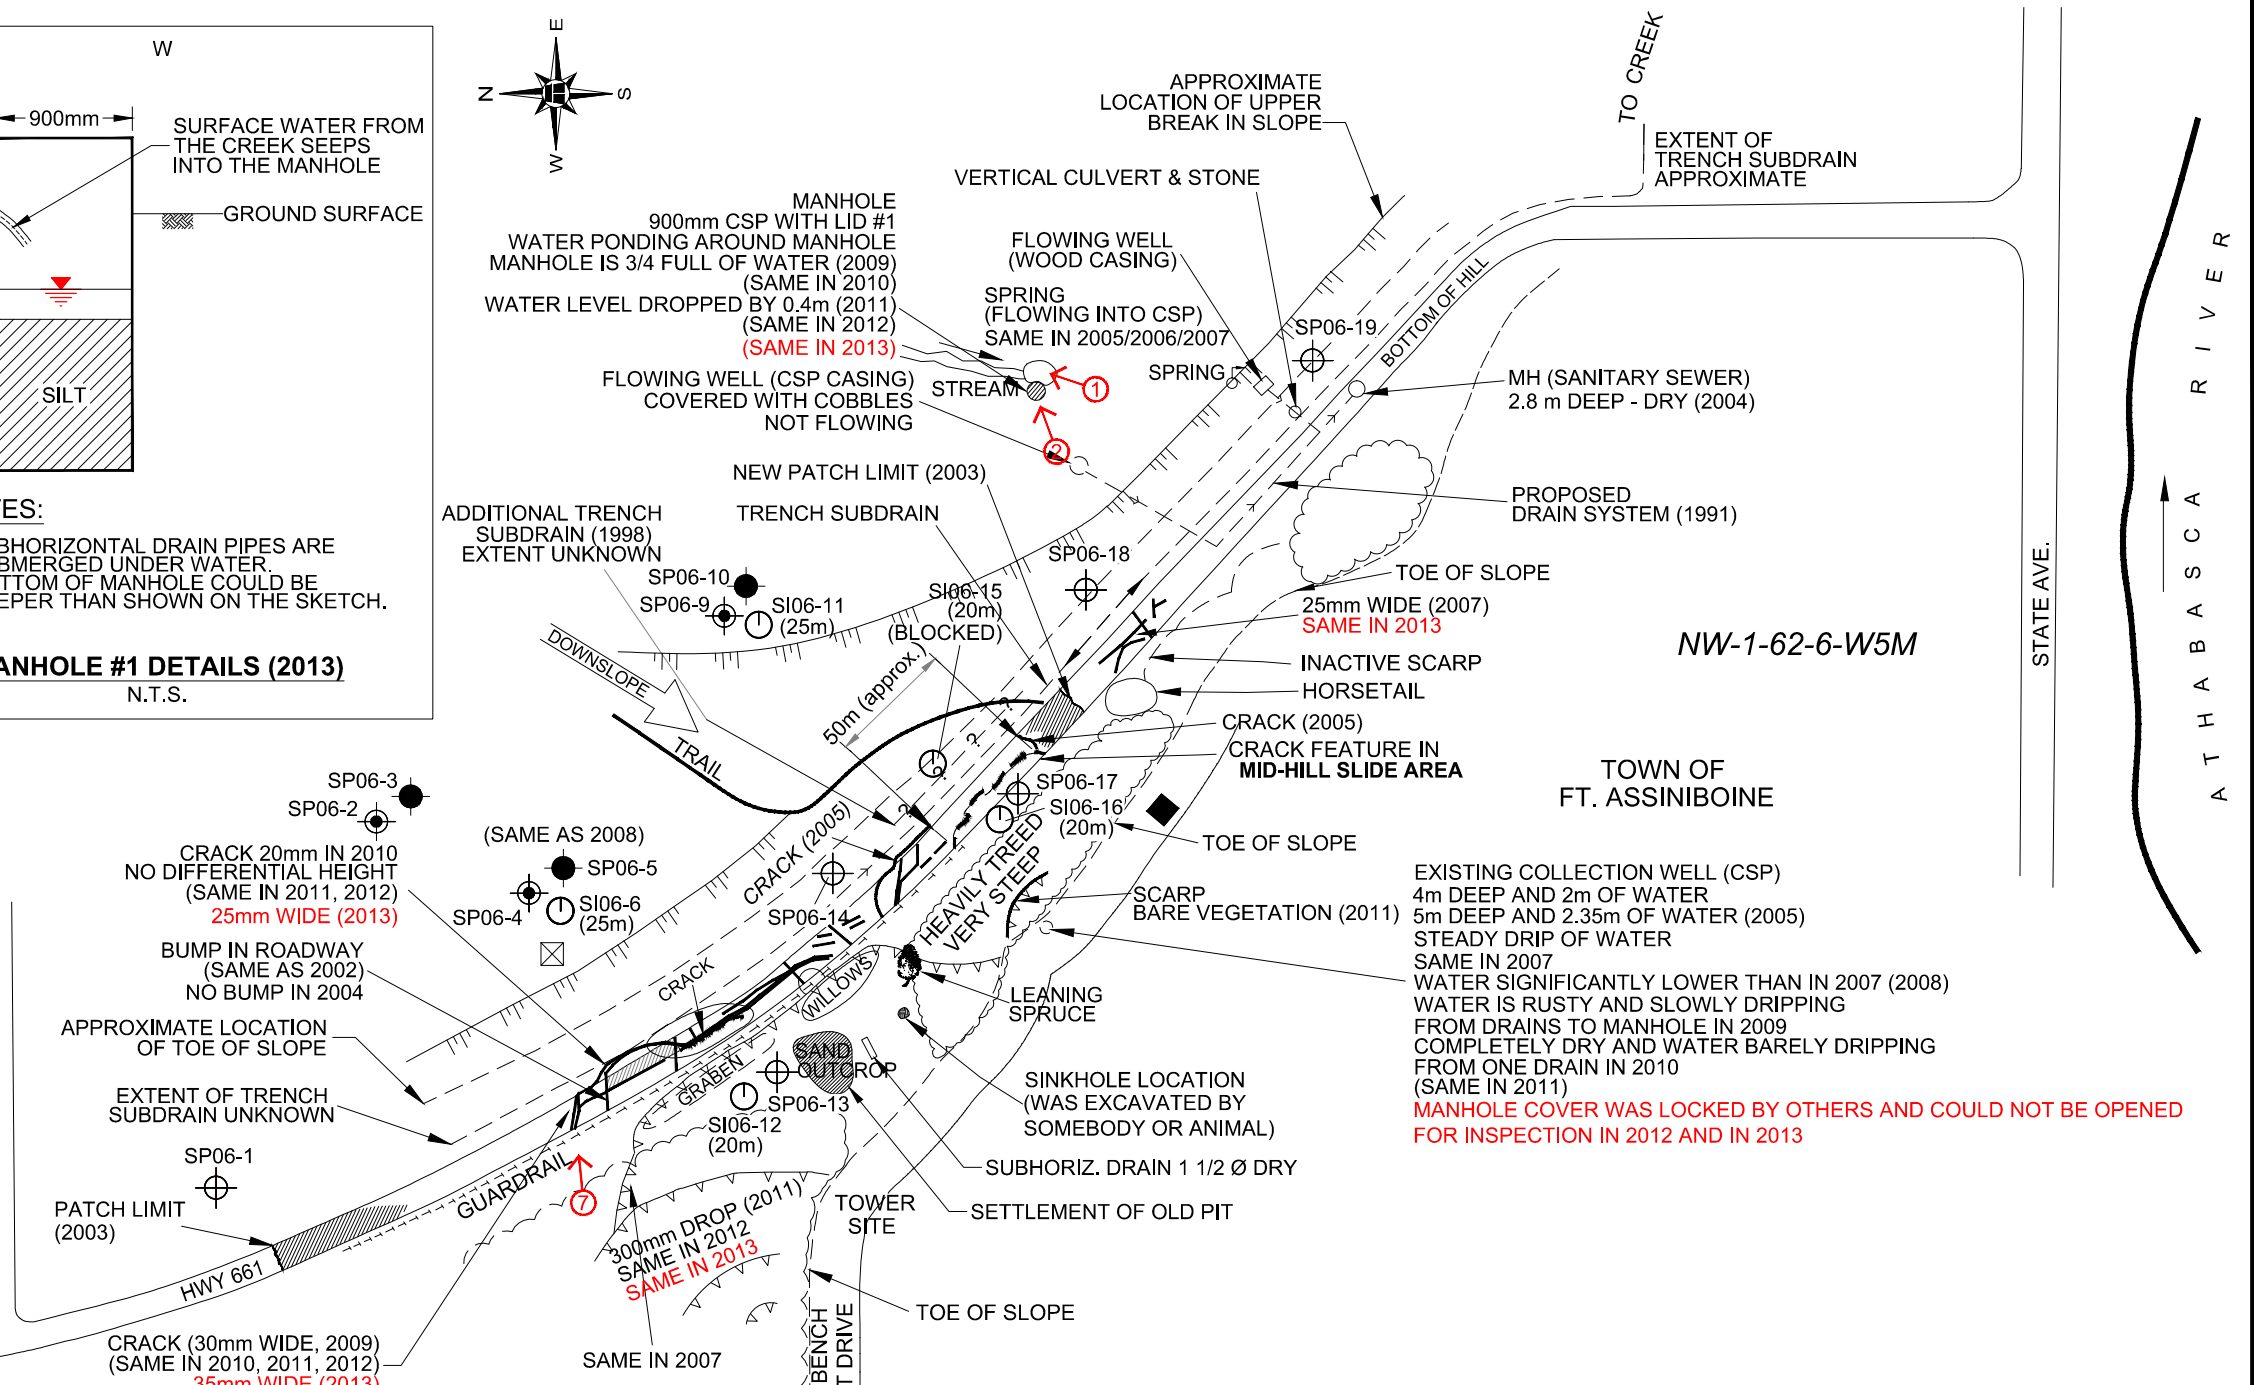
FIGURE NC14-1

1. FEATURE LOCATIONS ARE APPROXIMATE.
2. PREVIOUS OBSERVATIONS SHOWN IN BLACK
3. THREE LEVEL LOGGERS WERE INSTALLED IN SP06-2, SP06-3, AND SP06-13 AND TWO VIBRATING WIRE PIEZOMETERS WERE INSTALLED IN SP06-4 AND SP06-5.
4. **JUNE 10, 2013 OBSERVATIONS ARE SHOWN IN RED**

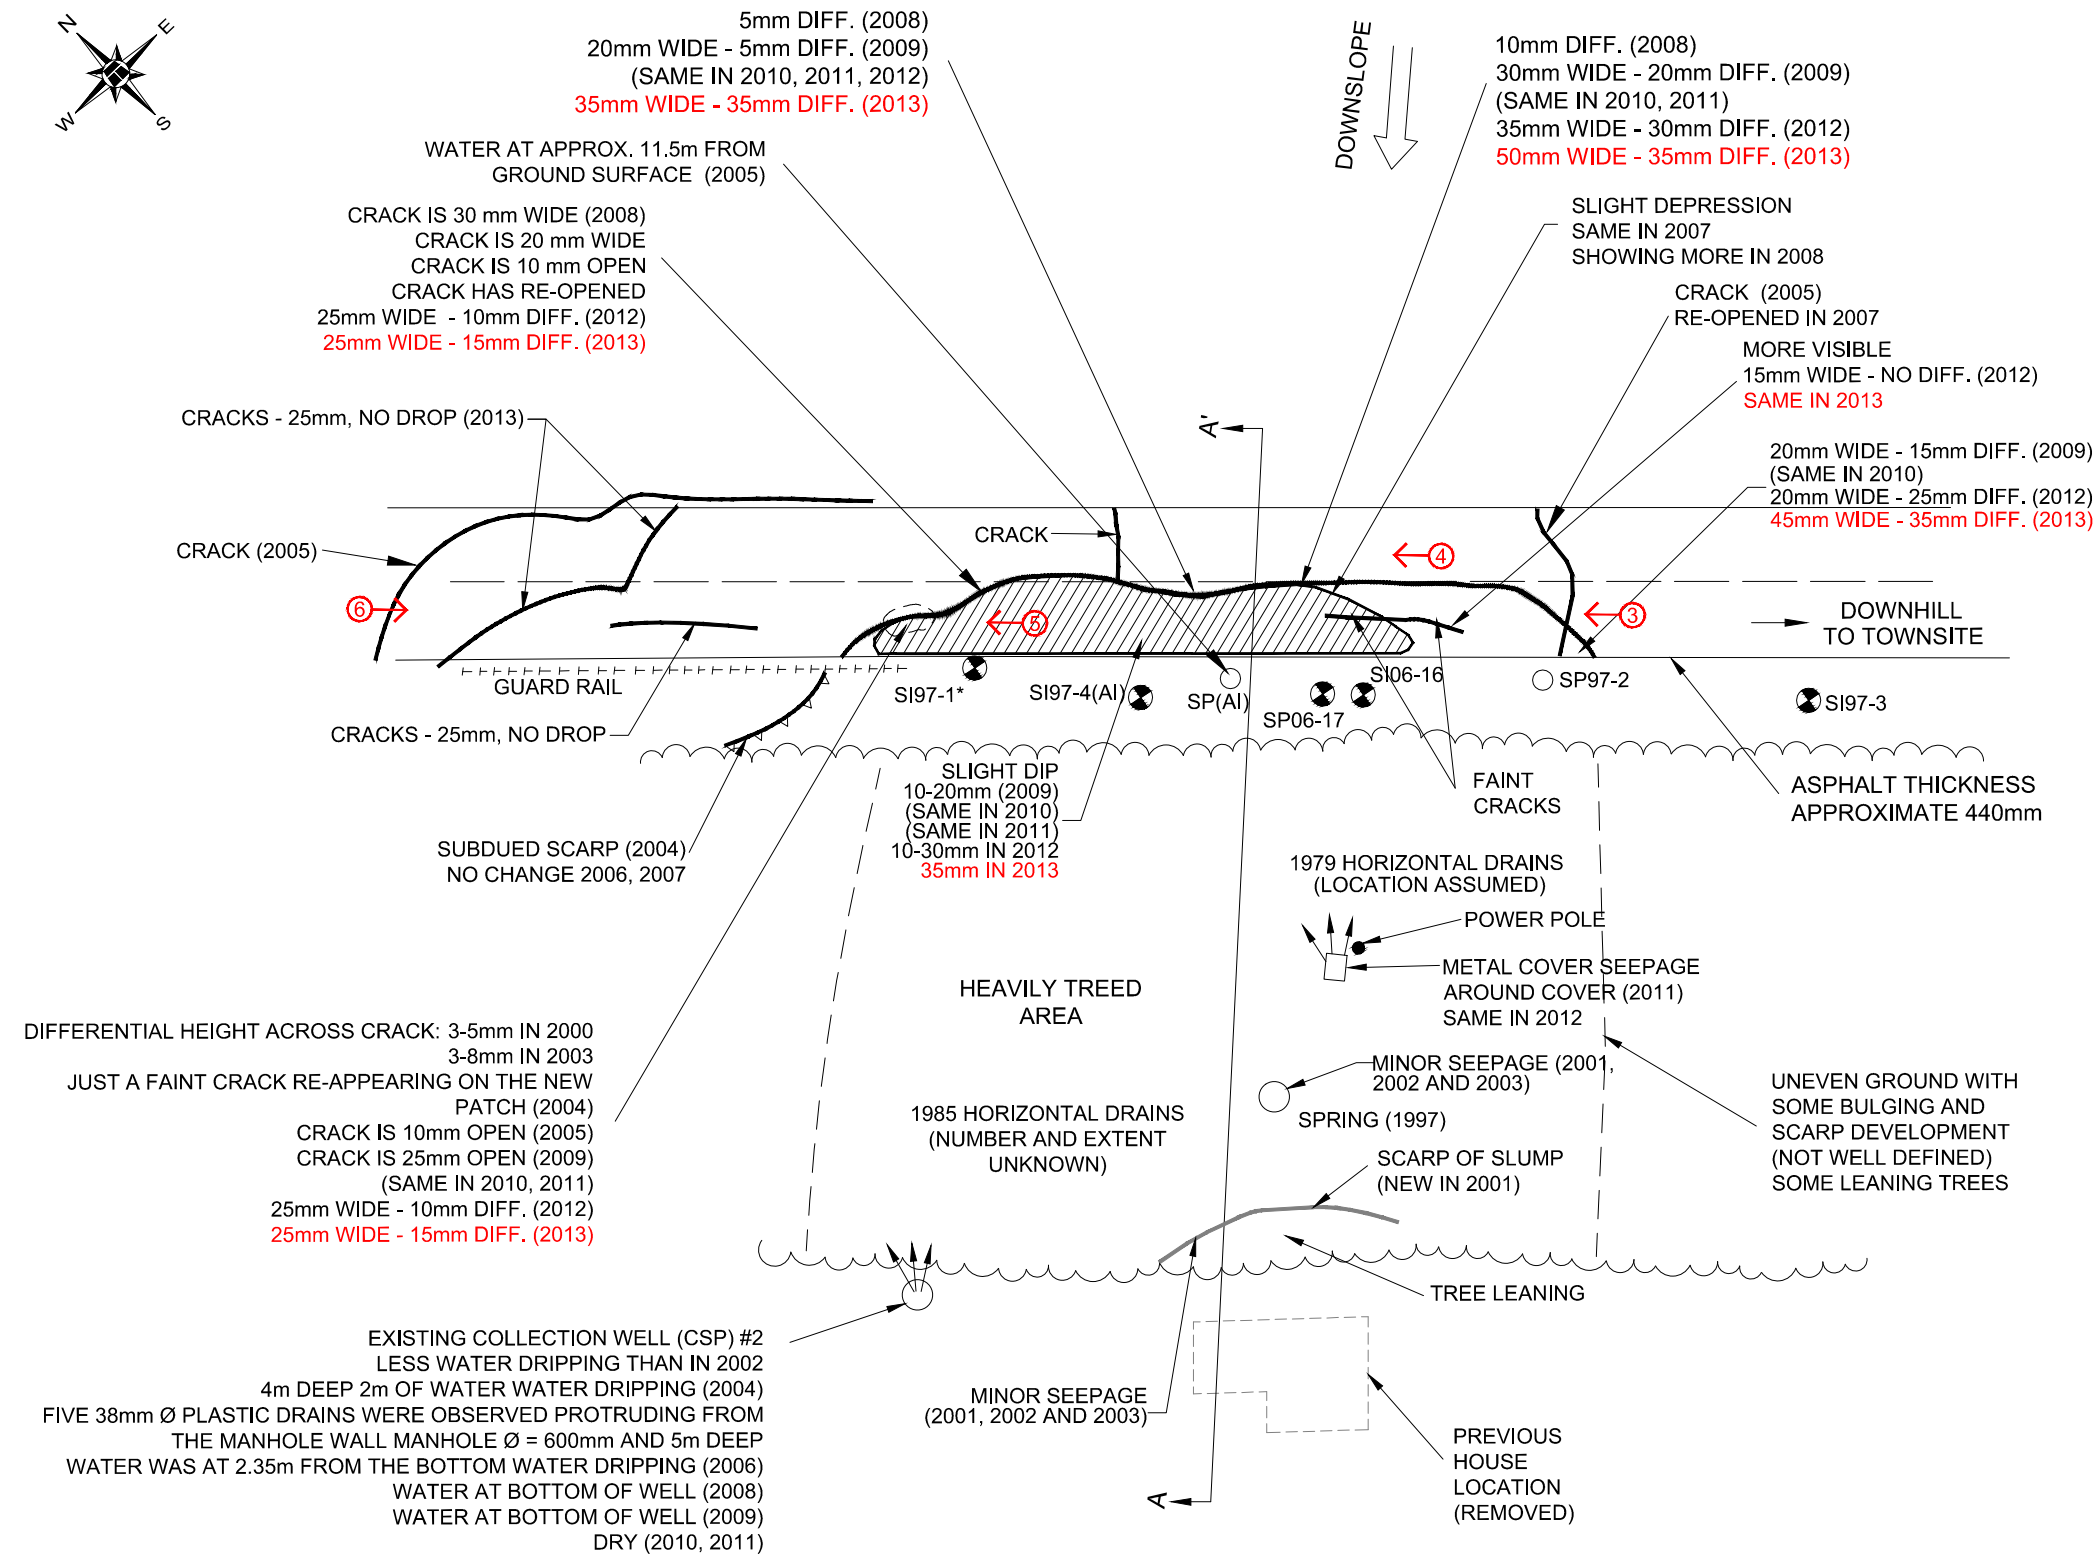
FIGURE NC14-2

1. FEATURE LOCATIONS ARE APPROXIMATE.
 2. PREVIOUS OBSERVATIONS SHOWN IN BLACK
 3. PREVIOUS CRACK PATTERN WAS COVERED BY NEW (2004) ASPHALT PATCH
 4. **JUNE 10, 2013 OBSERVATIONS ARE SHOWN IN RED**
- ① PHOTOGRAPH NUMBER, AND APPROXIMATE DIRECTION AND LOCATION (JUNE 10, 2013)
