**NORTH CENTRAL REGION (ATHABASCA AREA)  
- 2017 GEOHAZARD ASSESSMENT**

**NC014-1: HWY 661: 02 FORT ASSINIBOINE (km 1.8)  
SITE PLAN SHOWING MID-HILL SLIDE AREA**

**DWG NO. NC014-1-2**

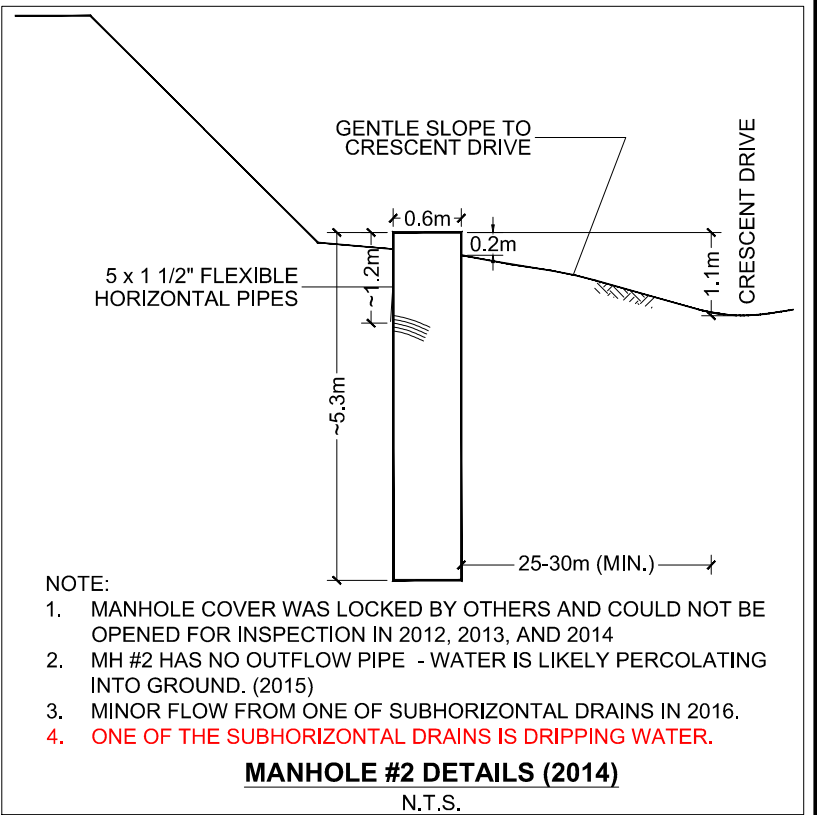
DIFFERENTIAL HEIGHT ACROSS CRACK: 3-5mm IN 2000  
3-8mm IN 2003  
JUST A FAINT CRACK RE-APPEARING ON THE NEW PATCH (2004)  
CRACK IS 10mm OPEN (2005)  
CRACK IS 25mm OPEN (2009)  
(SAME IN 2010, 2011)  
25mm WIDE - 10mm DIFF. (2012)  
25mm WIDE - 15mm DIFF. (2013)  
SAME IN 2014  
SAME IN 2015

EXISTING COLLECTION WELL (CSP) #2  
LESS WATER DRIPPING THAN IN 2002  
4m DEEP 2m OF WATER WATER DRIPPING (2004)  
FIVE 38mm Ø PLASTIC DRAINS WERE OBSERVED PROTRUDING FROM THE MANHOLE WALL MANHOLE Ø = 600mm AND 5m DEEP WATER WAS AT 2.35m FROM THE BOTTOM WATER DRIPPING (2006)  
WATER AT BOTTOM OF WELL (2008)  
WATER AT BOTTOM OF WELL (2009)  
DRY (2010, 2011)
