**ALBERTA TRANSPORTATION
GEOHAZARD ASSESSMENT PROGRAM
NORTH CENTRAL REGION – ATHABASCA &
FORT MCMURRAY DISTRICTS
2022 SITE INSPECTION**

Site Number	Location	Name	Hwy	km
NC093	22 Km north of Calling Lake	Rock Island Bridge (79692) Landslide	813:06	4.70
Legal Description		UTM Co-ordinates (NAD 83)		
NE 5-74-22-W4		12	6139937.91	E 351682.46

Date	PF	CF	Total
Previous Inspection:	June 23, 2021	10	6	60
Current Inspection	June 6, 2022	10	6	60
Road AADT:	480	Year:		2021
Inspected By:	José Pineda, Tarek Abdelaziz (Thurber) Arthur Kavulok, Rishi Adhikari, Amy Driessen (Alberta Transportation)			
Report Attachments:	<input checked="" type="checkbox"/> Photographs <input checked="" type="checkbox"/> Plans <input type="checkbox"/> Maintenance Items

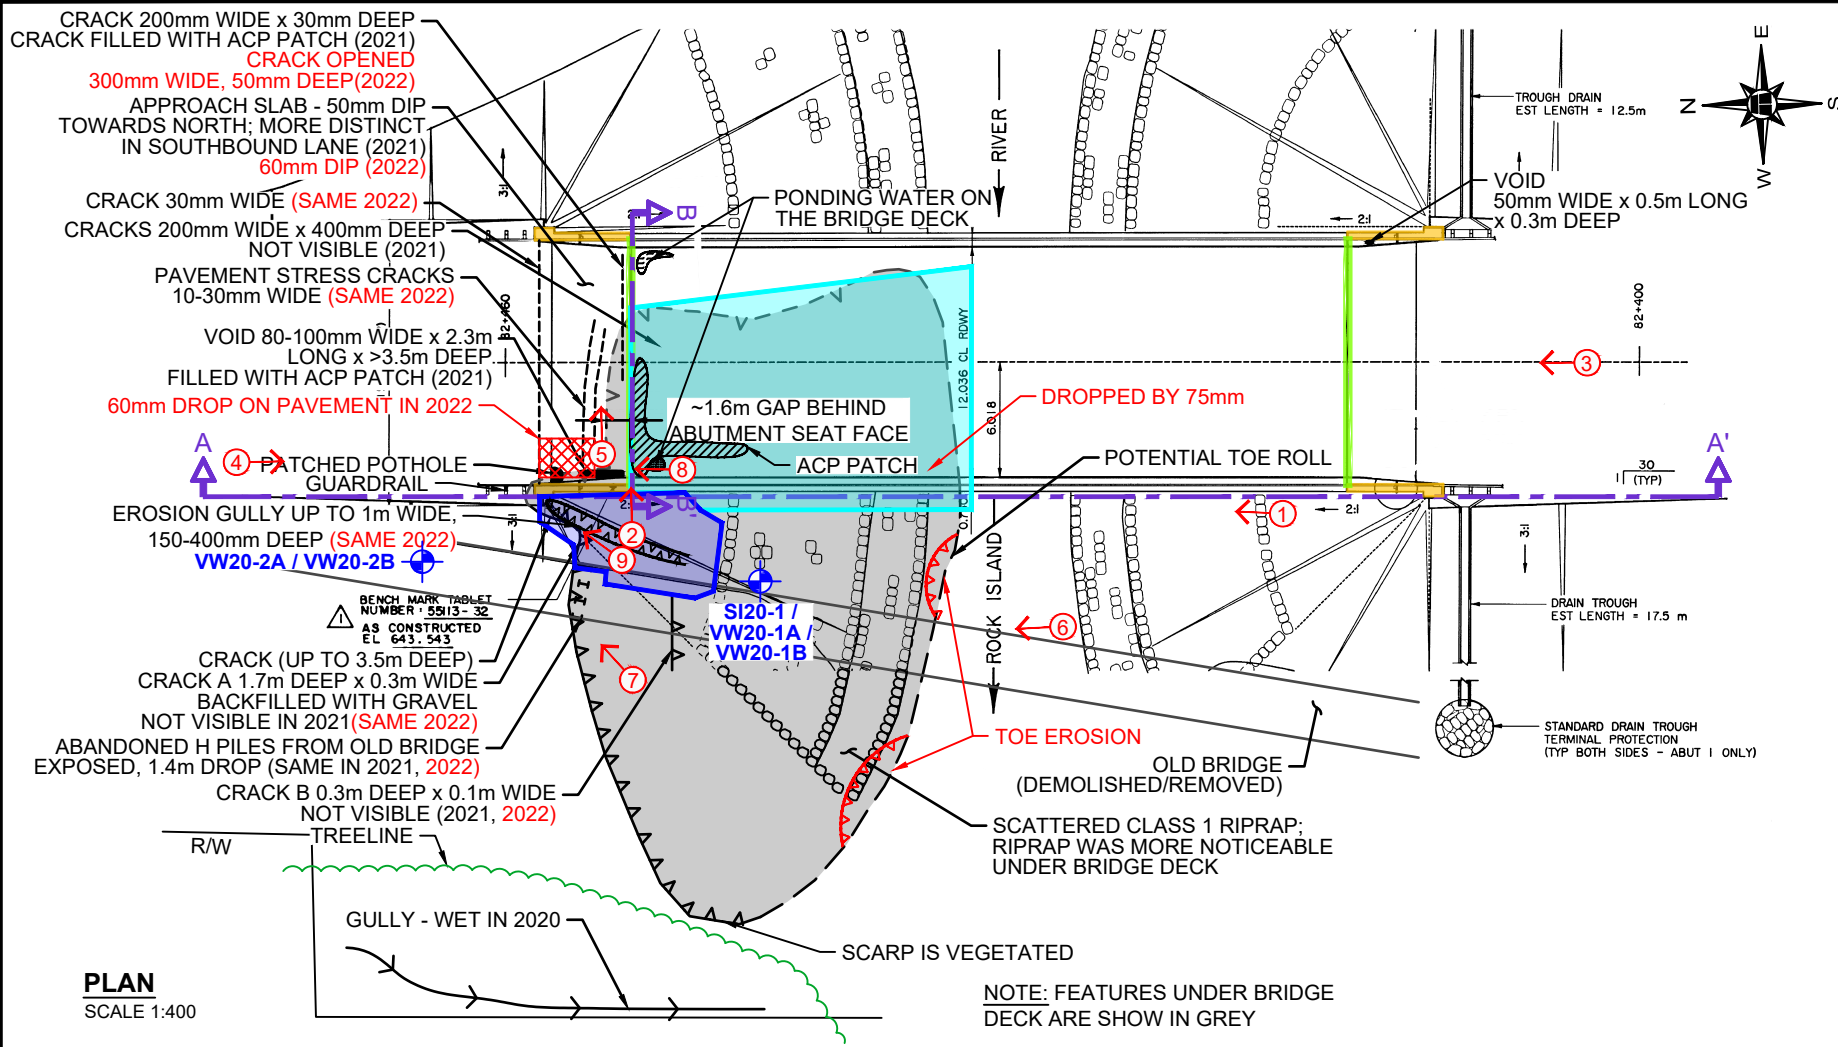
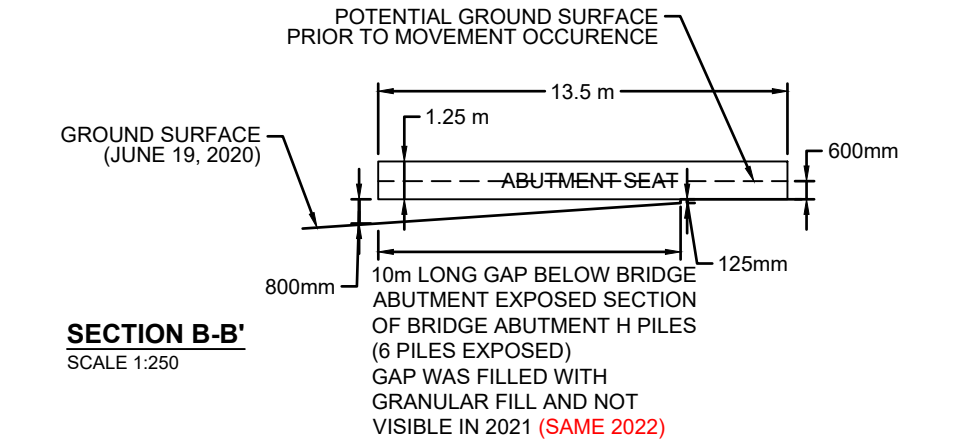
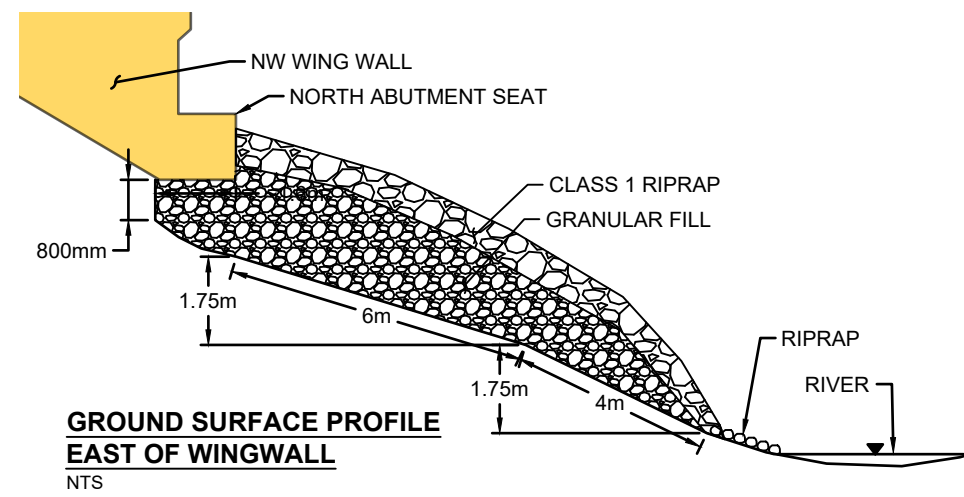
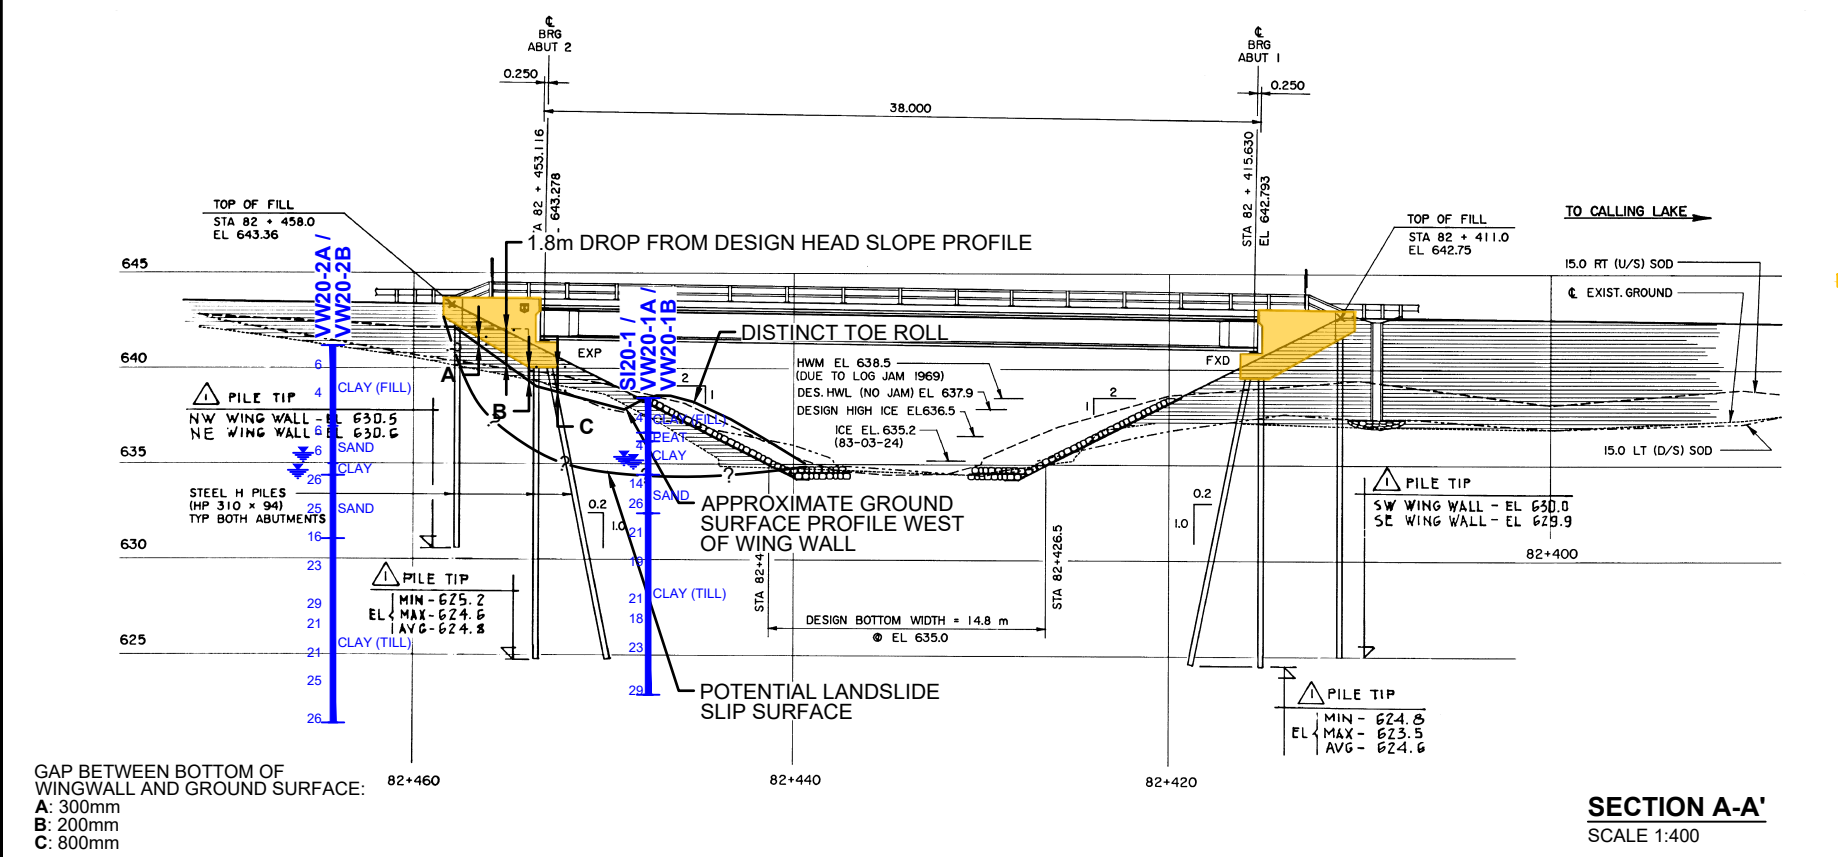
Primary Site Issue	Landslide within the NW approach fill of Bridge File (BF) 79692, impacting NW wing wall, highway and abutment supports
Dimensions:	The slide is approximately 25 m long (parallel to bridge alignment) and 40 m wide (perpendicular to bridge alignment)
Site History / Available Information:	<p>The existing bridge structure was first in service since 1989 to replace an older bridge structure that was located about 3 m west of the existing NW wing wall. The old bridge was a three-span structure also supported on steel H piles, which were cut off and left in place. The new structure consists of a 38 m single span concrete girder bridge with the abutments and the wing walls supported on driven steel H piles. The abutments are supported on 15 m deep piles and the wing walls are supported on 10 m deep piles.</p> <p>The approach fill head slope is inclined at 2H:1V. The side slopes of the approach fill are approximately 3H:1V on both sides of the river. Approximately 3 m and 6 m of fill was placed on the north and south of the river alignment, respectively to accommodate the construction of the new bridge.</p> <p>Records indicate that an instability/slump occurred within the north head slope as early as January 2016 when the headslope fill dropped to 0.5 m below the north abutment seat. We understand that repairs have not been completed since the drop was first noticed in 2016.</p> <p>A geotechnical investigation was conducted in 1987 for the design of the existing bridge. Available records show that the soil at the landslide area (Test hole # 3) prior to the construction of approximately 3 m of fill embankment consist of 9 m of saturated fine to medium grained loose to compact silty sand. A 2 m thick layer of medium to high plastic clay was interbedded within the sand between elevations 634 and 636 m. The sand clay in turn is overlaid by very still to hard clay till to the termination depth of the test hole. Similar soil conditions were encountered in Test Hole # 1 and # 2 drilled on the south side of the river with the exception of the high plastic clay layer noted within the sand formation.</p>
