SITE NUMBER AND NAME: <b>C058-1, -2, &amp; -3 Sinkholes</b>		HIGHWAY & KM: 570:02, 8.3, 9.2, 9.8	PREVIOUS INSPECTION DATE: June 24, 2021	INSPECTION DATE: <b>June 26, 2023</b>
LEGAL DESCRIPTION: 10-08-27-17 W4M	NAD 83 COORDINATES: UTM Northing Easting <b>C058-1</b> 12 5683470 405475 <b>C058-2</b> 12 5683845 404934 <b>C058-3</b> 12 5684148 404224		RISK ASSESSMENT: <b>C058-1:</b> PF: 8 CF: 5 TOTAL: 40 <b>C058-2:</b> PF: 8 CF: 5 TOTAL: 40 <b>C058-3:</b> PF: 8 CF: 5 TOTAL: 40	
AVERAGE ANNUAL DAILY TRAFFIC (AADT): 500 (west) & 400 (east) (Ref No. 116220 & 997198)			CONTRACT MAINTENANCE AREA (CMA): 521

PROJECT CENTRAL REGION GEOHAZARD RISK MANAGEMENT PROGRAM		
TITLE Site Plan C058-I - Sinkholes Hwy 570:01, km 8.3		
SCALE 1:750	PROJECT No. A05116A02	FIG No. 1

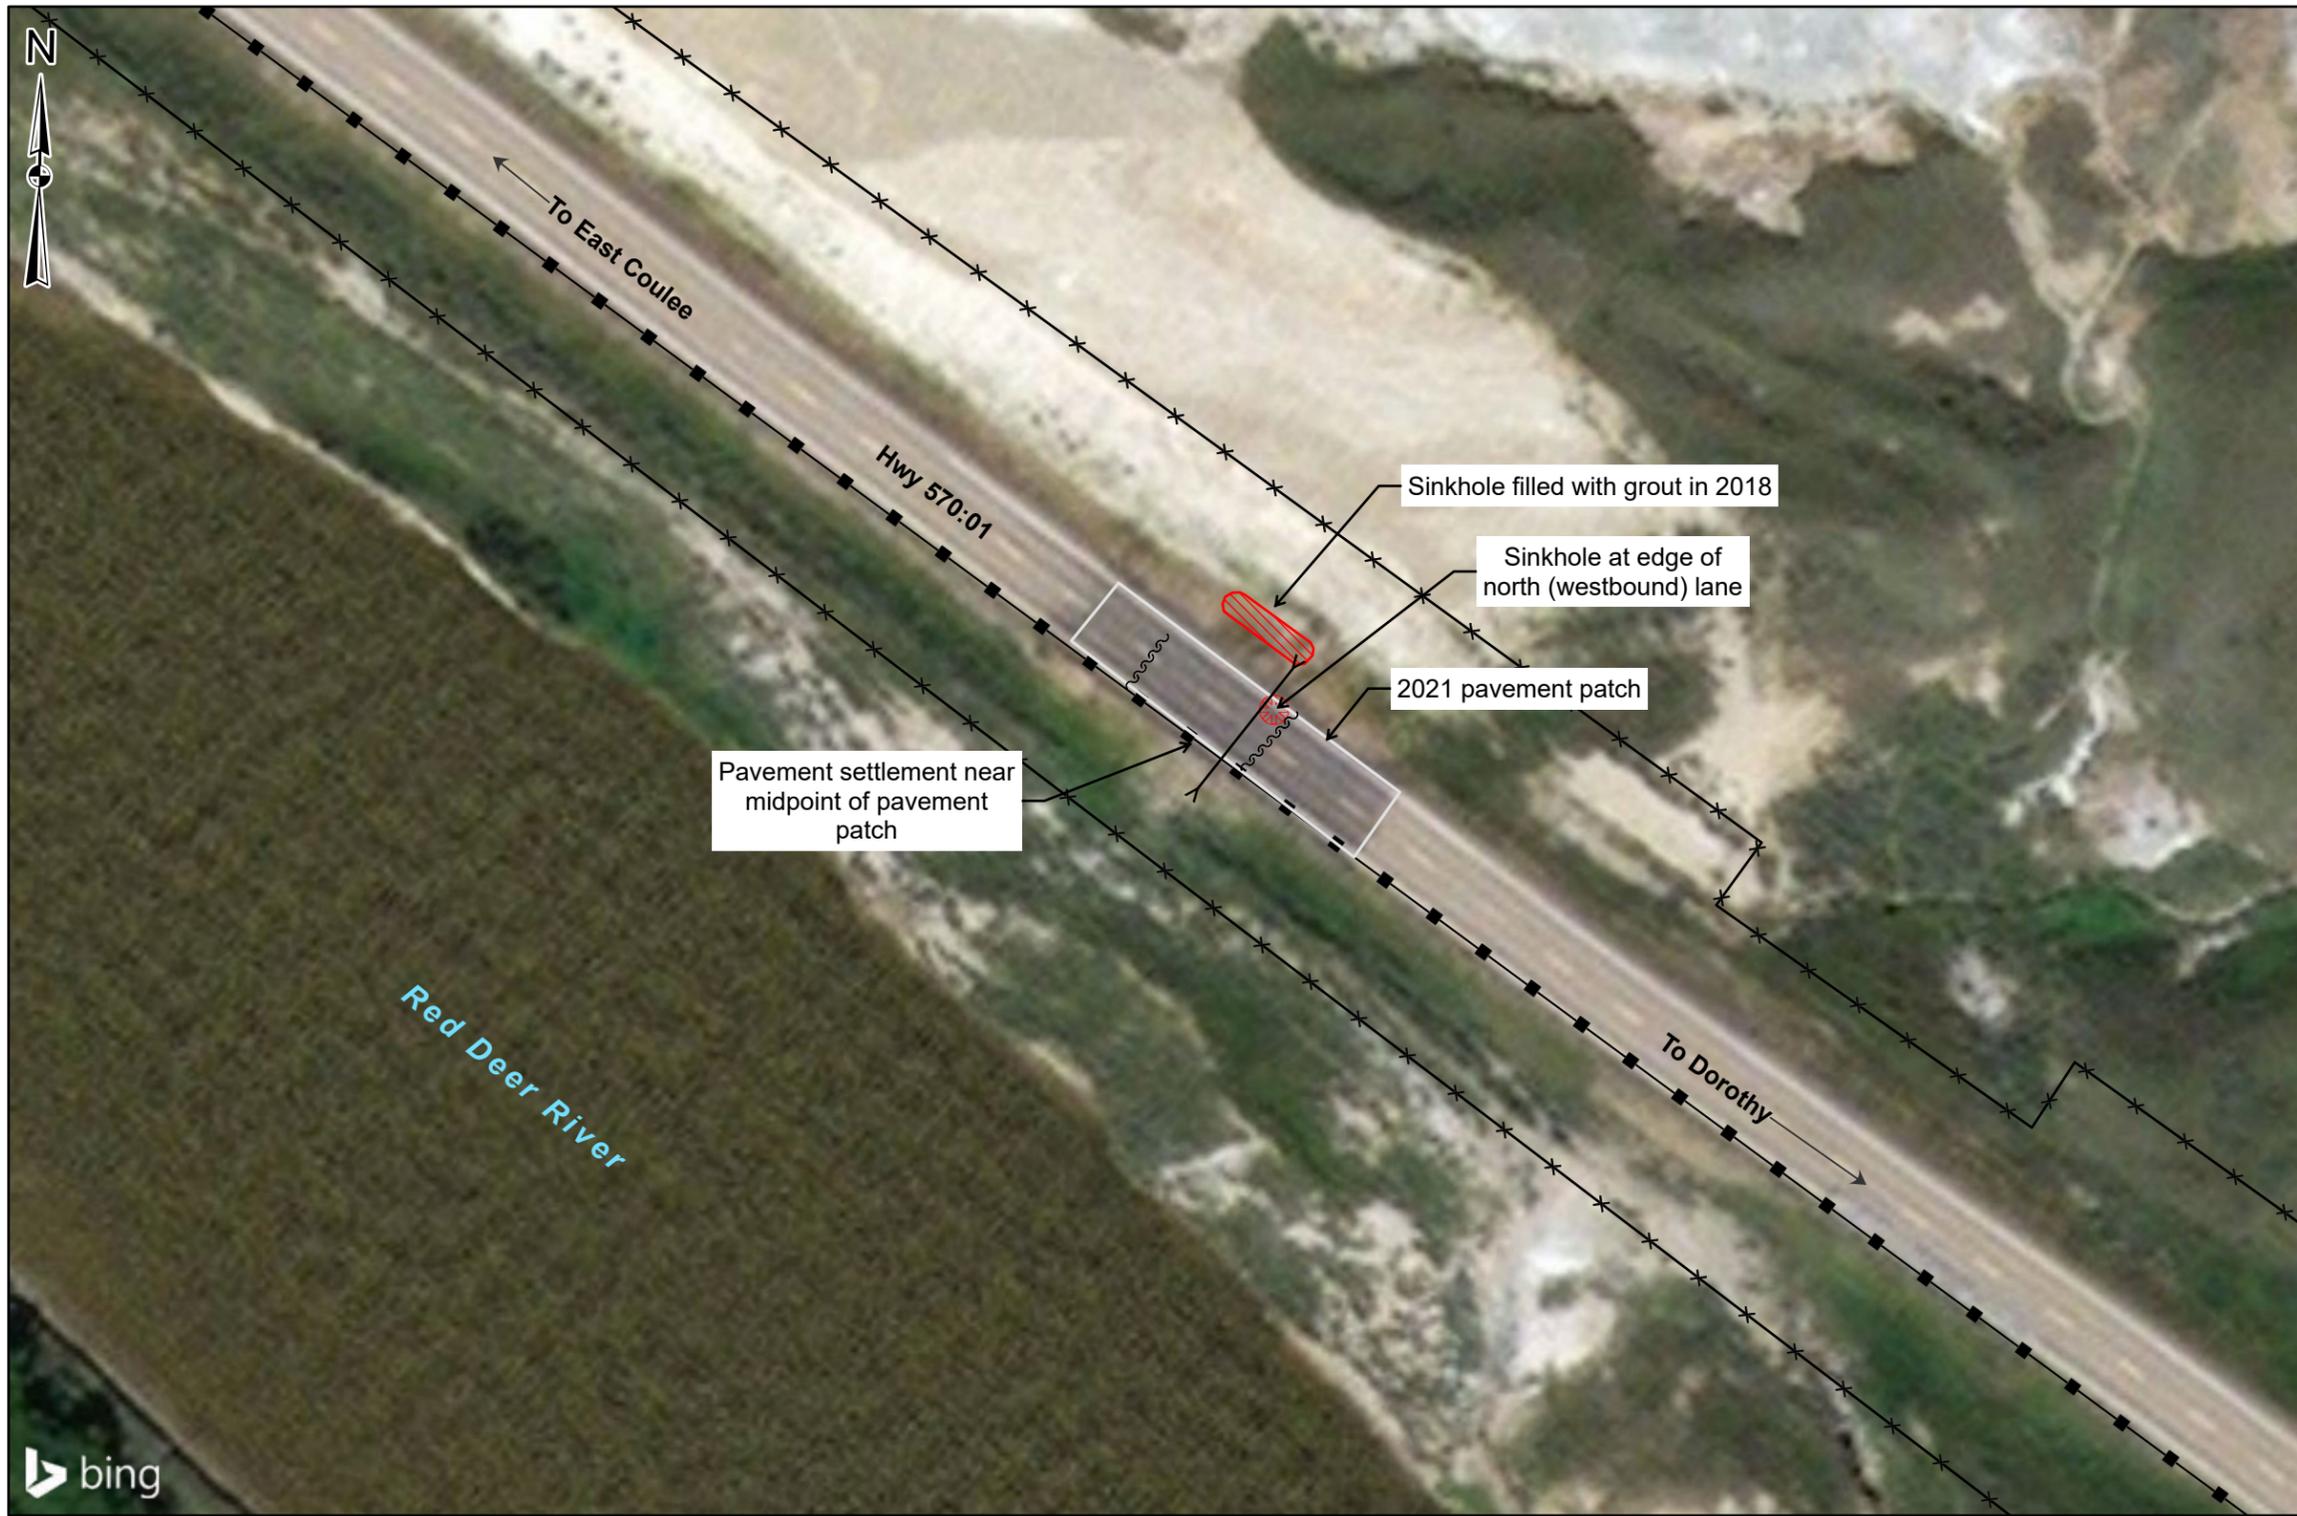
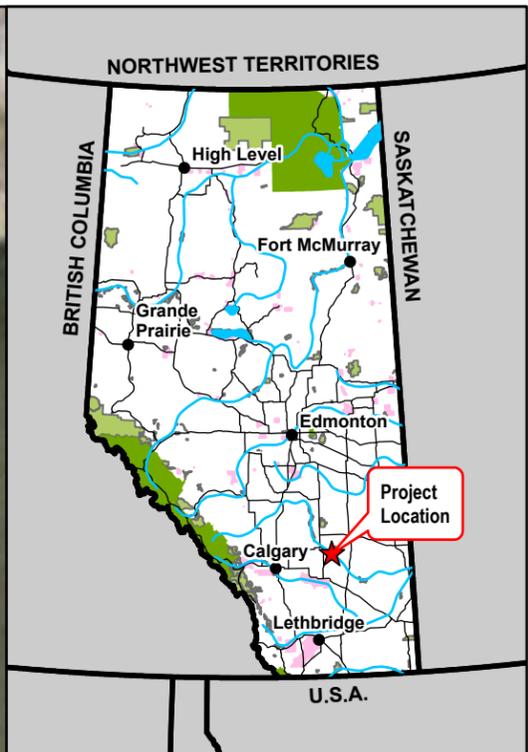
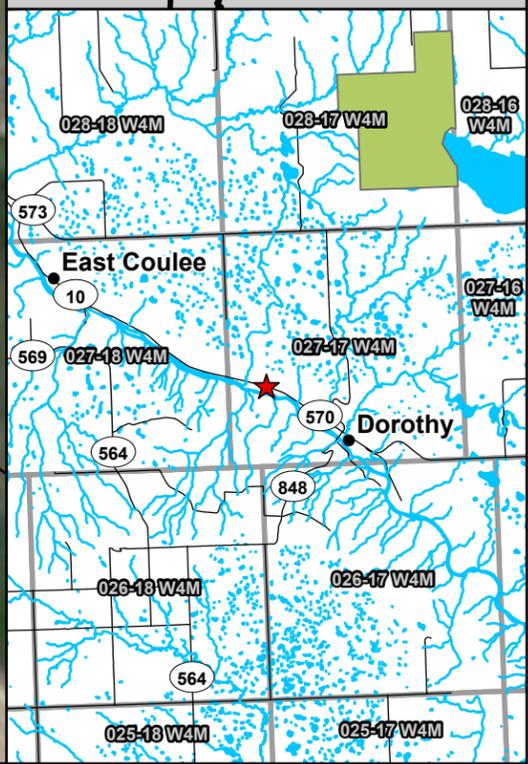
- The highway was last patched in 2021 (Photo 1). The dip in the highway surface (across both lanes) appears more significant than during the 2021 inspection.
- A small sinkhole (0.3 to 0.5 m in diameter) has formed on the north edge of the pavement (Photo 1 and 2). The sinkhole is located across the highway diagonally from a dip in the pavement surface on the south side of the highway indicating the presence of a void.
- A sinkhole at the culvert inlet (north of the highway) was filled in October 2018. The grout is intact and has not subsided since 2018.

- The sites should continue to be regularly inspected by TEC’s Maintenance Contract Inspector (MCI).
- The sites should continue to be inspected every two-years as part of the Central Region GRMP Section B Inspections.
- No repairs are required at the C058 sites. However, if voids are present at depth below the highway, anywhere the highway embankment is founded on dispersive soils or constructed with dispersive soils, enlargement of a void could result in subsidence of the pavement, followed by brittle collapse of the pavement. TEC’s strategy to date is to backfill sinkholes and voids and patch the pavement when subsidence of the pavement occurs. The hazard markers at the C058 sites should be maintained. A speed reduction should be implemented, and repairs conducted immediately if further subsidence is noted.
