SITE NUMBER AND NAME: C073-I and -II: Slide and Erosion Sites		HIGHWAY & KM: 580:02, 23.604 2A:12, 15.725	PREVIOUS INSPECTION DATE: August 14, 2020	INSPECTION DATE: June 23, 2021
LEGAL DESCRIPTION: C073-I: SE 06-30-01-W5M C073-II: NE 29-30-01-W5M	NAD 83 COORDINATES: UTM Northing Easting 11 5713022 699532 11 5720905 701123		RISK ASSESSMENT: PF: 1 CF: 2 TOTAL: 2 PF: 1 CF: 7 TOTAL: 7	
AVERAGE ANNUAL DAILY TRAFFIC (AADT): C073-I: 1240 (east) & 1620 (west) (Reference No. 68250 & 76260) C073-II: 4660 (north) & 2760 (south) (Reference No. 70000526 & 70000216)			CONTRACT MAINTENANCE AREA (CMA): 514

Inspection Photographs

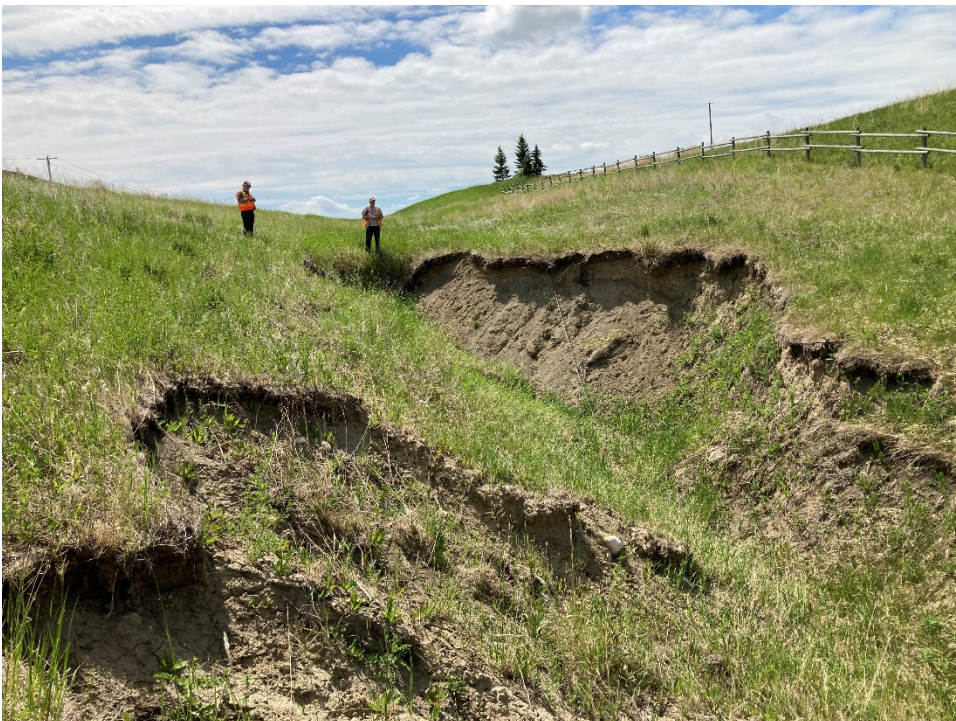
- KCB and AT believe the erosion gully formed due to the steepness of the ditch at the erosion site (estimated to be between 12.5% to 14%), large catchment area, and inadequate erosion protection (i.e., only vegetation). Erosion is likely exacerbated by periods of increased precipitation.

- The depth of the erosion gully decreases further downstream (north) where a well-vegetated area acts as a sediment trap. No sediments were observed at the outlet of the erosion gully.

Photo 7 The sides of the erosion gully are near-vertical, and the depth of the erosion gully decreases as it progresses north. Photo taken June 23, 2021 facing northwest.

- AT should have the HMC (Volker) complete the repairs at the C073-II site. The repair options could include backfilling the erosion gully with fine-grained material (e.g., clay till), grading the ditch to allow for positive drainage, and hydro-seeding. However, due to the steepness of the ditch, the repair may need to incorporate more permanent erosion control measures (e.g., geocell armoring, TRM with bonded-fibre matrix, geosynthetics, riprap etc.).
- KCB will complete a hydrotechnical assessment to determine the flow the ditch will have to accommodate (e.g., maximum flow for the 1:10 year rain event) and provide sketches to the HMC for the repair work.
