Alberta Transportation and Economic Corridors  
4<sup>th</sup> Floor, Provincial Building  
4920 – 51<sup>st</sup> Street  
Red Deer, Alberta  
T4N 6K8

**CON0022160 Central Region GRMP Instrumentation Monitoring  
Site C065; H585:02, km 16.136 East of Trochu Slides  
Section C – 2024 Spring Readings**

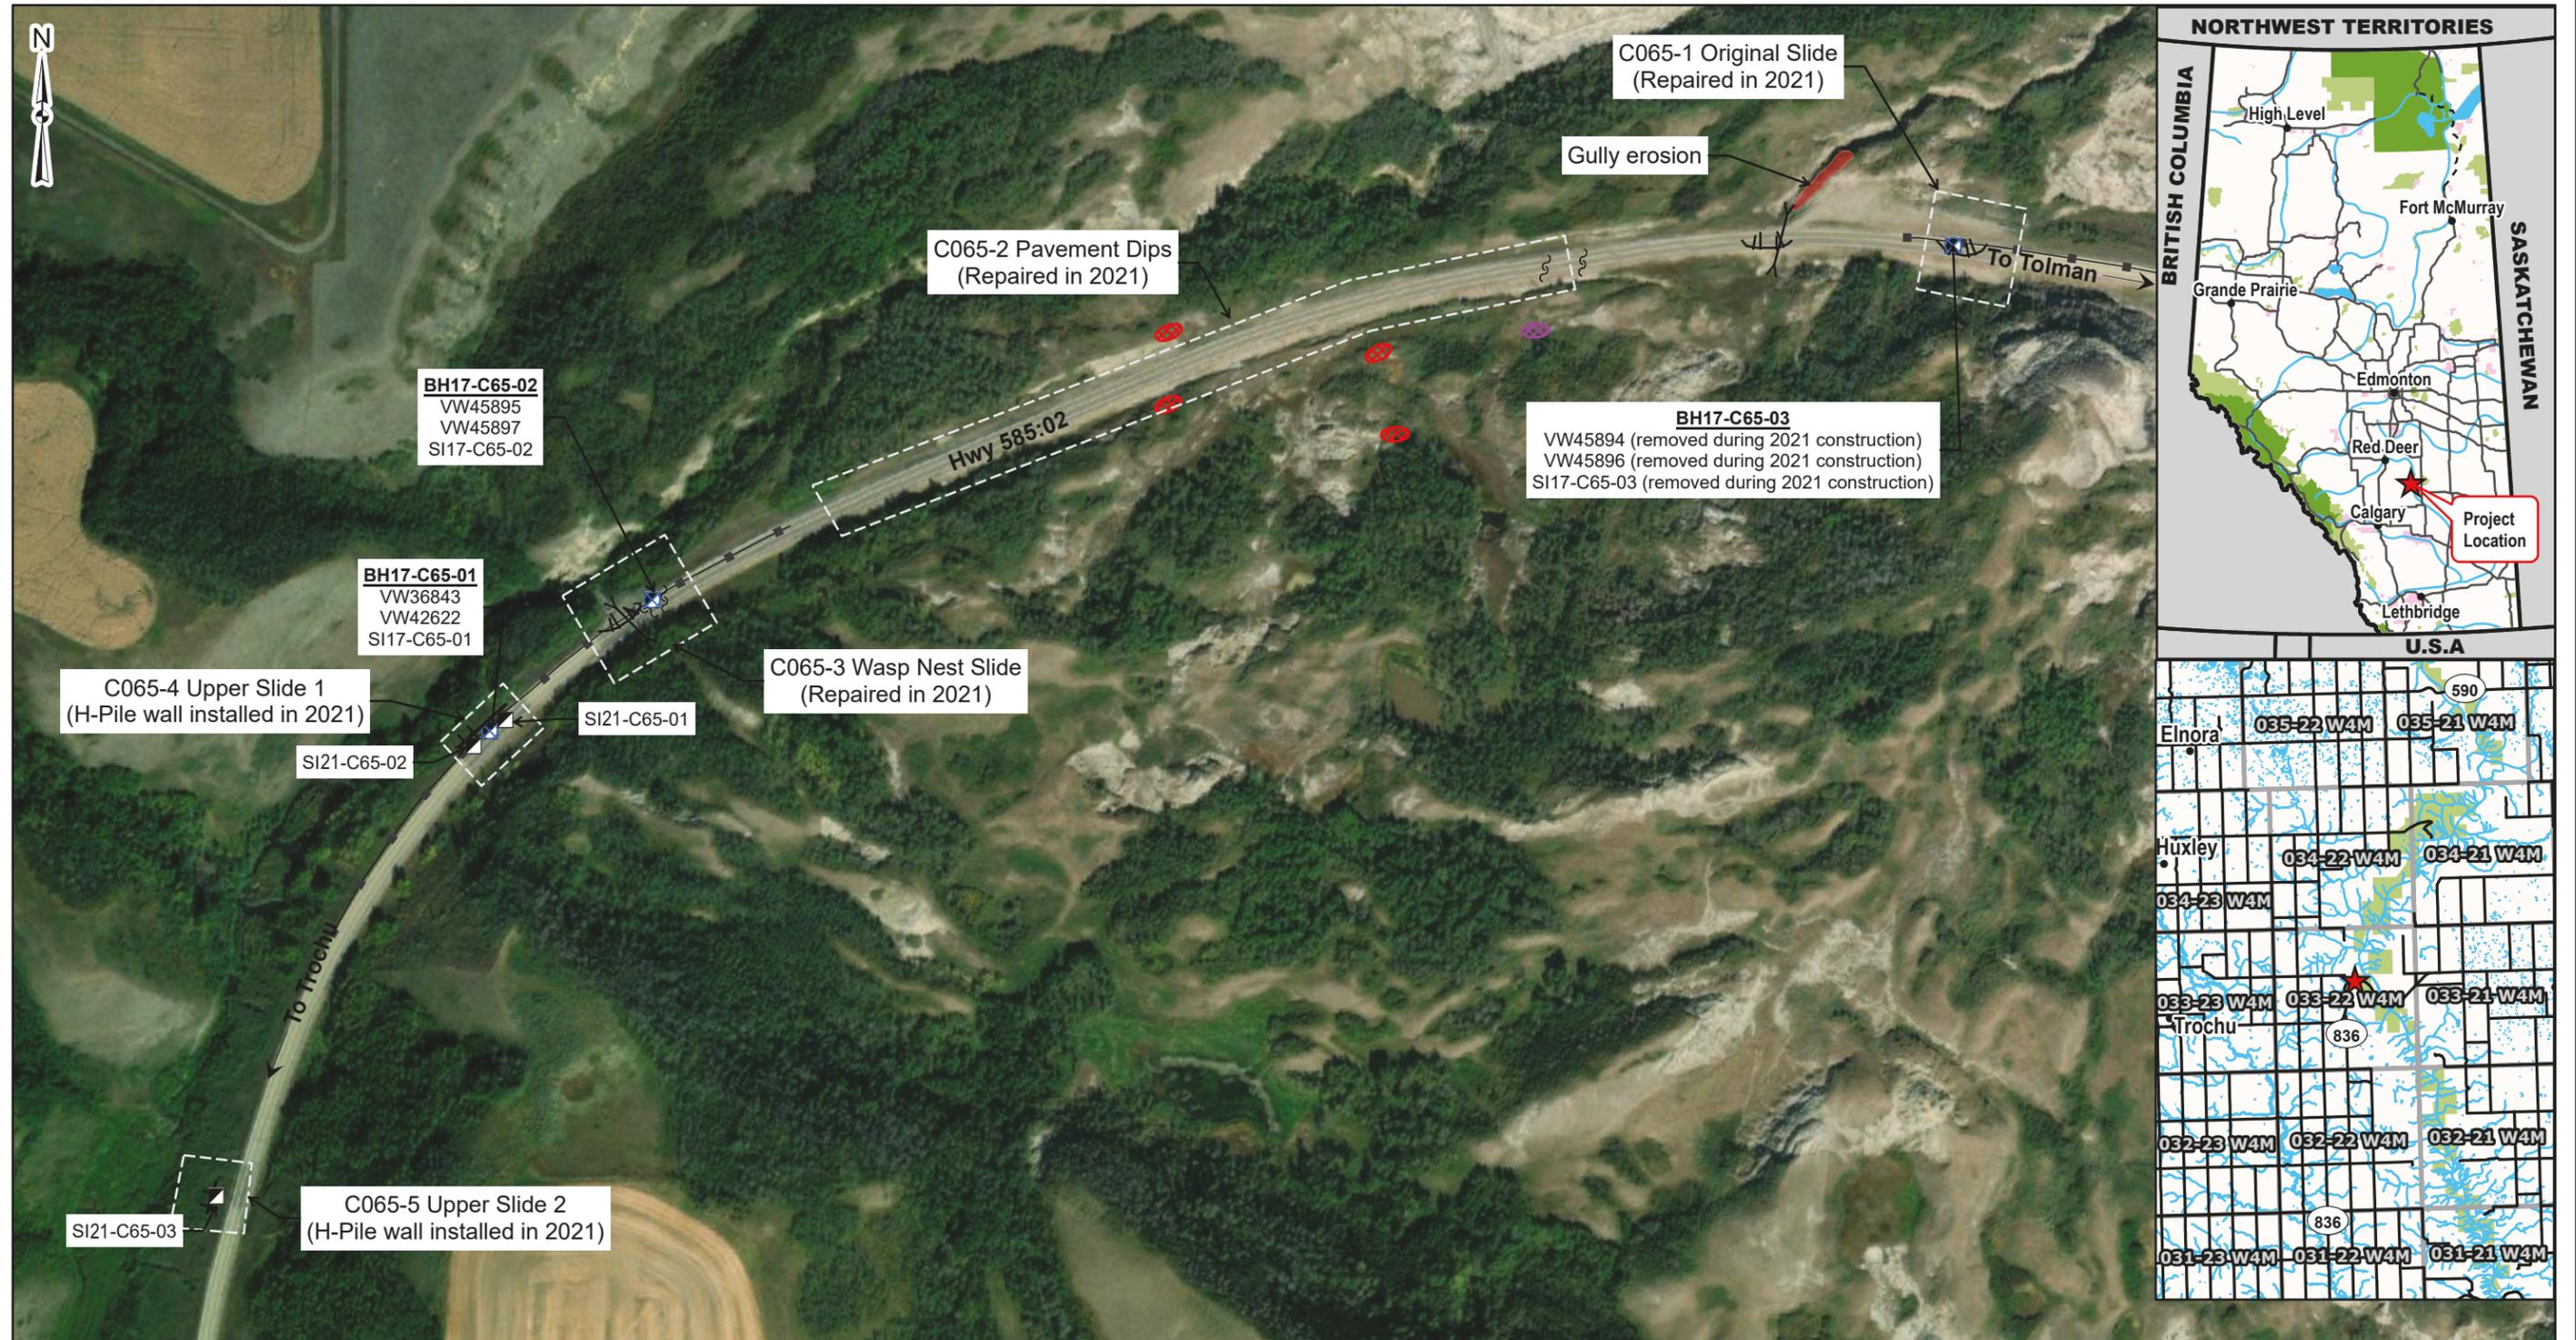
## FIGURE

Five slope inclinometers (SIs) (SI17-C65-01 and SI17-C65-02, and SI21-C65-01 through SI21-C65-03) and four vibrating wire piezometers (VWPs) (VW36843, VW42622, VW45895, and VW45897) were read at the C065 site in the Central Region on May 15, 2024 by Aden Shipton, E.I.T. of Klohn Crippen Berger Ltd. (KCB). These instruments were read as part of the Central Region Geohazard Risk Management Program (GRMP). The site is located on Hwy 585:02, km 16.136, approximately 13 km east of Trochu, Alberta and 2 km west of the Tolman Bridge, which crosses the Red Deer River. The approximate site coordinates are 5746288 N, 359329 E (UTM Zone 12, NAD 83). A site plan is presented in Figure 1.
