Central Region GeoHazard Assessment
Site C30 H734:12 Slide
Geotechnical Callout Report

This geotechnical callout report was prepared by Klohn Crippen Consultants Ltd. (Klohn Crippen) for Alberta Transportation Central Region under the Geohazard Assessment Agreement CE 045/2004. The site inspection was undertaken on June 29, 2005 by Mr. Darren Ratcliffe, P.Eng., of Klohn Crippen Consultants Ltd. Mr. Ratcliffe was accompanied by Mr. Alain Momed and Mr. Fred Cheng of Alberta Infrastructure & Transportation. A second inspection was conducted on July 12, 2005 following remedial work to re-open the highway.

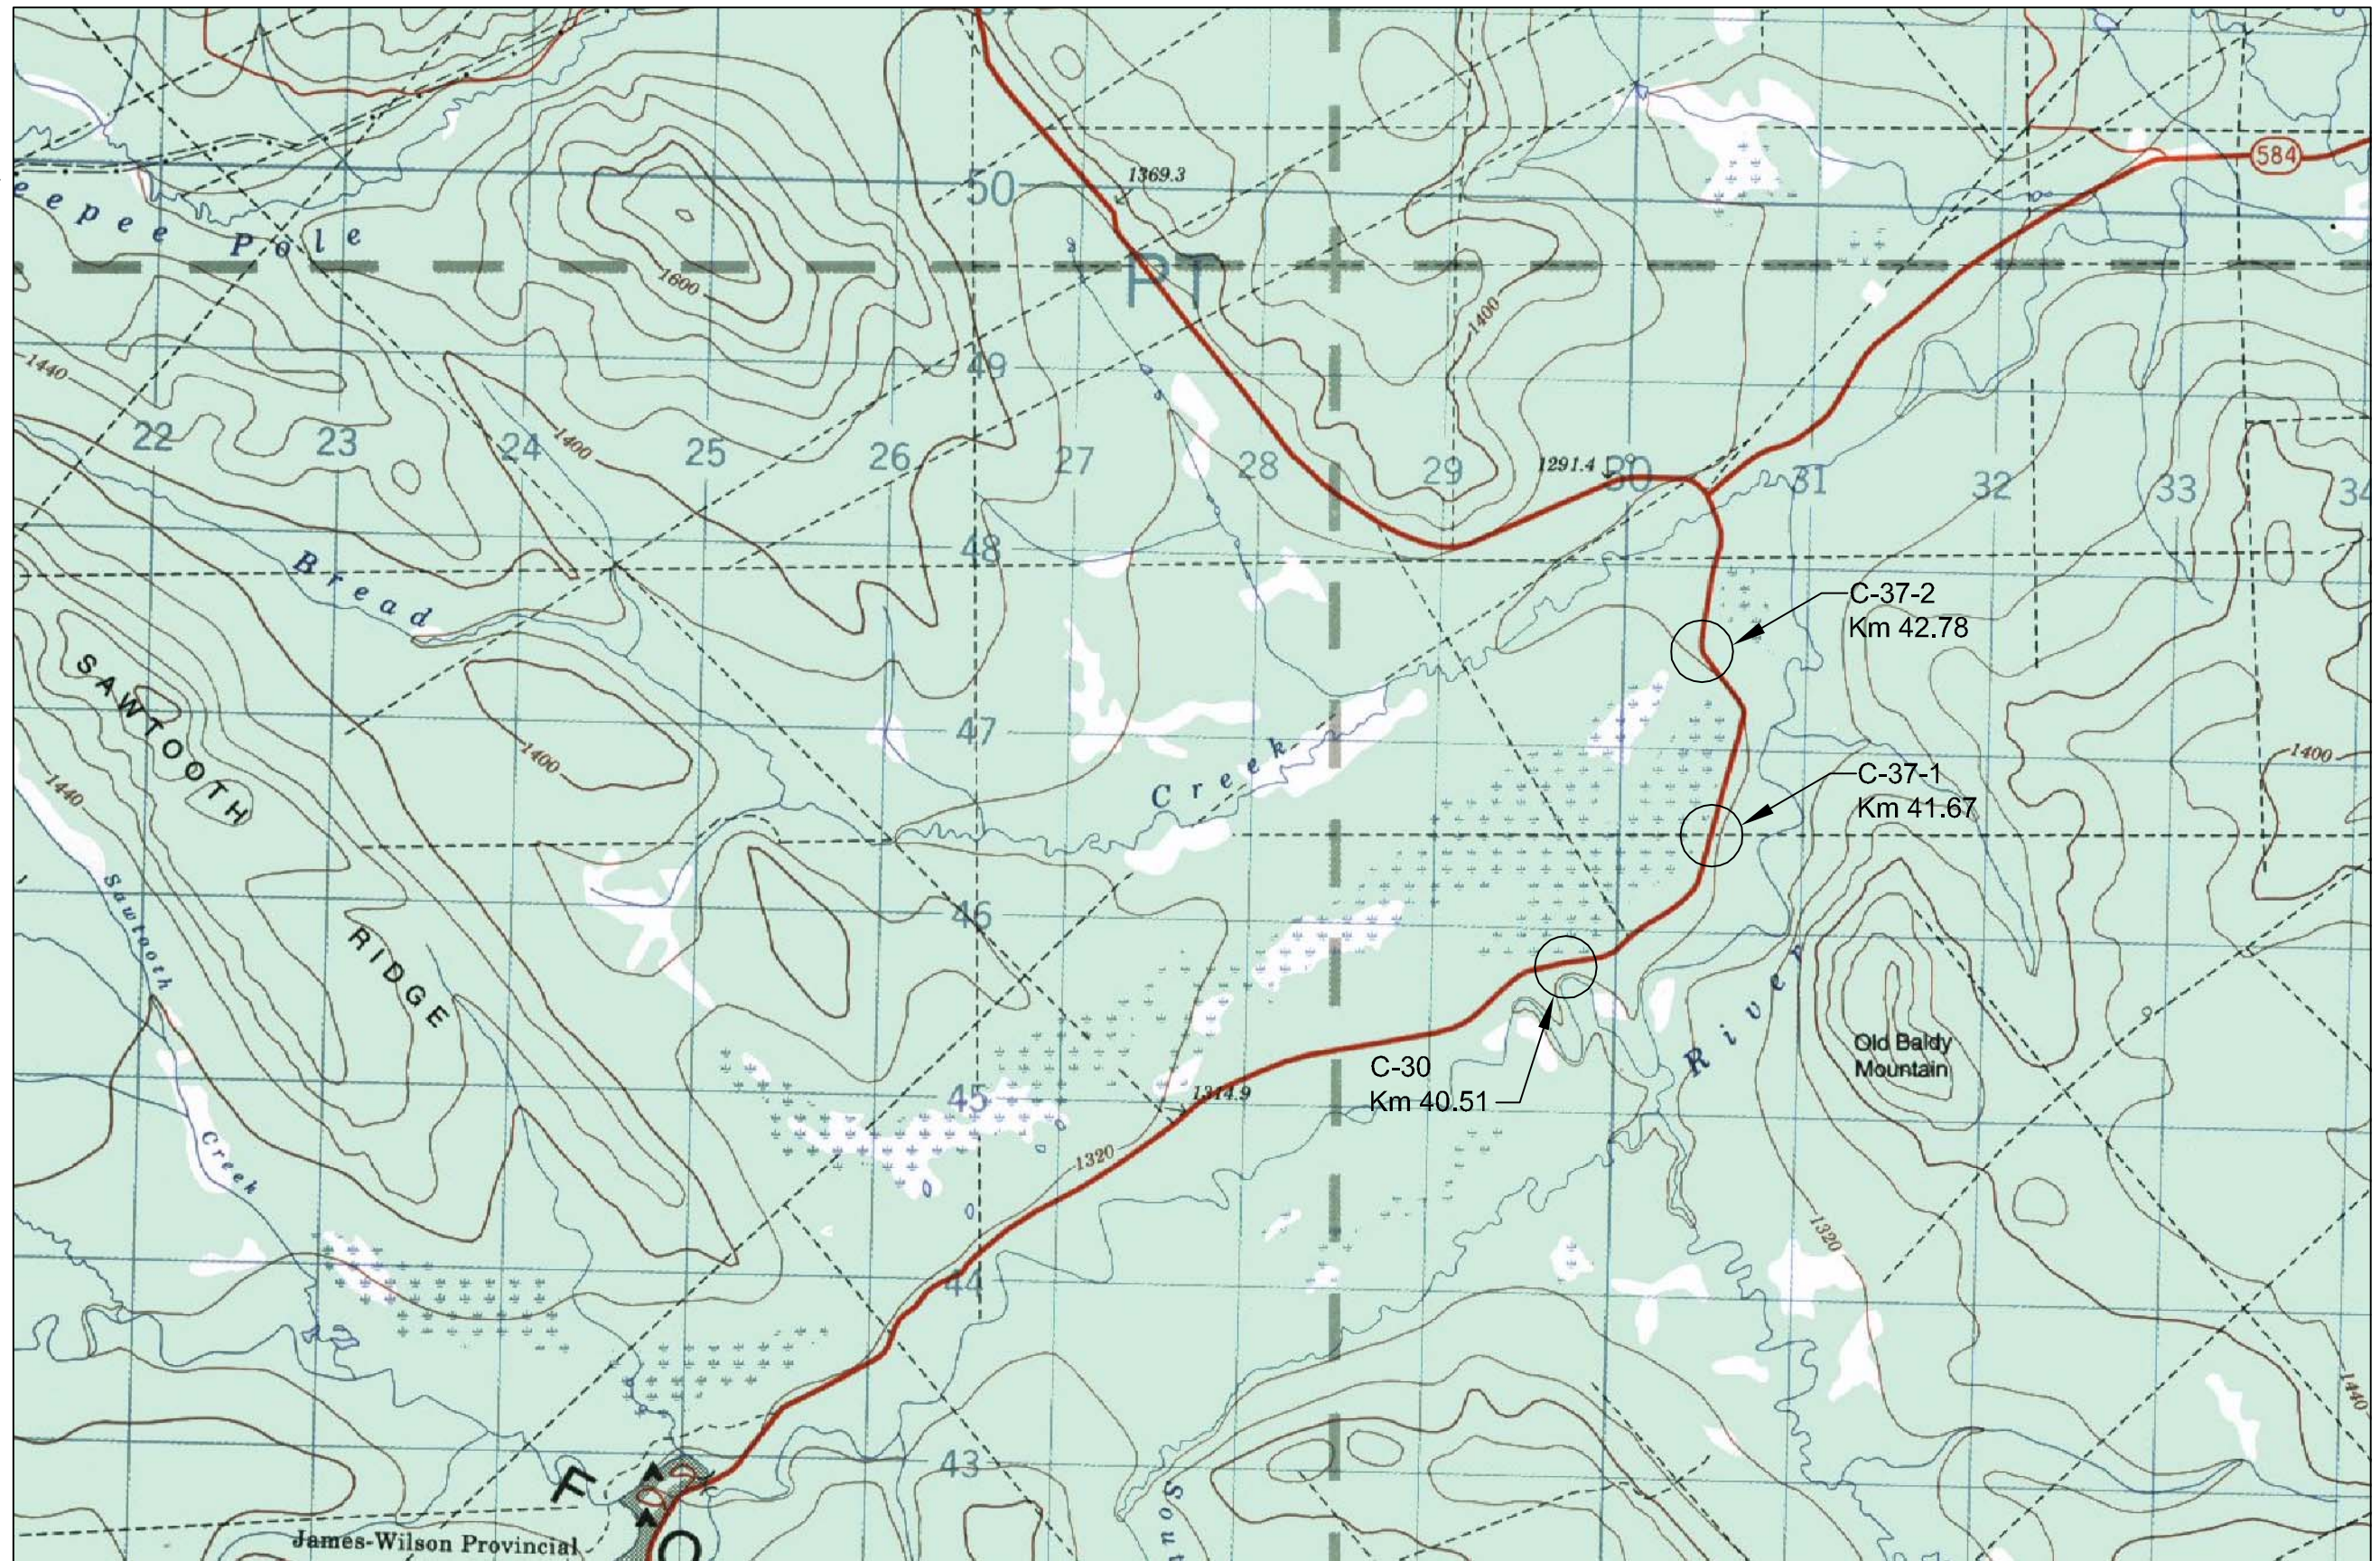
PROJECT				CENTRAL REGION					
		Ⓖ				DRAWN BY	CHECKED BY				GEOHAZARD RISK ASSESSMENT									
		Ⓕ				M.D.	D.W.R.				TITLE									
		Ⓕ				SCALE					SITE C30 H734 : 12									
		Ⓕ				1:250 0 2,5 5 m					POST FLOOD CONDITIONS									
MARK		DESCRIPTION OF REVISIONS	DATE	DWN.	ENG.

- Due to the loss of ground downslope, cracks in the highway surface have reappeared in a similar location to those observed previously.
- The HDPE off-take drain pipes have been displaced downslope by the flows.

The observed damage to the site in June 2005 can be directly attributed to erosion from flood flows. The area of reinforced fill was largely undamaged and the flood eroded a section of highway to the east due to road overtopping due to the inadequate capacity of the culverts. For this reason, it is considered that the required repair work should be funded based on damage caused by the flood.
