SITE NUMBER AND NAME: C055-1 and -2 Galahad Slide and Riverbank Erosion		HIGHWAY & KM: 861:02, 26.00	PREVIOUS INSPECTION DATE: May 31, 2022	INSPECTION DATE: June 17, 2024
LEGAL DESCRIPTION: 13-14-040-14 W4M	NAD 83 COORDINATES: UTM Northing Easting C055-1 12 5811270 437304 C055-2 12 5811329 437306		RISK ASSESSMENT: C055-1 PF: 6 CF: 3 TOTAL: 18 C055-2 PF: 7 CF: 2 TOTAL: 14	
AVERAGE ANNUAL DAILY TRAFFIC (AADT): 60 (north) & 60 (south) (Ref No. 70000159)			CONTRACT MAINTENANCE AREA (CMA): 518

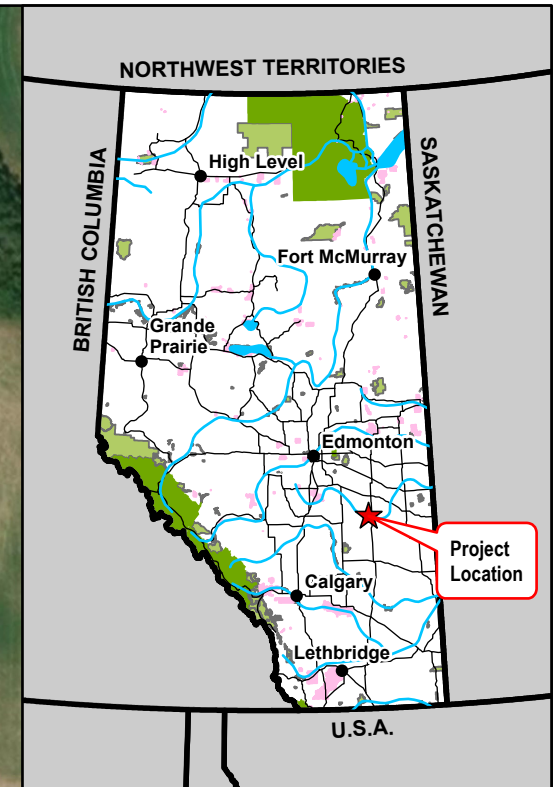
COMMENTS
<p><u>C055-1:</u></p> <ul style="list-style-type: none"> In late-2021 the site was repaired. The repair included guardrail replacement, material placement at the edge of the highway beneath where the guardrail was settled, and slope grading from the crest to toe. During construction, the instrumentation at the top of the slide was removed (one SI and two piezometers) but the instrumentation at the toe (one SI and one piezometer) was not. The SI at the crest of the slope is inoperable (sheared at an approximate depth of 7.7 m at the silty clay till-mudstone bedrock contact) but one of the piezometers was still active before being buried during 2021 construction. The road surface was graded recently and appears to be in good condition with no signs of slope movement (ground cracks and/or settlement) (Photo 1). The south (eastbound) ditch is well vegetated and appears to be in good condition (Photo 2).

Photo 1 **The highway surface upslope of C055-1 is in good condition. Photo taken June 17, 2024, facing east.**
