GEOHAZARD ASSESSMENT PROGRAM

NORTH CENTRAL REGION – EDSON

2009 INSPECTION

Site Number	Location	Name	Hwy	km
NC63	S. of Mayerthorpe, AB	South of Mayerthorpe	22:32	32.3
Legal Description		UTM Co-ordinates		
SW¼ 33-56-8 W5M		11U E 622123.7	N 5971086.9

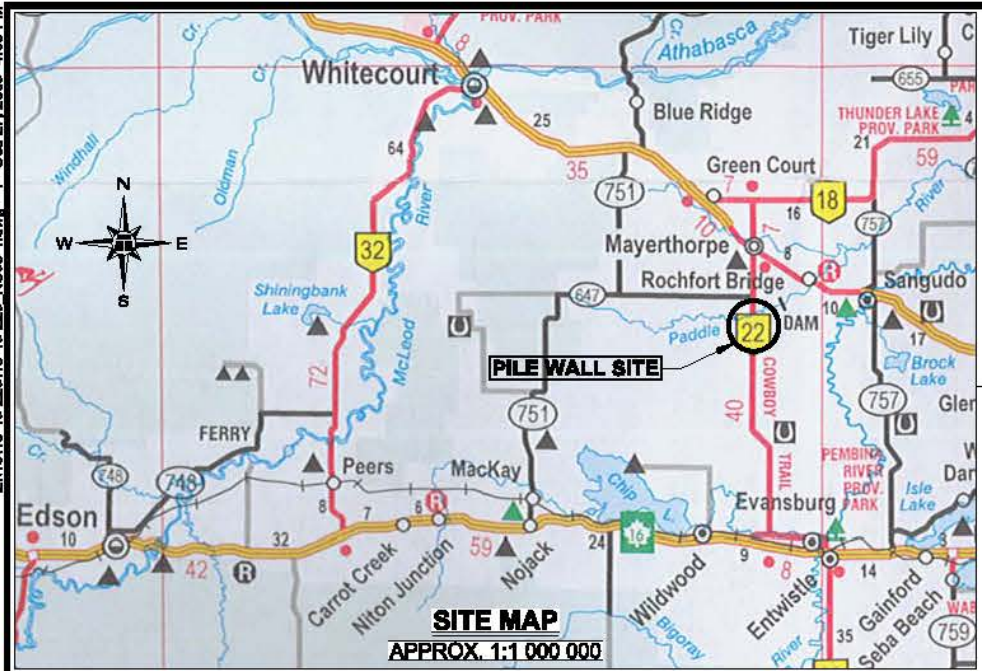
Assessment (Refer to Figure NC63):
 The remediation repair is performing well and no signs of pavement or sideslope distress were observed during this site visit. A faint arc shaped crack was noted on the pavement, however this crack was expected to occur until the pile wall reaches its final equilibrium position.
 There is currently a small slump occurring above the existing culvert inlet that is retrogressing.

JUNE, 2009 OBSERVATIONS SHOWN IN RED

Recommendations:
 This site may be discontinued from the program.
 Consideration should be given to repair the culvert slump now while it is small and is relatively inexpensive to repair. The estimated cost to repair the slump is \$ 5,000, which could consist of removing the failed soil, replacing it with well compacted medium plastic clay and readjusting the riprap protection at the inlet.
