August 26, 2008

File: 15-16-218

**NORTH CENTRAL REGION GEOHAZARD ASSESSMENT  
HWY 734:22 EROSION OF PEMBINA RIVER BANKS (NC28)  
SITE 8  
2008 ANNUAL INSPECTION REPORT**

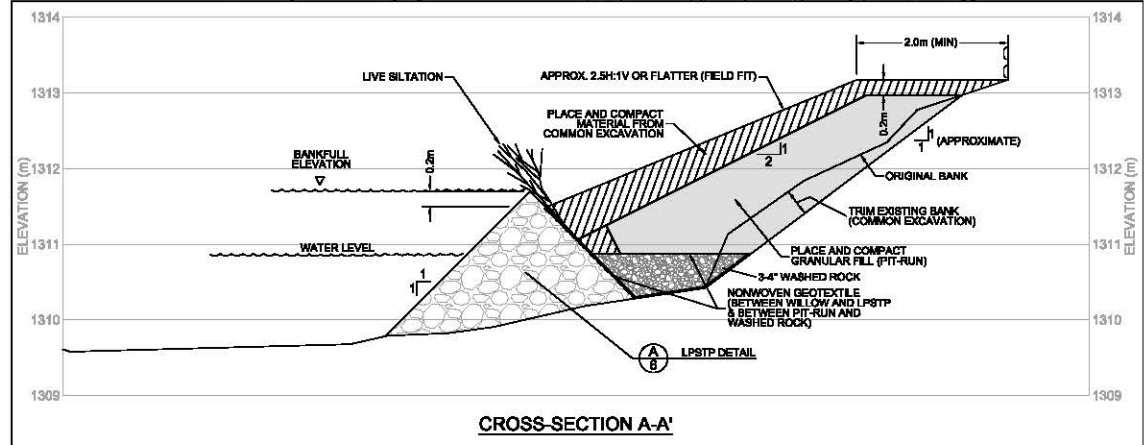
AS-BUILT SURVEY OCTOBER 21, 2006.  
BASE PLAN PROVIDED BY EXH ENGINEERING SERVICES LTD. THURBER PROJECT #15-16-218

Site 8 is located 39 km southeast of Robb on Hwy 734:22 (km 40.2, corrected from past reports) at legal land description SW18-46-18-W5M. Site features are shown in Figures NC28-2A and -2B (attached for inclusion in Section F). Cross-section A-A' on Figure NC28-2A shows the reconstructed slope in the guardrail area.
