| To: | Amy Driessen Alberta Transportation | From: | Leslie Cho and Carrie Murray Stantec Consulting Ltd. |
| File: | 123315222 | Date: | June 12, 2022 |

Reference: North Central Region, Edson, Site NC074 - Highway 22:30 South of Entwistle Slide, Spring 2022 Instrumentation Monitoring Report

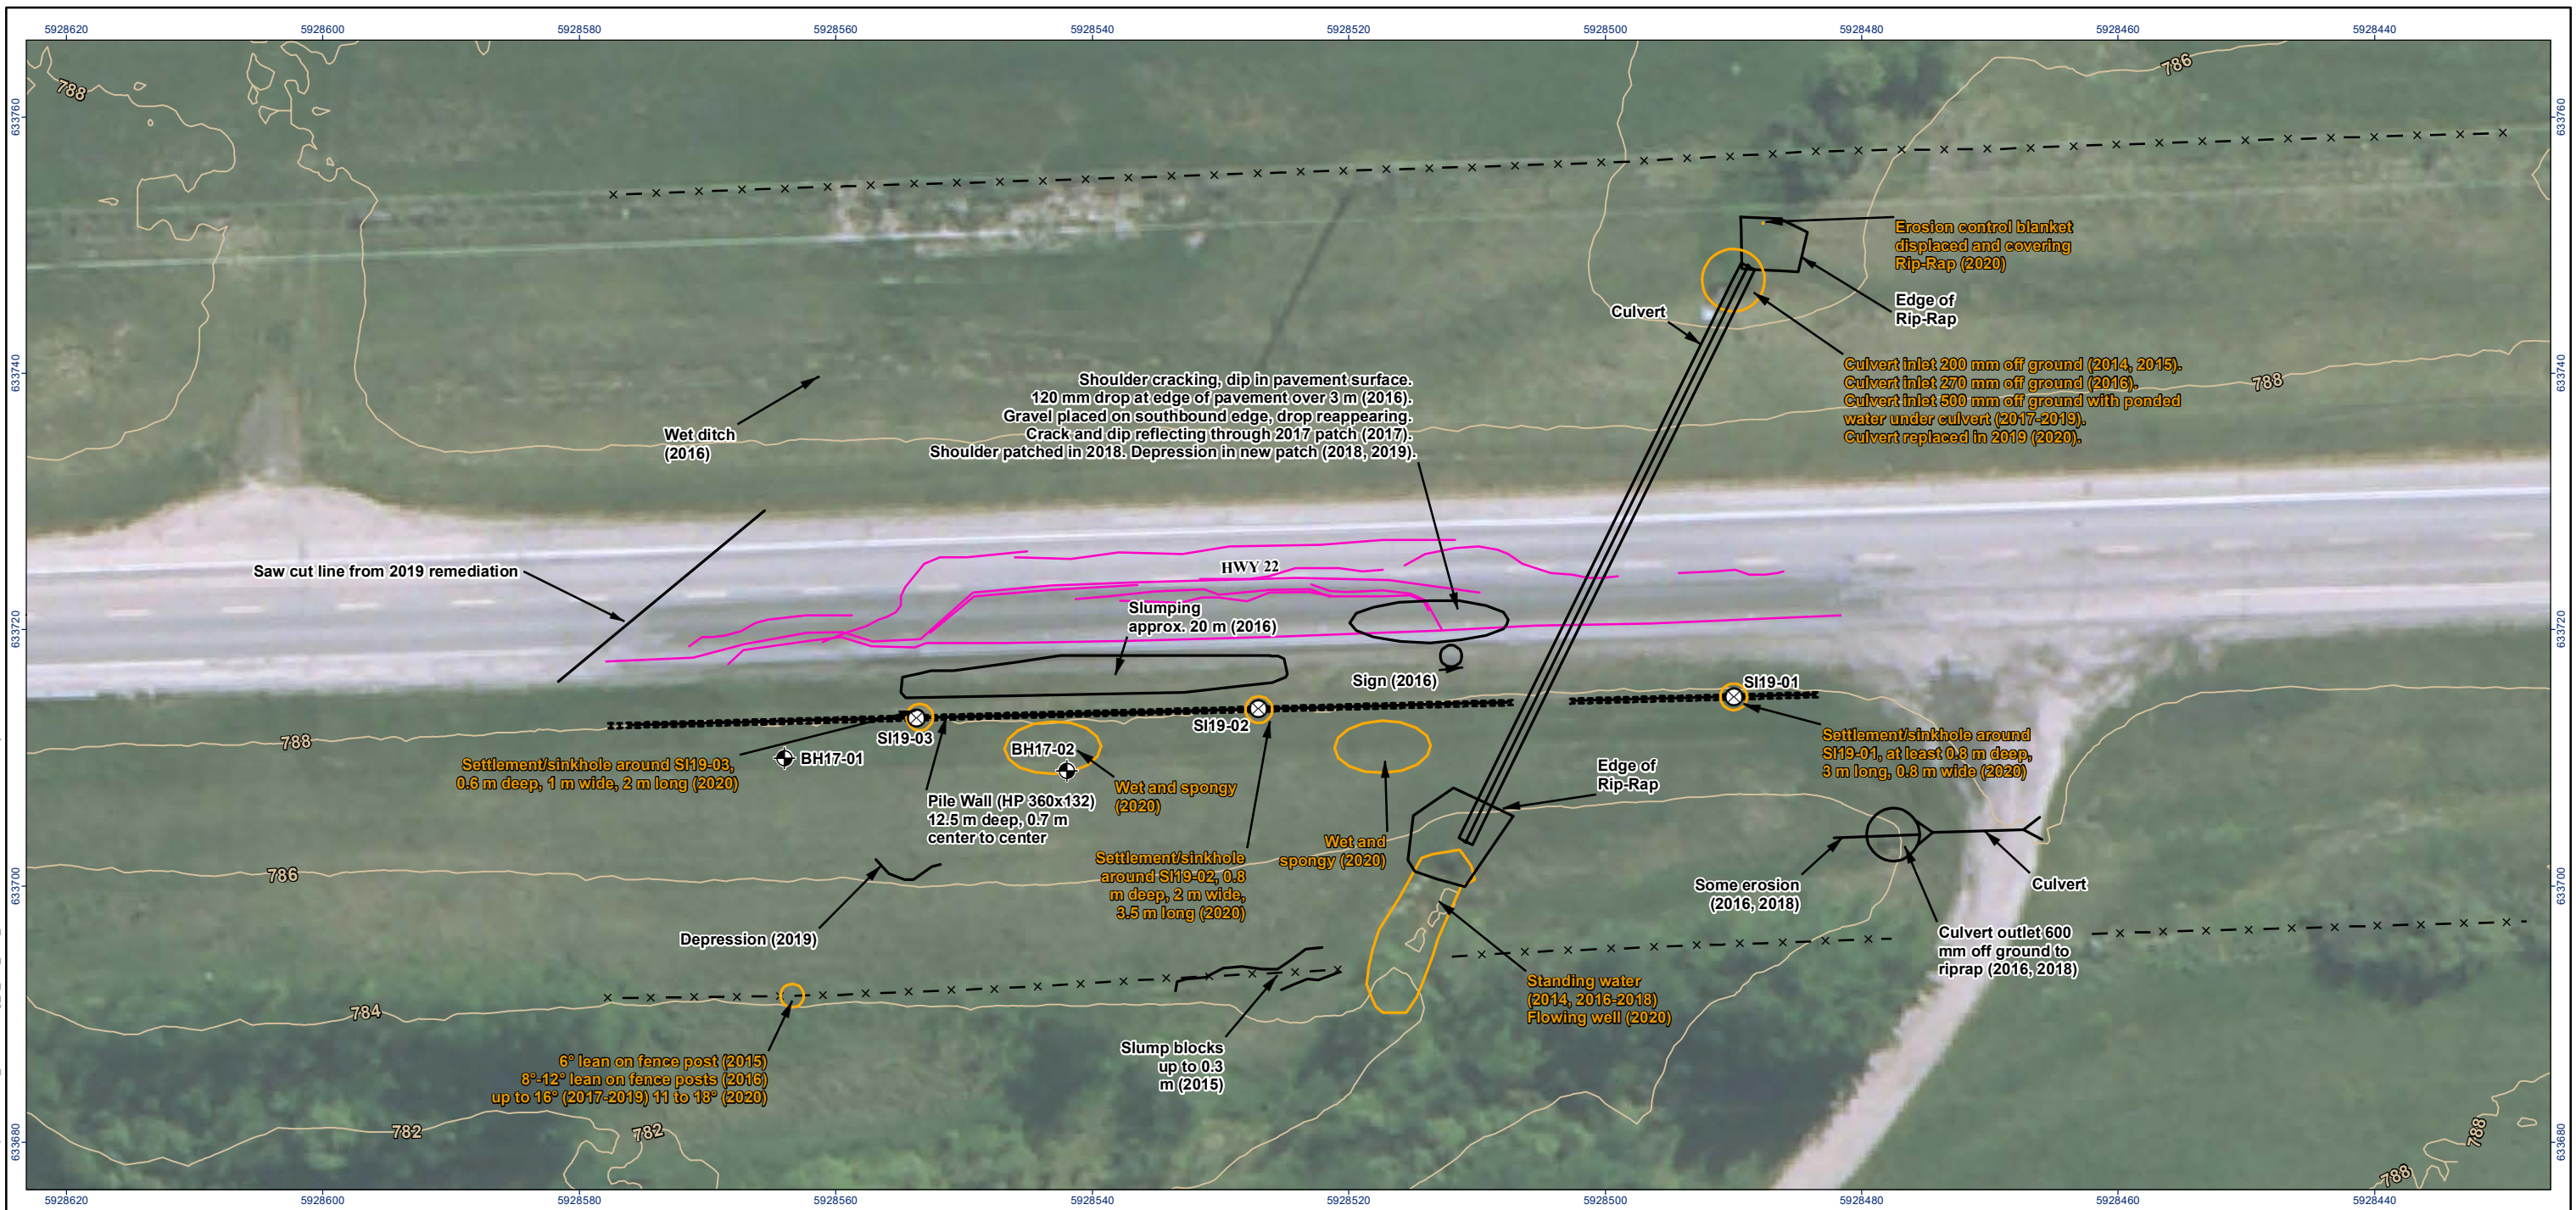
Figure No.
1

No discernable zone of movement was observed; however, small movements were observed in all SI near the pile top. These movements may reflect deflection of the pile wall.

All SI were installed within the H-piles. **SI19-01** to **SI19-03** shows various magnitudes of deflection at the top of pile ranging from 25 mm to 103 mm. The observed deflection at the pile top is likely a result of deflection necessary to mobilize resistance against slope movements.

No instruments require repair at this site.
