SITE NUMBER AND NAME: NC036 – Lazy “S” Slide	HIGHWAY AND KM: 22:32, km 30.338	PREVIOUS INSPECTION: June 16, 2022	CURRENT INSPECTION: June 13, 2024
LEGAL DESCRIPTION: SW-28-56-08-W5M (NC036-1) NW 21-56-08-W5M (NC036-2)	NAD83 COORDINATES: UTM11U 5969791N, 622172E		RISK ASSESSMENT: PF: 9 CF: 6 Total: 54
AVERAGE ANNUAL DAILY TRAFFIC (AADT): 1,340 (2023)		CONTRACTOR MAINTENANCE AREA (CMA): 509

**NORTH CENTRAL REGION GRMP
EDSON / STONY PLAIN
SITE INSPECTION FORM**

Client/Project
 Transportation and Economic Corridors
 Geohazard Monitoring Program
 NC36-1 Lazy "S" Slide

2024 Site Inspection Photos at NC036

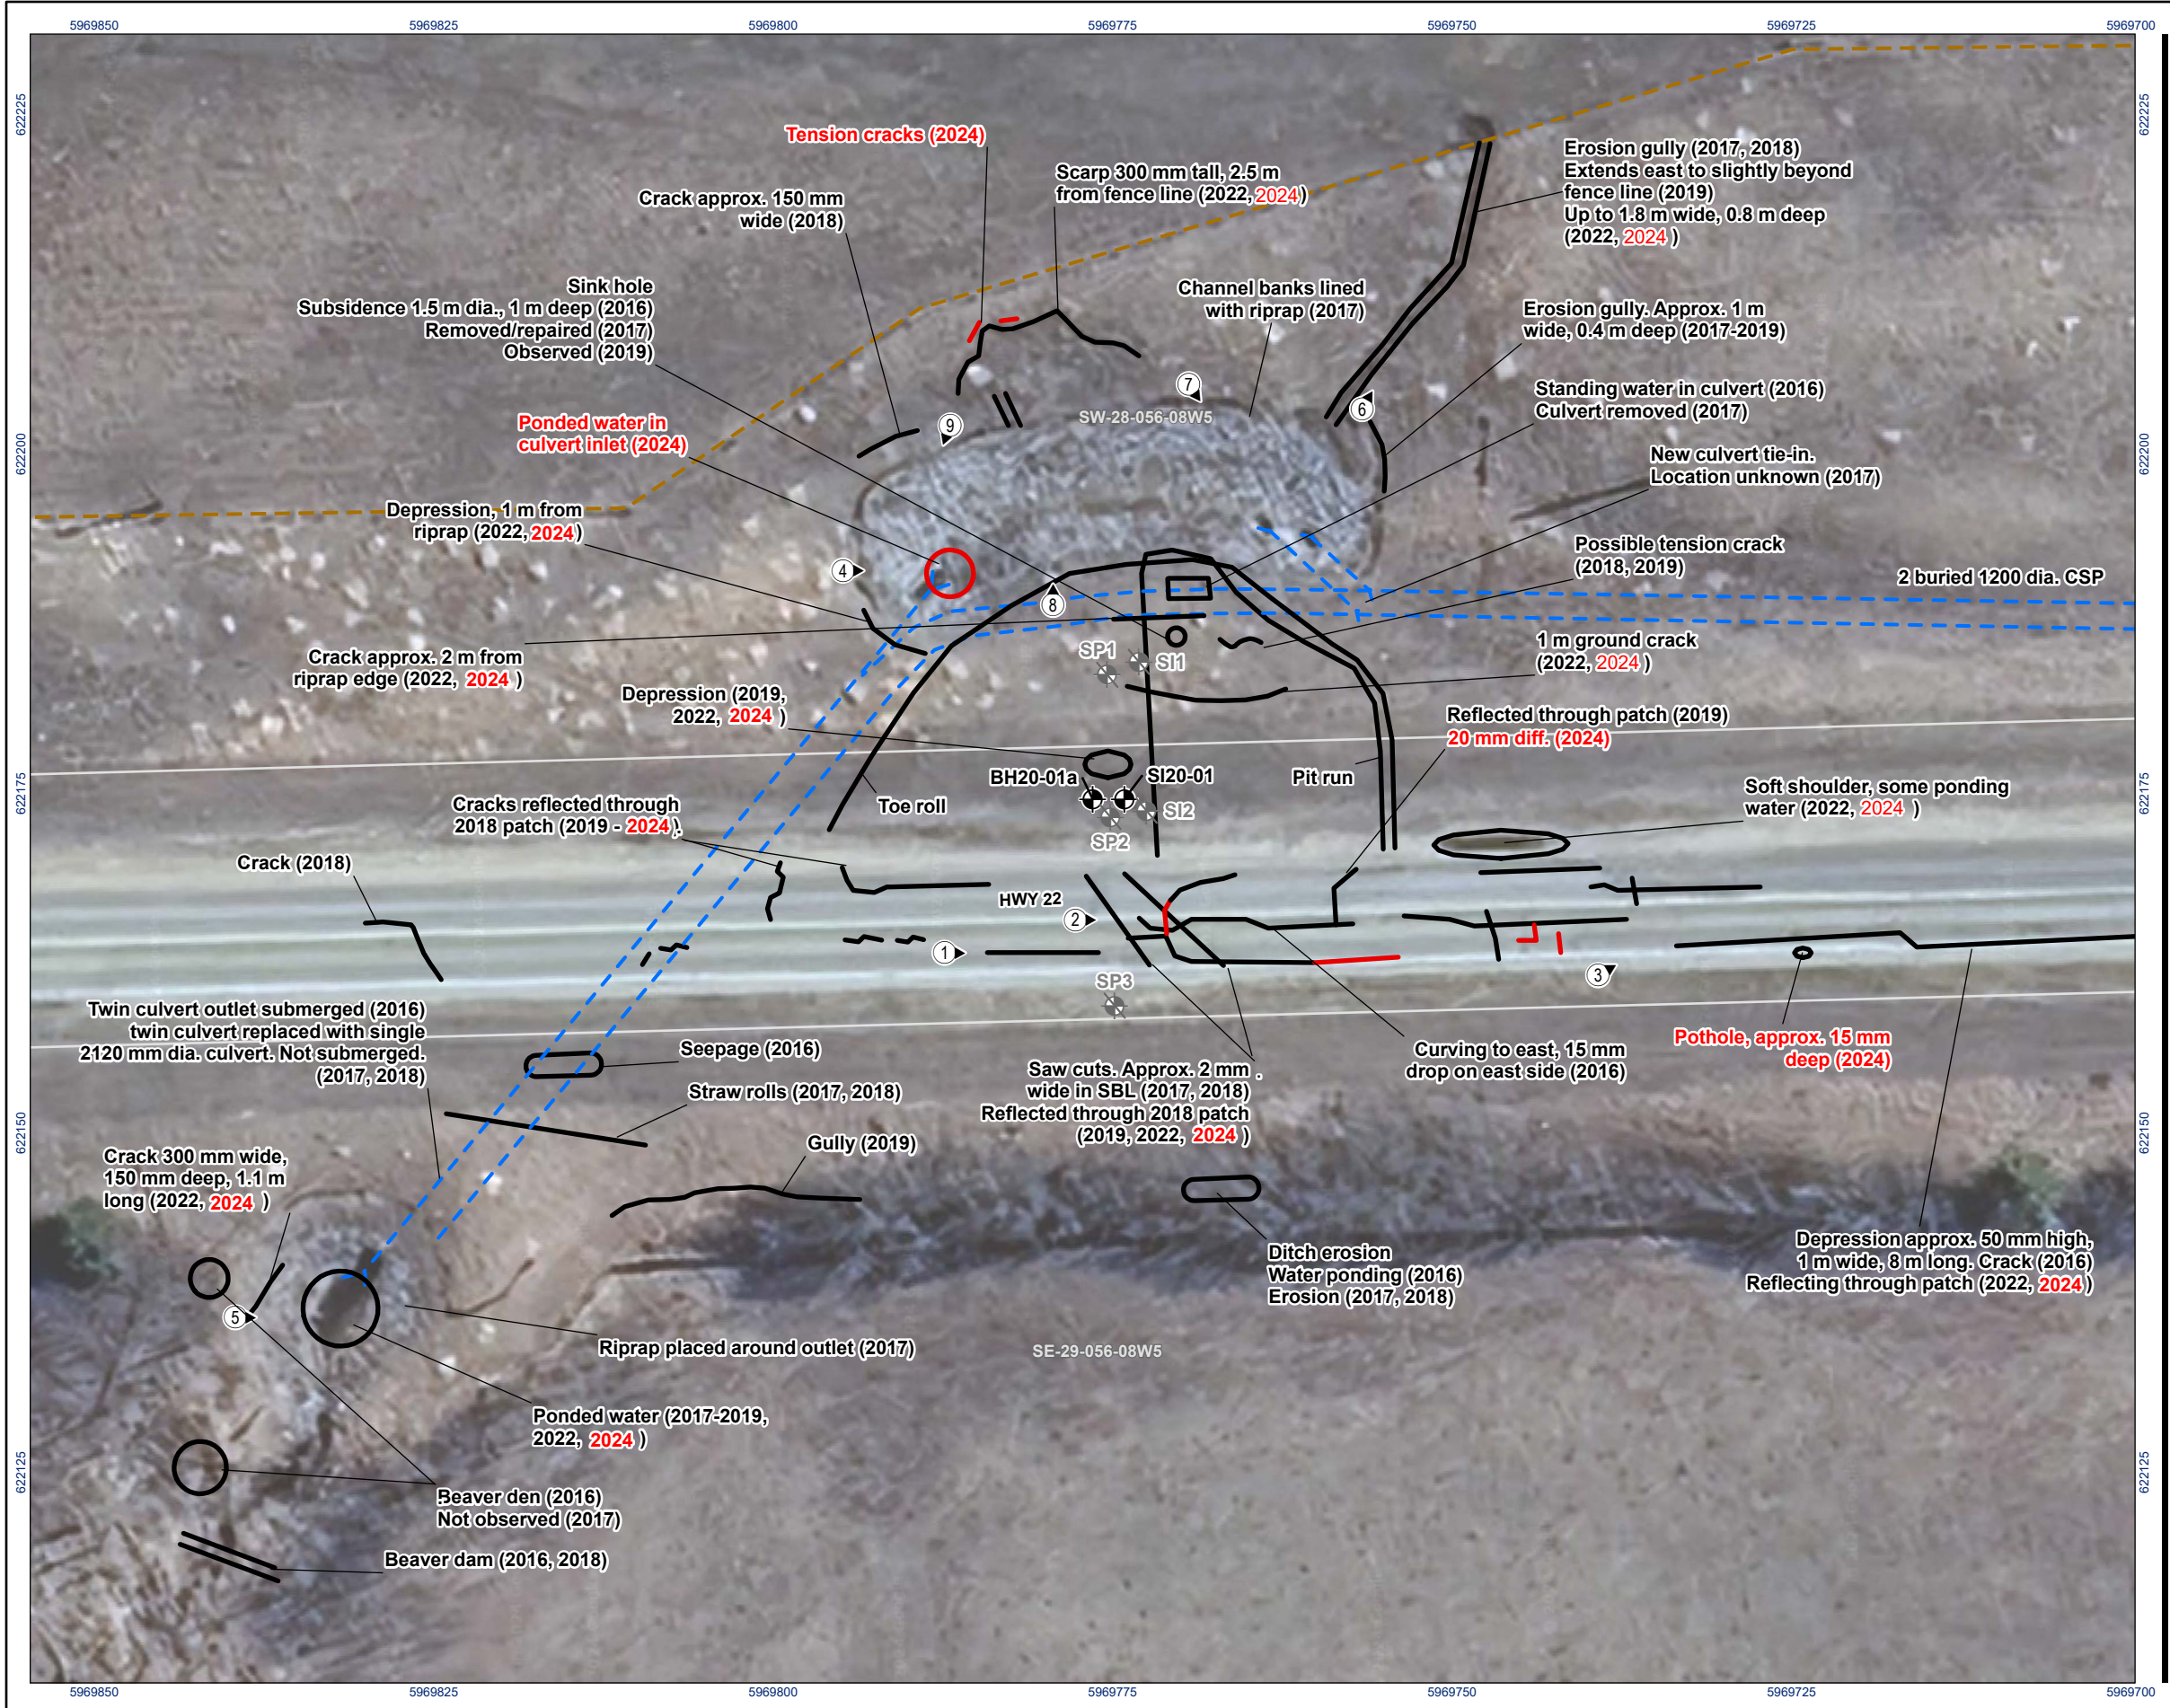
Title
Site Plan

COMMENTS
<u>NC036-1</u>
<ul style="list-style-type: none"> Previously observed pavement cracks continue to resurface through the 2018 patch. Cracking has progressed near the south end of the site compared to the 2022 site inspection (Photos 1 to 3).

- On-going erosion of the natural swale southeast of the riprap channel was observed as shown in Photo 6. The erosion channel was up to 1.8 m wide and 0.8 m deep, similar as measured in 2022. The erosion channel extends past the fence line (i.e. TEC's right-of-way). Vegetation is growing within the channel.

- A depression and ground crack was observed downslope from SI20-1 as shown on Photo 7.
- The scarp on the east side of the riprap lined channel was observed to be approximately 300 mm tall and 2.5 m from the fence, similar to 2022 (Photo 8). Tension cracks were observed behind the scarp.

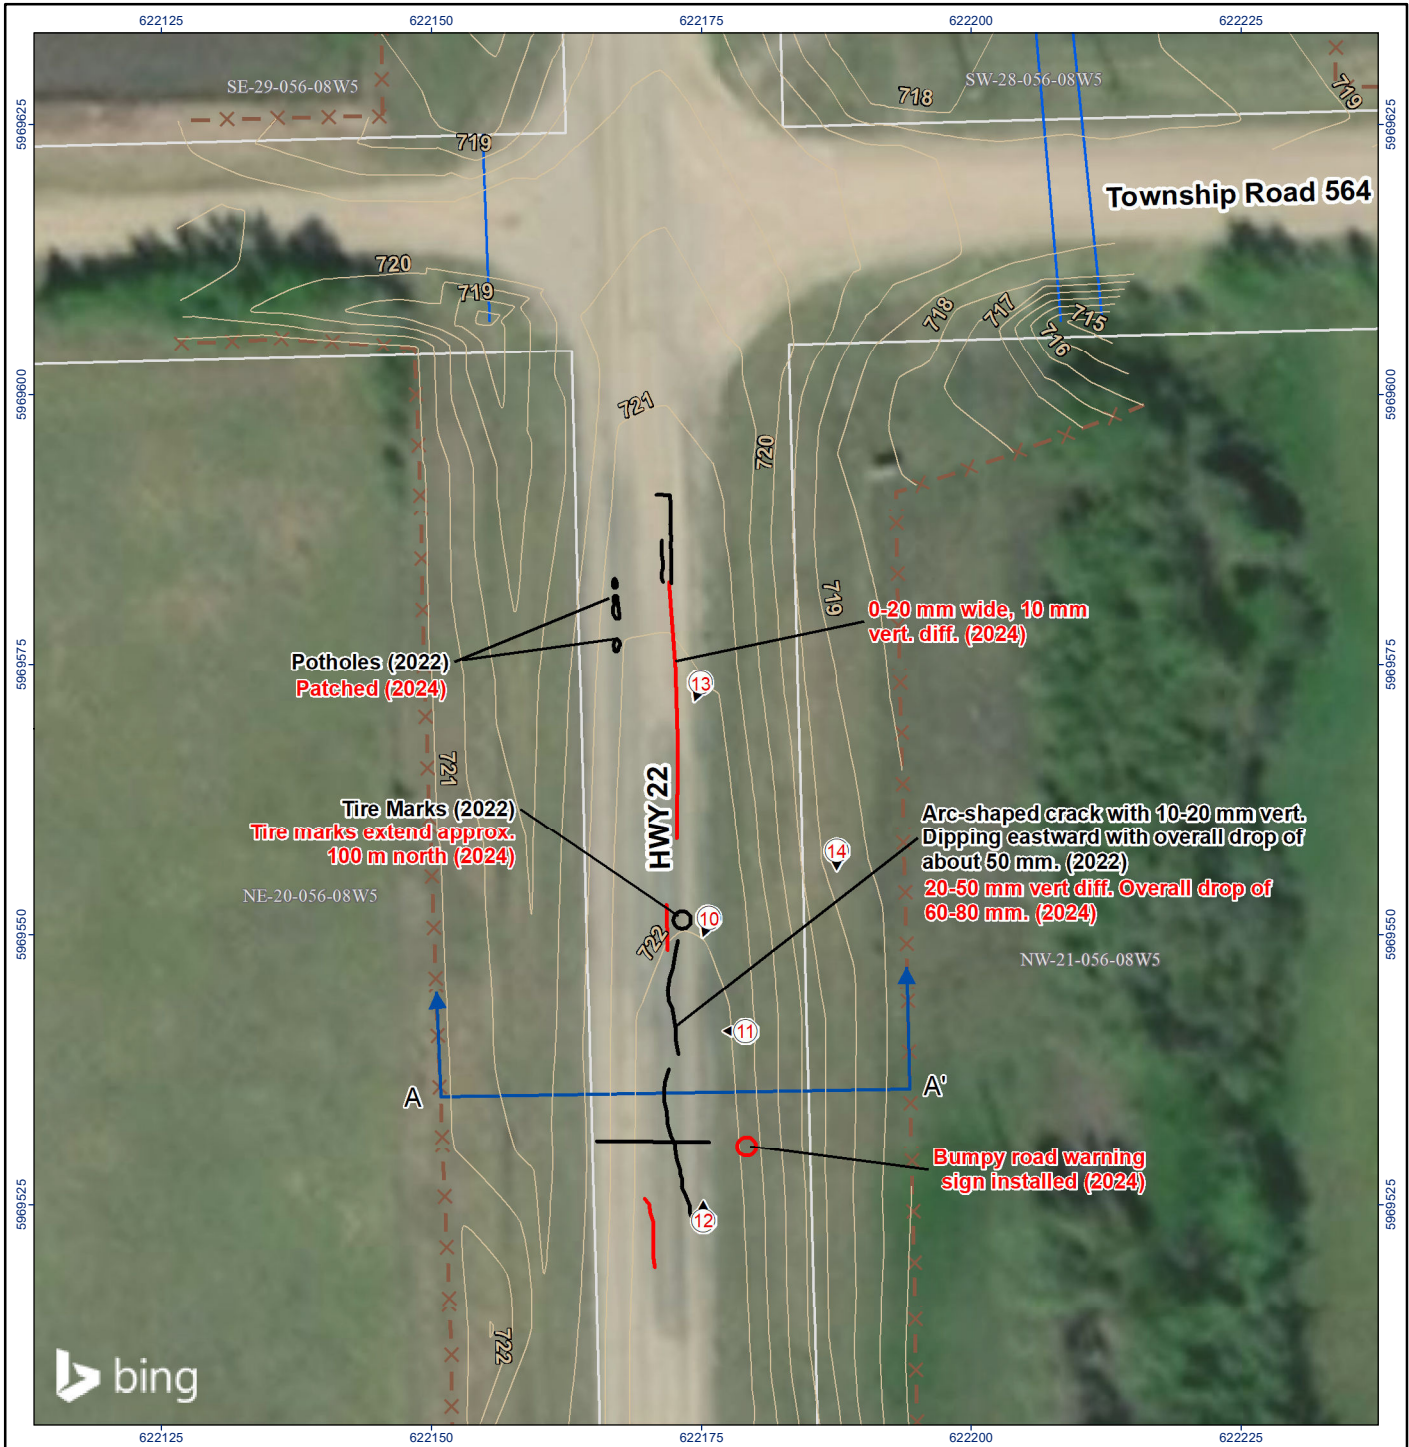
- The semi-circular crack on the NBL remains approximately 25 m long, and the vertical difference has increased since the 2022 call-out inspection to between 20 and 50 mm. The crack is between 5 and 20 mm wide. An apparent dip towards the east of approximately 60 to 80 mm was observed along the crack (Photos 10 to 12).

- Tire marks were observed in the NBL, north of (after) the semi-circular crack. The longitudinal cracking north of the semi-circular cracking has also progressed, and is up to 20 mm wide (Photo 13).

- The possible toe bulge observed at the base of the east embankment, at the fence line, appears similar to the previous observation (Photo 14).
- A 'bumpy road' warning sign was installed on the east side of the highway, near the south extent of the semi-circular cracking.

- The design for NC036-2 has been completed. The selected remediation option includes removal of the landslide mass and replacement with granular backfill and geogrid. The granular backfill will be underlain by a gravel drainage blanket daylighting at the toe of the slope.
