SITE NUMBER AND NAME: NC108 - Highway 32 Slide 1.7 km south of TWP592	LOCATION: On Highway 32 approximately 1.7 km south of Township Road 592	HIGHWAY: 32:10	KM: 23.700
LEGAL DESCRIPTION: NE-2-59-13-W5M	NAD83 COORDINATES: UTM11U 5992905N, 576550E		
AVERAGE ANNUAL DAILY TRAFFIC (AADT): 1,790 (2021)		CONTRACTOR MAINTENANCE AREA (CMA): 508

PRIMARY SITE ISSUE: Failure of the east embankment causing pavement distress along Highway 32.
APPROXIMATE DIMENSIONS: 150 m wide. Unclear where the toe is.
SITE HISTORY: No files were available from AT for review. Google Earth images suggest that both lanes were last patched in 2020 over an approximately 480 m long section of Highway 32. St-Onge (1973) ¹ suggests surficial deposits along this section of Highway 32 consists of deltaic sand deposits. Fenton et al. (2013) ² indicates glaciofluvial sediment deposited by glacial meltwater streams. Sediment ranges from massive to stratified, poor to well sorted, coarse to fine grained. Till may also be included. The estimated overburden thickness at the site is in the order of 30 m (Carlson and Green 1976) ³ . LiDAR data suggests this section of Highway 32 is located along the crest of an ancient landsli

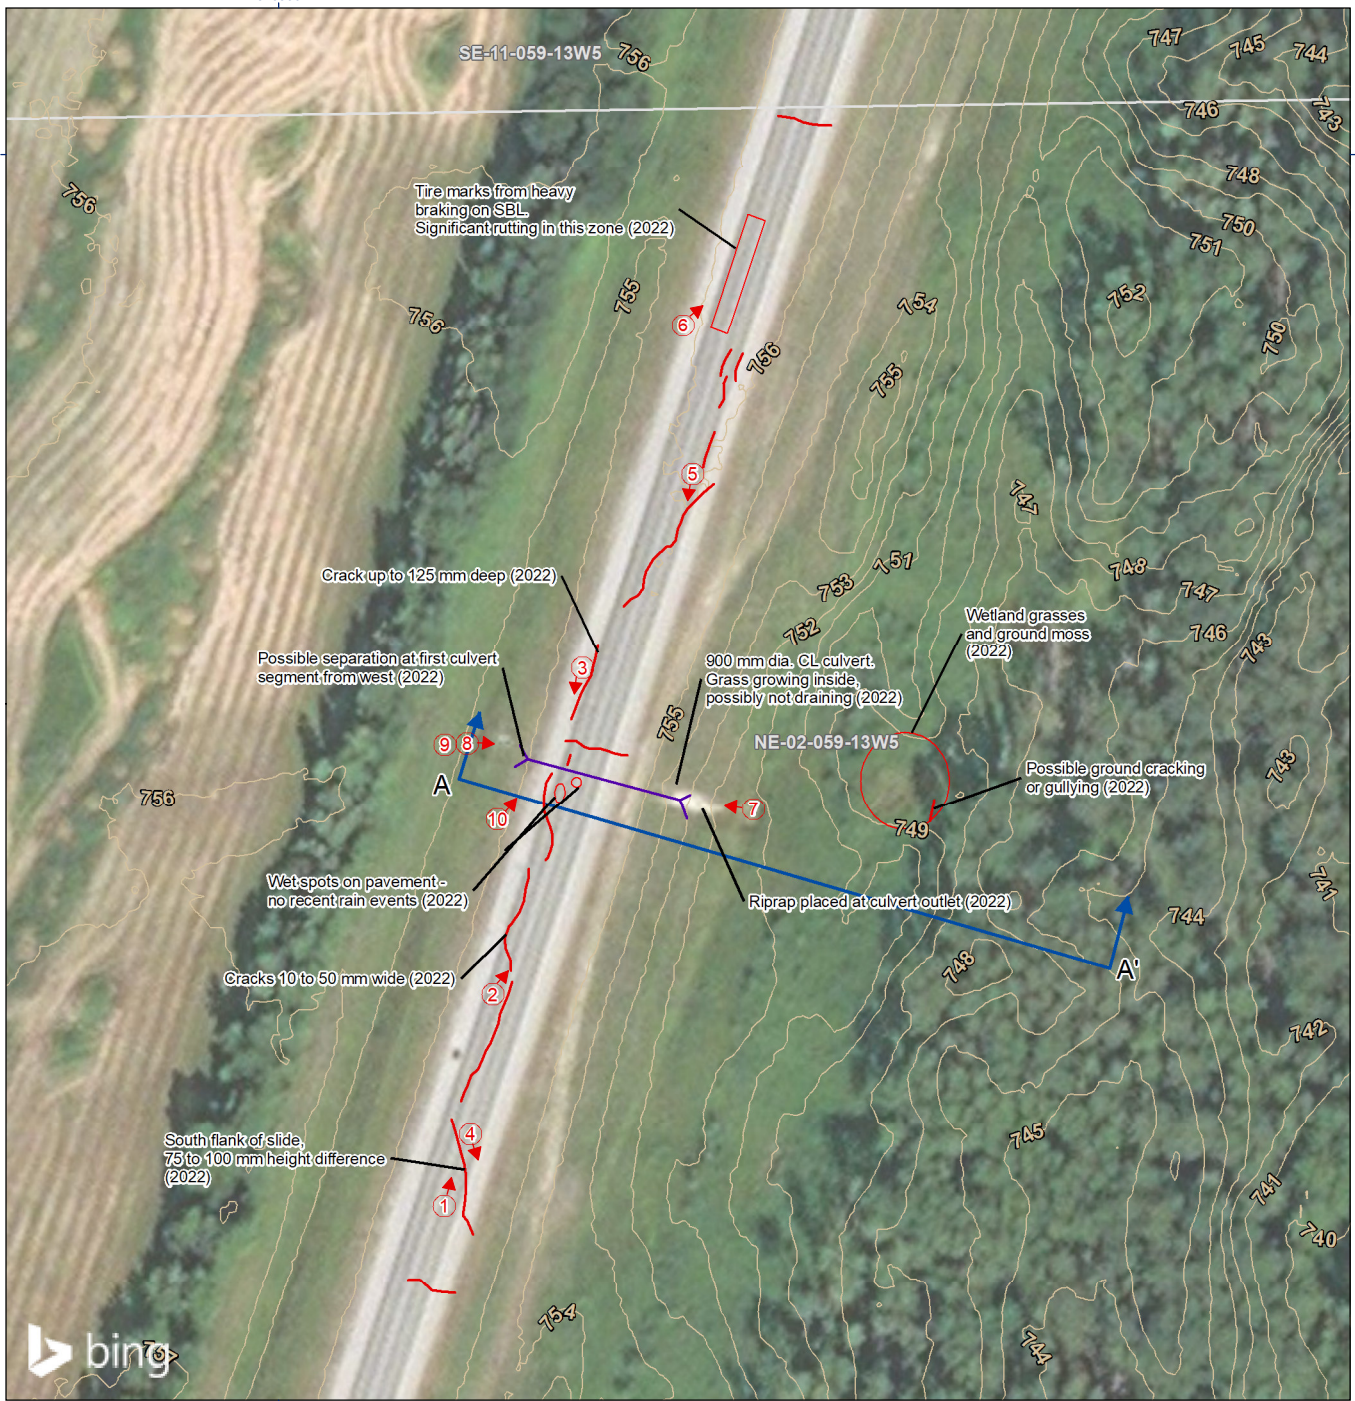
- Significant cracking and pavement distress has resurfaced since the 2020 patch.
- Pavement cracks were observed to be between 5 to 50 mm wide, with most of the wider cracks occurring on the shoulder of the southbound lane (SBL) (Photo 2). One crack on the SBL shoulder on the north side of the culvert was measured to be up to 125 mm deep (Photo 3).

- The semi-circular pavement cracks at the north and south flanks of the slide have vertical displacements of up to approximately 100 mm (Photos 4 & 5).

- The 900 mm diameter centerline culvert was observed to be dry, with some grass growing inside the beveled end of the outlet (Photo 7). Riprap lined the slope below the outlet. At the inlet on the west side, a possible separation was noted between the first and second segments of culvert as a thin ring of light was seen (Photos 8 & 9).

- In the short-term, Stantec recommends that all pavement cracks should be sealed to reduce surface water infiltration into the embankment and landslide. This could include milling and paving to improve rideability. Paving should be conducted such that the final highway surface should match the existing elevation or lower (i.e., no net addition of loads).
