To: Amy Driessen
Alberta Transportation
File: 123315222

From: Leslie Cho and Carrie Murray
Stantec Consulting Ltd.
Date: June 12, 2022

Reference: North Central Region, Edson, Site NC037 - Highway 32:10 South of Whitecourt, Spring 2022 Instrumentation Monitoring Report

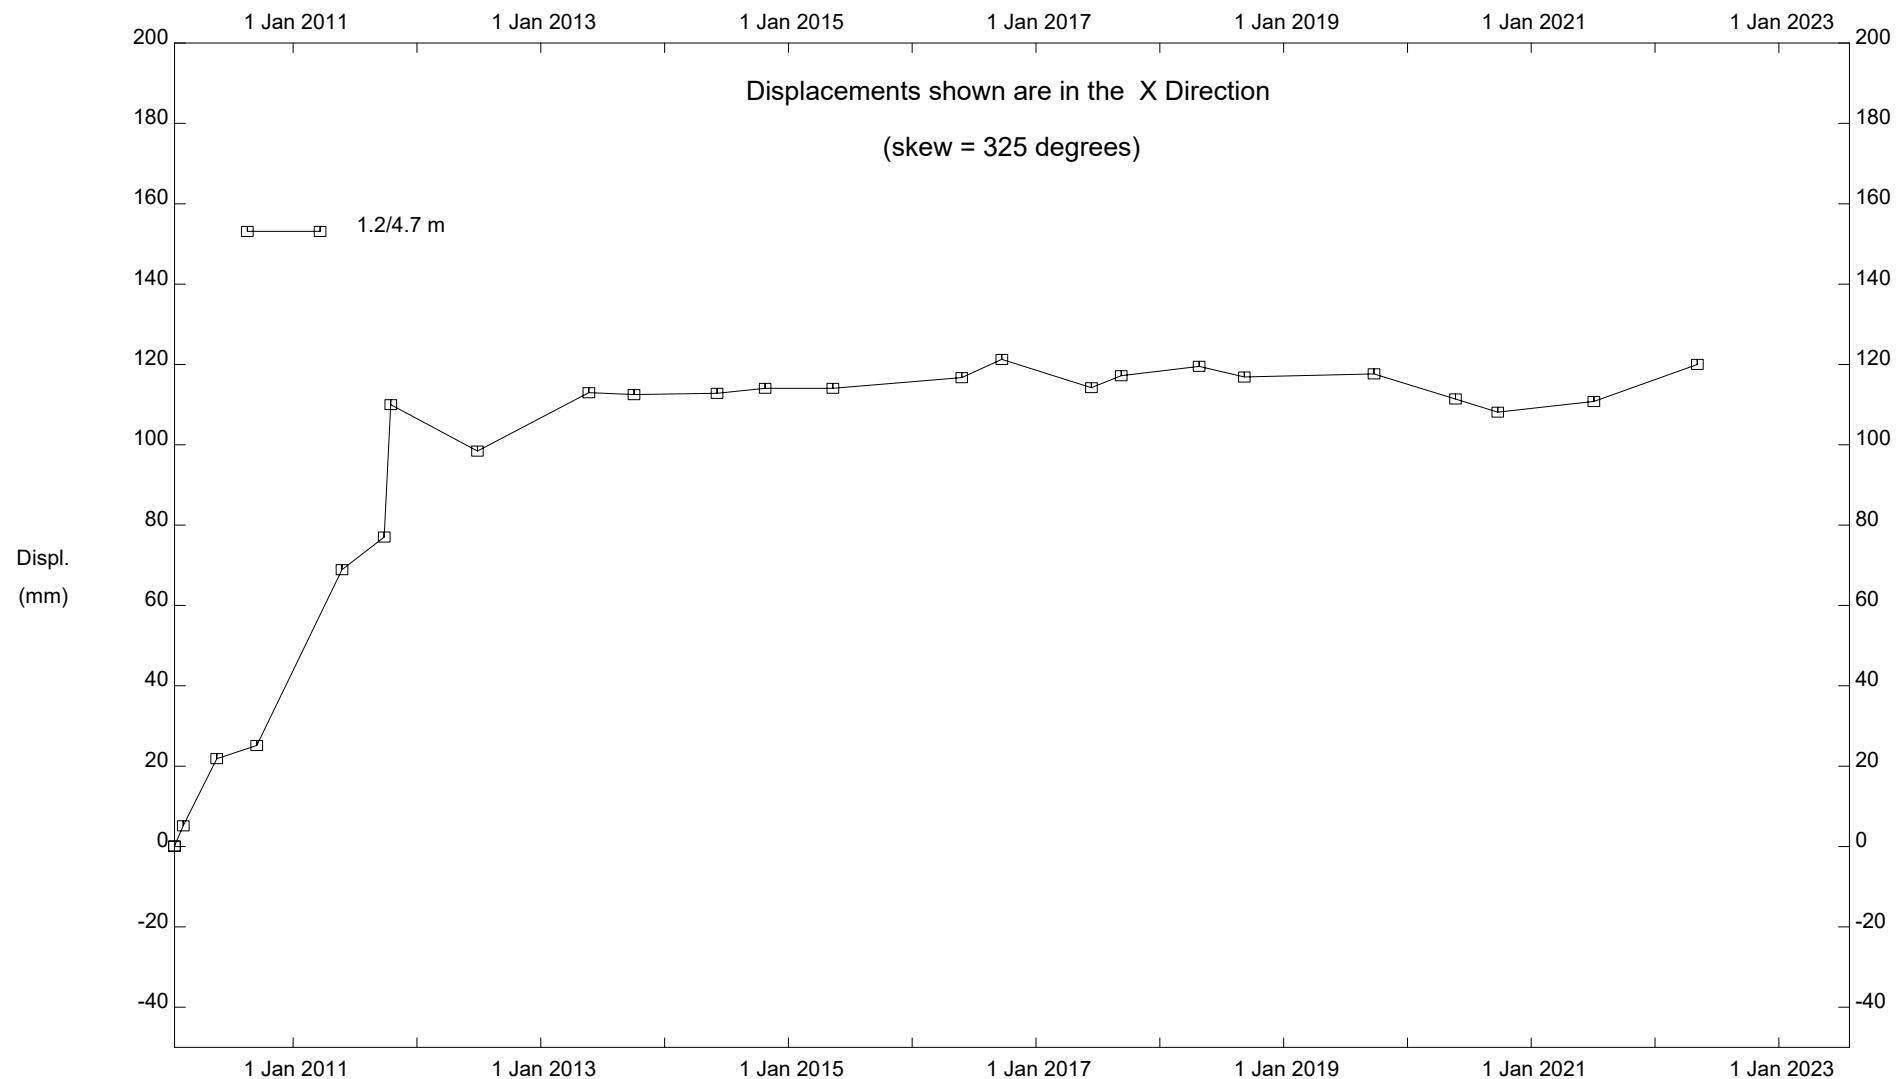
HWY32:10 South of Whitecourt (NC037), Inclinometer SI10-7

The absolute position plot for SI10-7 suggests there is disturbance of about 40 mm in the soil surrounding the inclinometer casing between 6 m to 15 m depth. This disturbance may be causing the erratic movement observed in the incremental and cumulative movement plots.
