To: Amy Driessen  
Transportation and Economic Corridors  
File: 123315222

From: Leslie Cho and Xiteng Liu  
Stantec Consulting Ltd.  
Date: June 18, 2024

**Reference: North Central Region, Edson, Site NC037 - Highway 32:10 South of Whitecourt, Spring 2024 Instrumentation Monitoring Report**

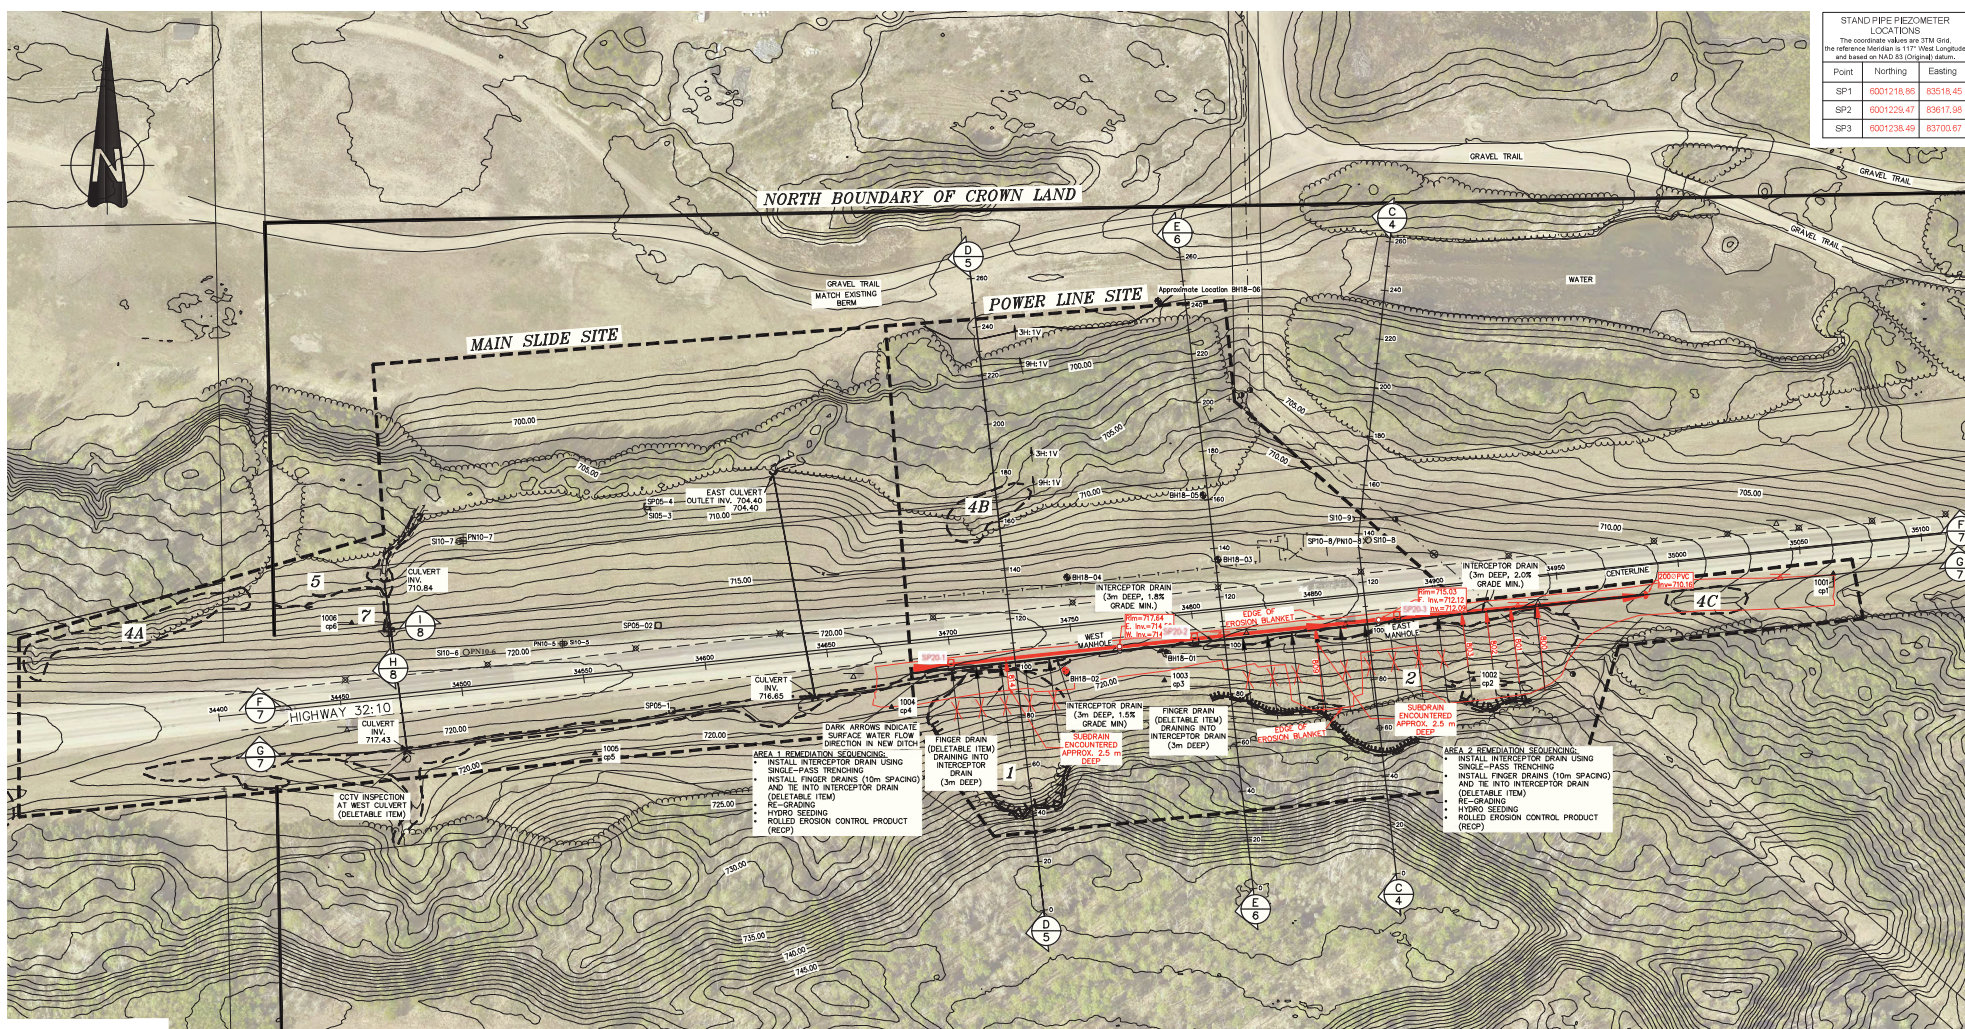
**PLAN**  
1:1000

DEPARTMENT BAR CODE: 21302-202005-RD-0003  
 DRAWING: 32.10  
 CONTRACT: 21302  
 DESCRIPTION: SLOPE FAILURE - NC37 WHITECOURT, AB REMEDIATION PLAN  
 PHOTO  
 DATE: 2018-05-28  
 BY: DM  
 SURVEYED
