From: Leslie Cho and Xiteng Liu
Stantec Consulting Ltd.
Date: June 18, 2024

Reference: North Central Region, Edson, Site NC050 - Highway 40:28 Gregg River Slide, Spring 2024 Instrumentation Monitoring Report

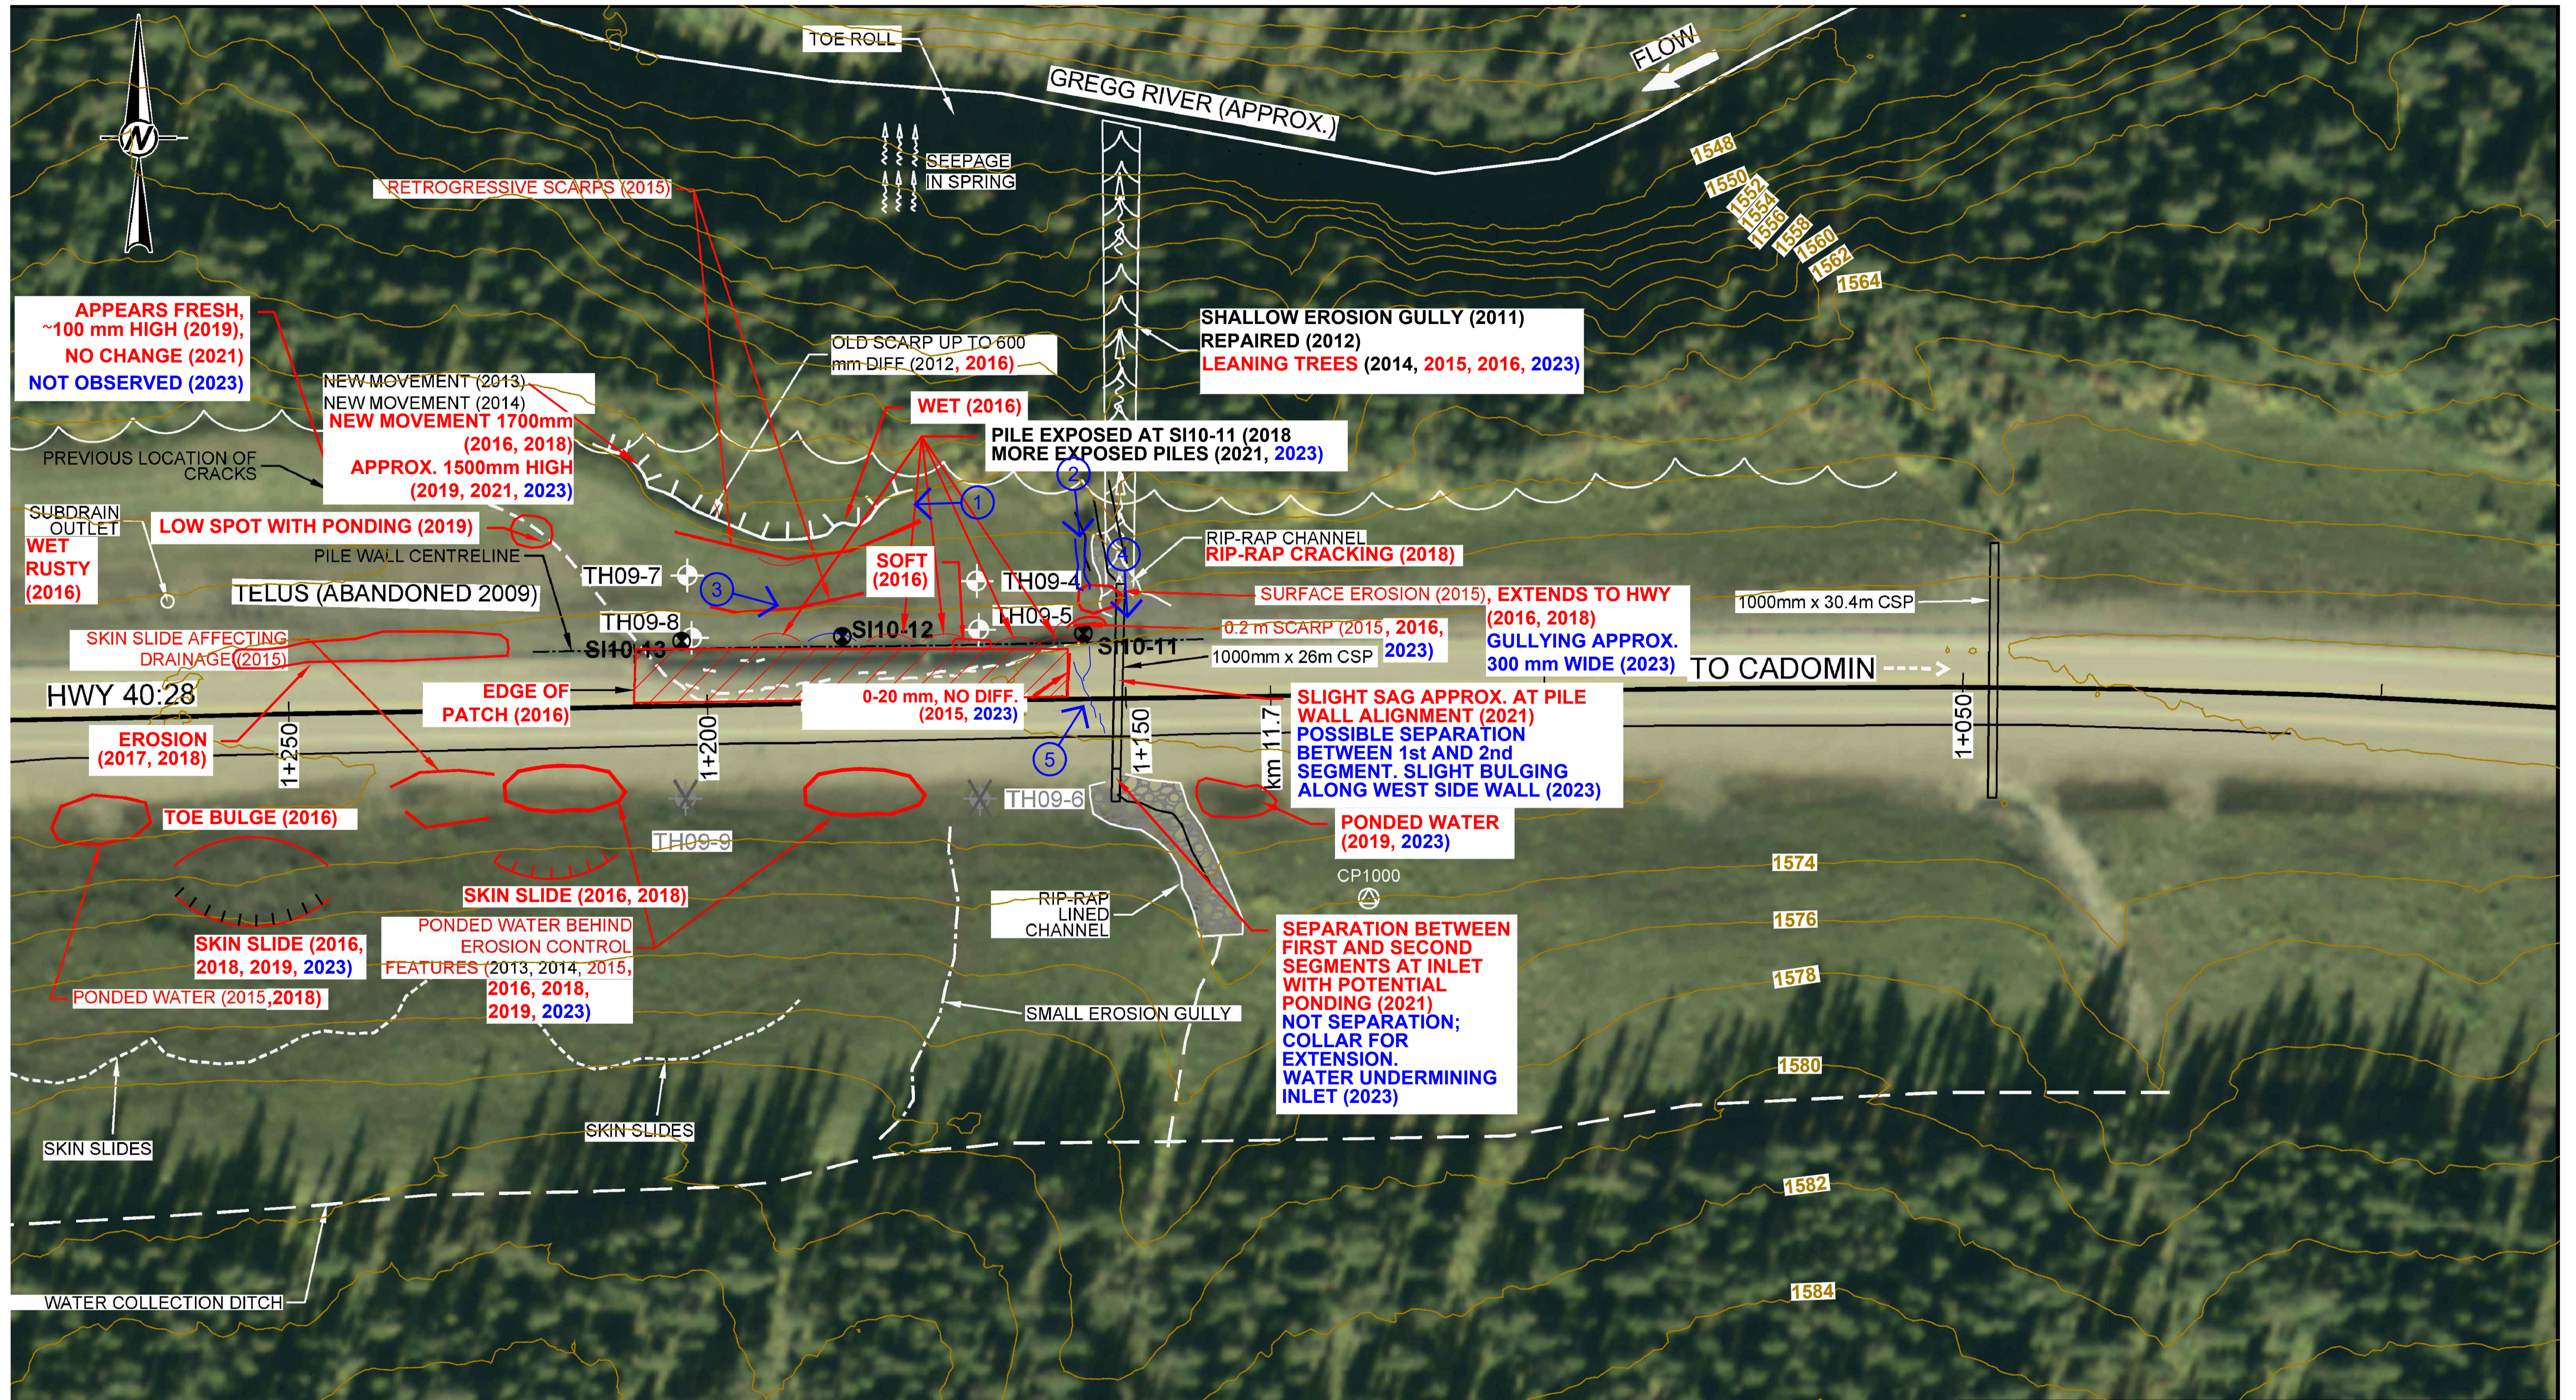
FIGURE 1

No new zones of movement were observed in any of the operational slope inclinometers. Directions of movement are referenced to the azimuth of the A+ groove in each SI casing in Table NC050-1.
