**NORTH CENTRAL REGION GRMP  
EDSON / STONY PLAIN  
SITE INSPECTION FORM**

<b>SITE NUMBER AND NAME:</b> NC011 – 5.5 km North of Highway 16 (Near Hinton)	<b>HIGHWAY AND KM:</b> 40:30, km 5.617	<b>PREVIOUS INSPECTION:</b> May 26, 2020	<b>CURRENT INSPECTION:</b> July 15, 2021
<b>LEGAL DESCRIPTION:</b> NW-01-51-26-W5	<b>NAD83 COORDINATES:</b> UTM11U 5914110N, 452891E		<b>RISK ASSESSMENT:</b> PF: 13 CF: 8 Total: 104
<b>AVERAGE ANNUAL DAILY TRAFFIC (AADT):</b> 1,260 (2020)		<b>CONTRACTOR MAINTENANCE AREA (CMA):</b> 508

**Client/Project**  
 Alberta Transportation  
 Geohazard Monitoring Program  
 NC11 5.5 km North of Hwy 16 (Near Hinton)

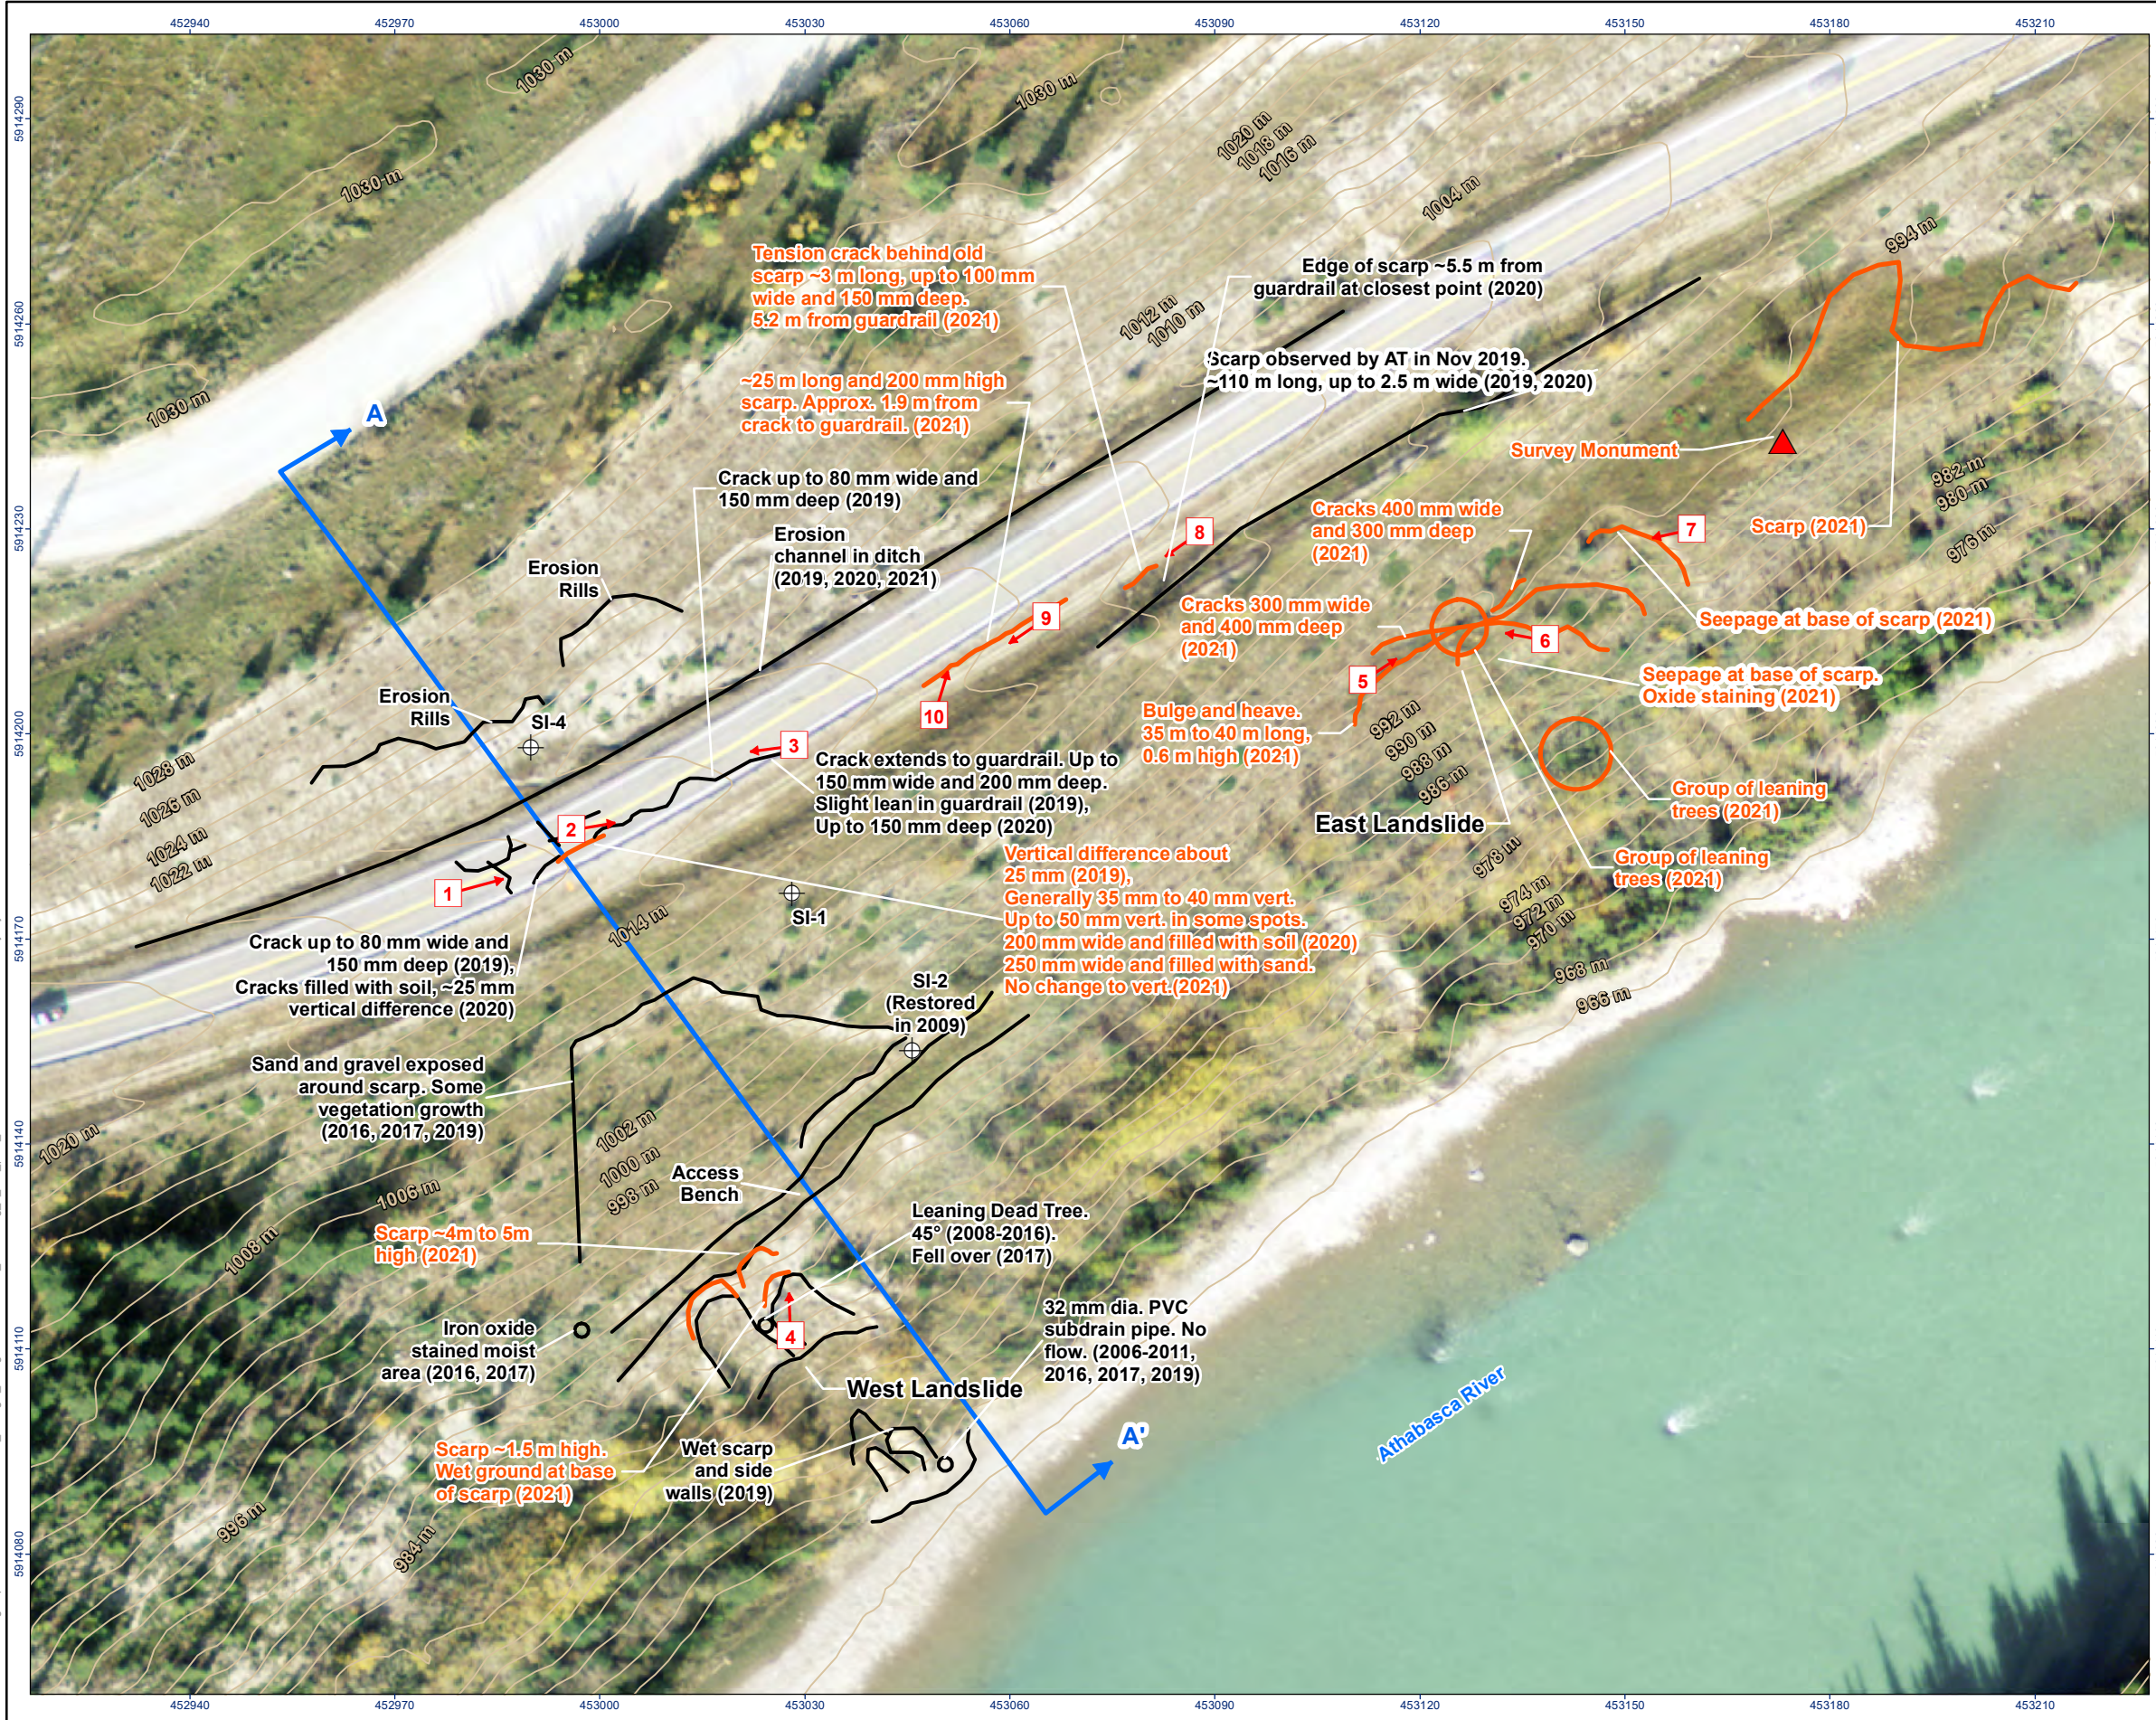
**Figure No.**  
**1**

<b>COMMENTS</b>	
<ul style="list-style-type: none"> <li>• Site plan Figure 1, cross section Figure 2 and a photo log are attached for reference.</li> <li>• The previously observed pavement cracks were filled with sand. Crack dimensions were up to 250 mm wide with 30 mm to 40 mm vertical difference. Pavement cracks are shown on Photos 1 to 3.</li> <li>• SI4 has not shown discernable movement since initialization in 2009 suggesting slope movements are limited to the highway surface, particularly the eastbound lane (EBL).</li> <li>• SI2 showed less than 1 mm of incremental movement between Fall 2020 and Spring 2021. Comparatively, in 2019, about 6 mm of incremental movement was measured.</li> <li>• The west midslope landslide movement located downslope from the access bench appeared to have retrogressed upslope. Two successive scarps were observed on the east portion. The main scarp was about 4 m to 5 m high followed by a second scarp about 1.5 m high. Wet soil was observed at the base of the 1.5 m high scarp (Photo 4).</li> <li>• A 35 m long ridge/graben feature about 600 mm high was observed at the west extent of the east midslope landslide. At the east extent of this feature, ground cracks about 400 mm wide and 300 mm deep were observed. Some leaning trees were also noted at the east end of the ground cracks (Photo 5). A survey control monument appeared to be sliding downhill due to slope movement.</li> <li>• Leaning mature coniferous and deciduous trees were observed within the east landslide.</li> <li>• The highway surface does not appear to be affected by the east landslide at the time of the site visit.</li> <li>• Seepage was observed within the east landslide near the east and west extents (Photo 6 and 7).</li> <li>• The south shoulder scarp is retrogressing towards the highway as indicated by a new tension crack. The crack was about 3 m long, up to 150 mm deep and 100 mm wide. The crack is about 5.2 m away from the guardrail (Photo 8).</li> <li>• A scarp about 25 m long and 200 mm high was observed south of the highway approximately at the same station as the "Hinton Entrance" sign. The scarp was at the base of the embankment and about 1.9 m away from the guardrail (Photo 9 and 10).</li> <li>• Most of the north highway ditch was severely eroded.</li> <li>• The river levels appear to be higher than previous inspections despite a relatively dry season. This could be due to excessive melting of the Athabasca glaciers because of an intense heatwave prior to the site visit.</li> </ul>

<b>RECOMMENDATIONS</b>	
<ul style="list-style-type: none"> <li>• The NC11 slope remediation tender was recently awarded in mid-July and is scheduled for construction this year. As part of construction, the highway backslope will be excavated to make room for realigning about 750 m of Hwy 40. No other remedial recommendations are required at this time.</li> <li>• Given the lack of instrumentation at the east midslope landslide location, survey control points could be installed to monitor slide retrogression towards the highway. Alternatively, InSAR or LiDAR change detection can be completed to monitor landslide activity.</li> <li>• The site should continue to be inspected annually.</li> <li>• Instrumentation monitoring should continue semi-annually.</li> </ul>
