To:	Amy Driessen Alberta Transportation	From:	Leslie Cho and Xiteng Liu Stantec Consulting Ltd.
File:	123315222	Date:	October 7, 2022

Reference: North Central Region, Edson/Stony Plain, Site NC011 – Highway 40:30 5.5 km North of Highway 16 (Near Hinton), Fall 2022 Instrumentation Monitoring Report

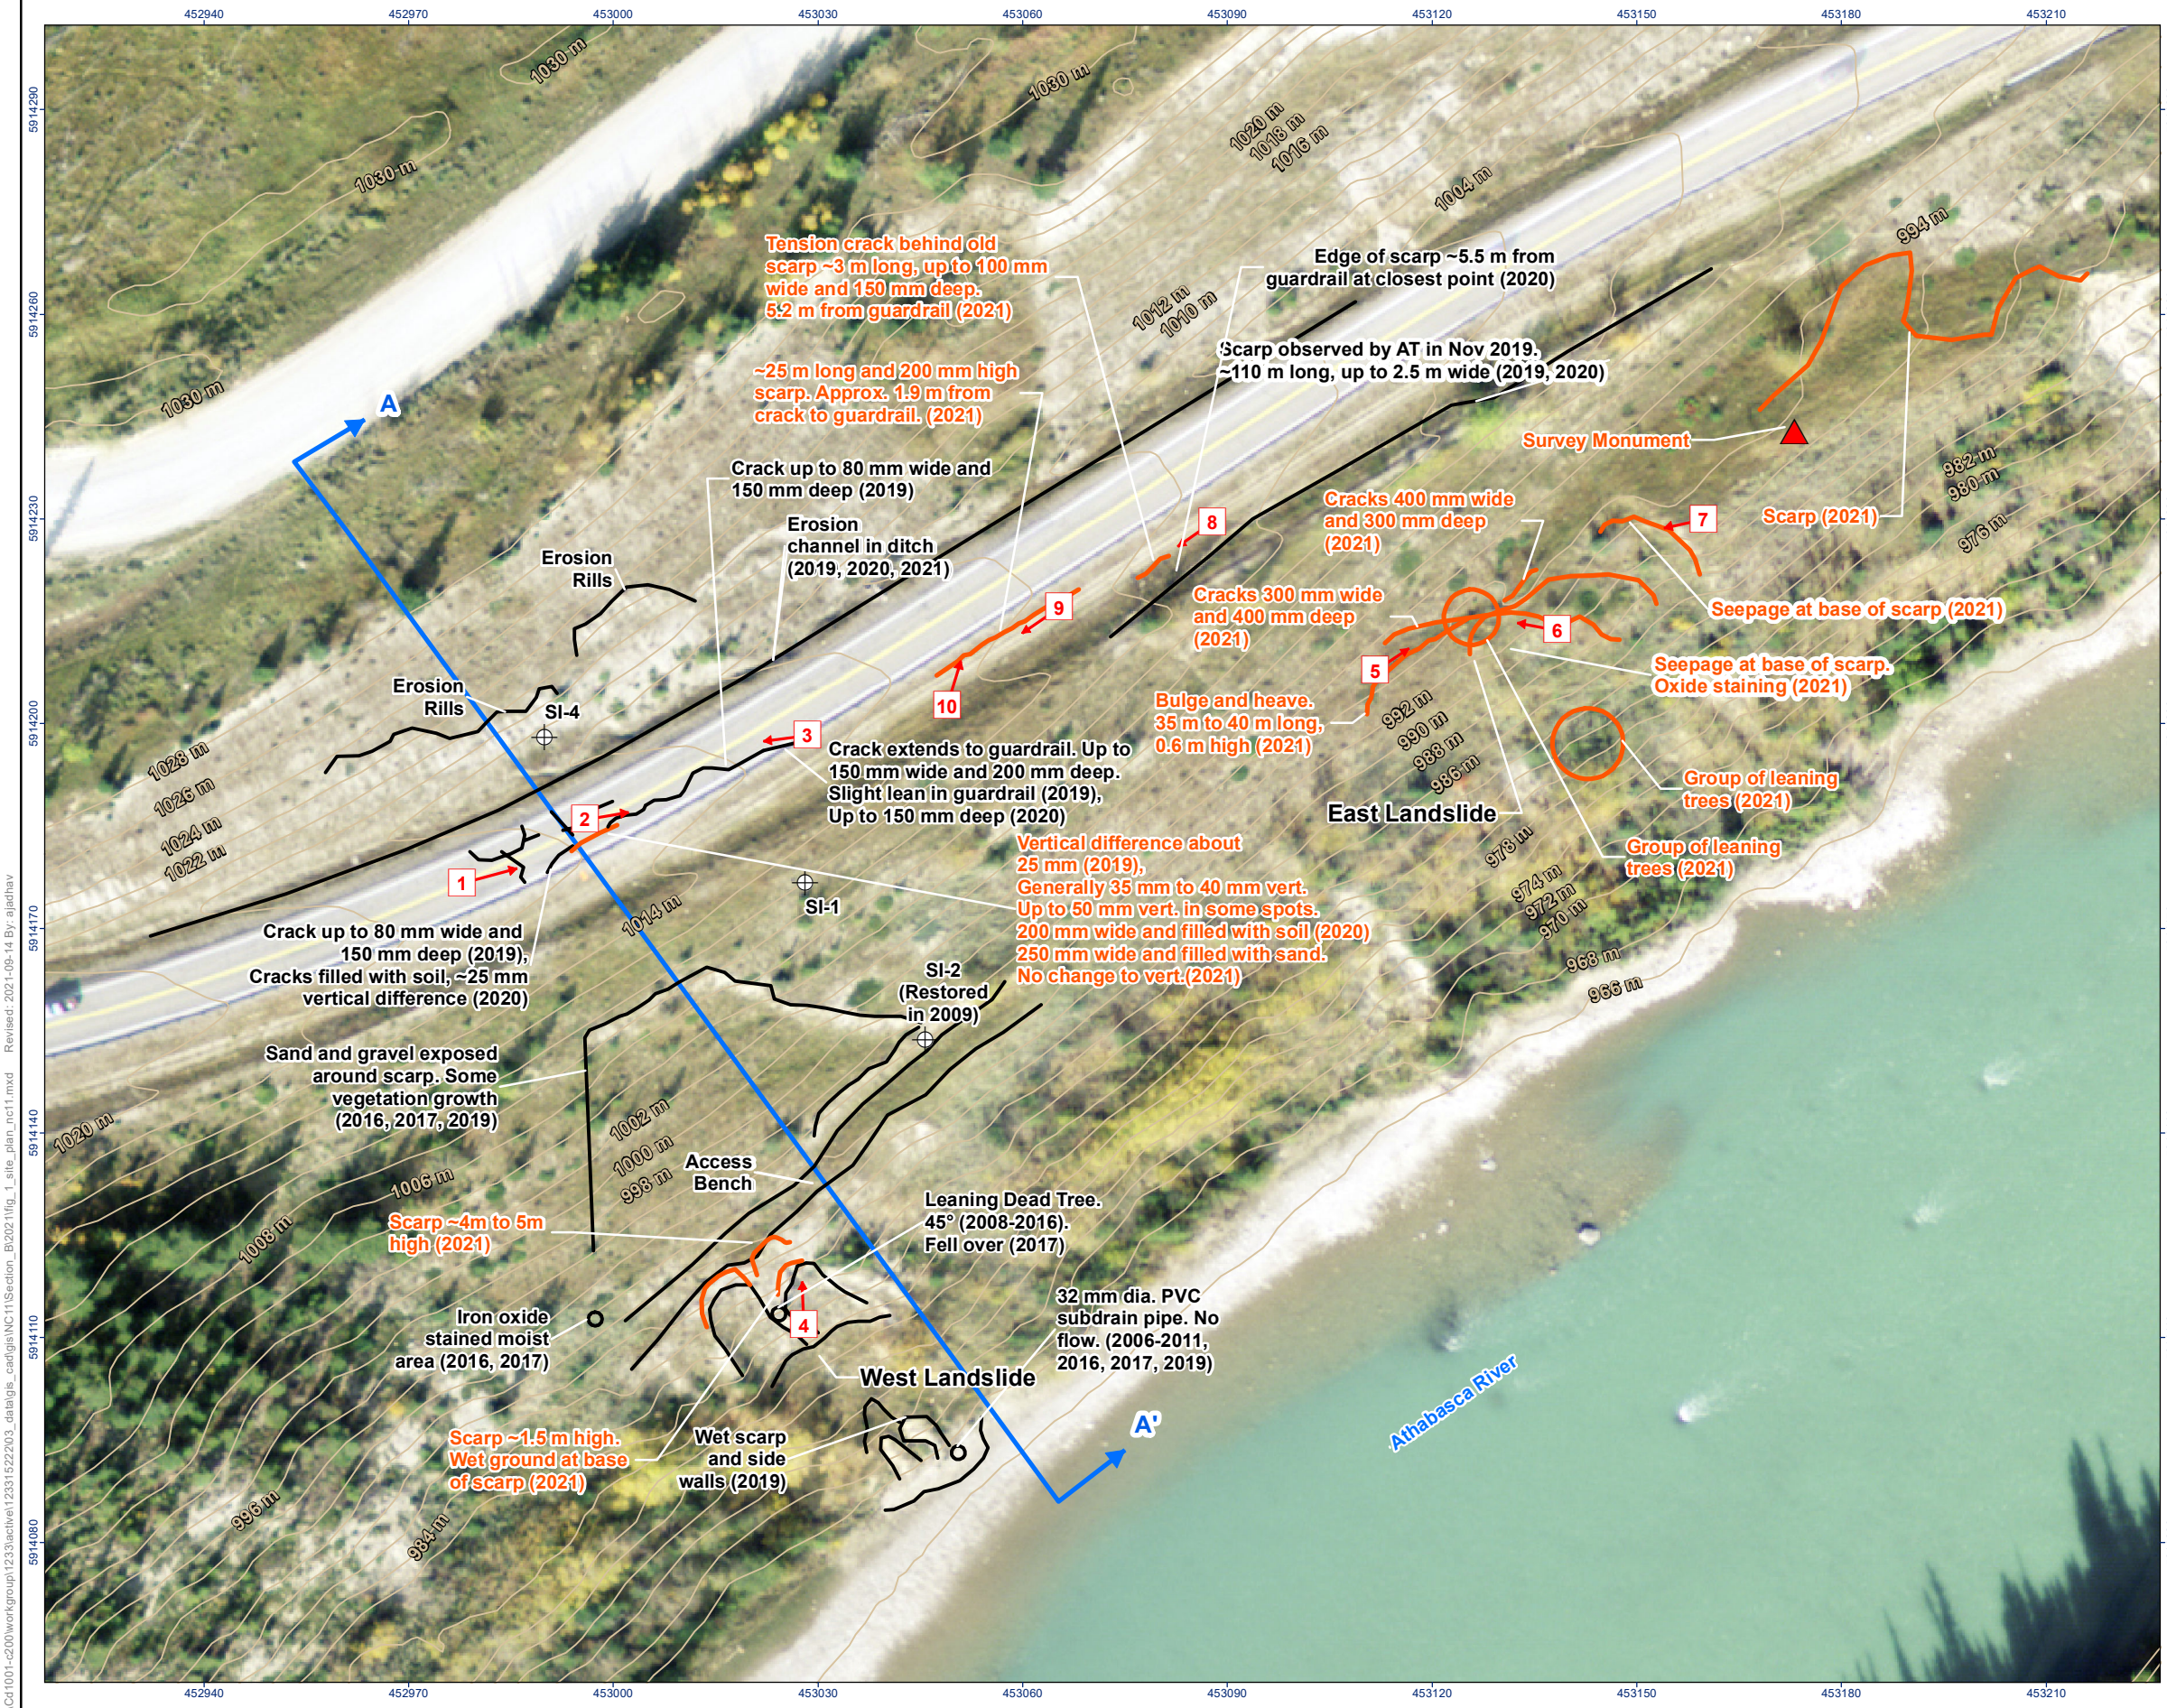
Figure No.
1

The Fall 2022 reading cycle consisted of instrument readings of one slope inclinometer (SI-2). **Figure 1** attached provides a schematic of the site. The instrument readings were taken by Sonja Pharand, E.I.T. and Brian Qin, E.I.T. on September 8, 2022.
