To:	Amy Driessen	From:	Leslie Cho and Xiteng Liu
	Transportation and Economic Corridors		Stantec Consulting Ltd.
File:	123315222	Date:	October 18, 2024

Reference: North Central Region, Edson/Stony Plain, Site NC011 – Highway 40:30 5.5 km North of Highway 16 (Near Hinton), Fall 2024 Instrumentation Monitoring Report

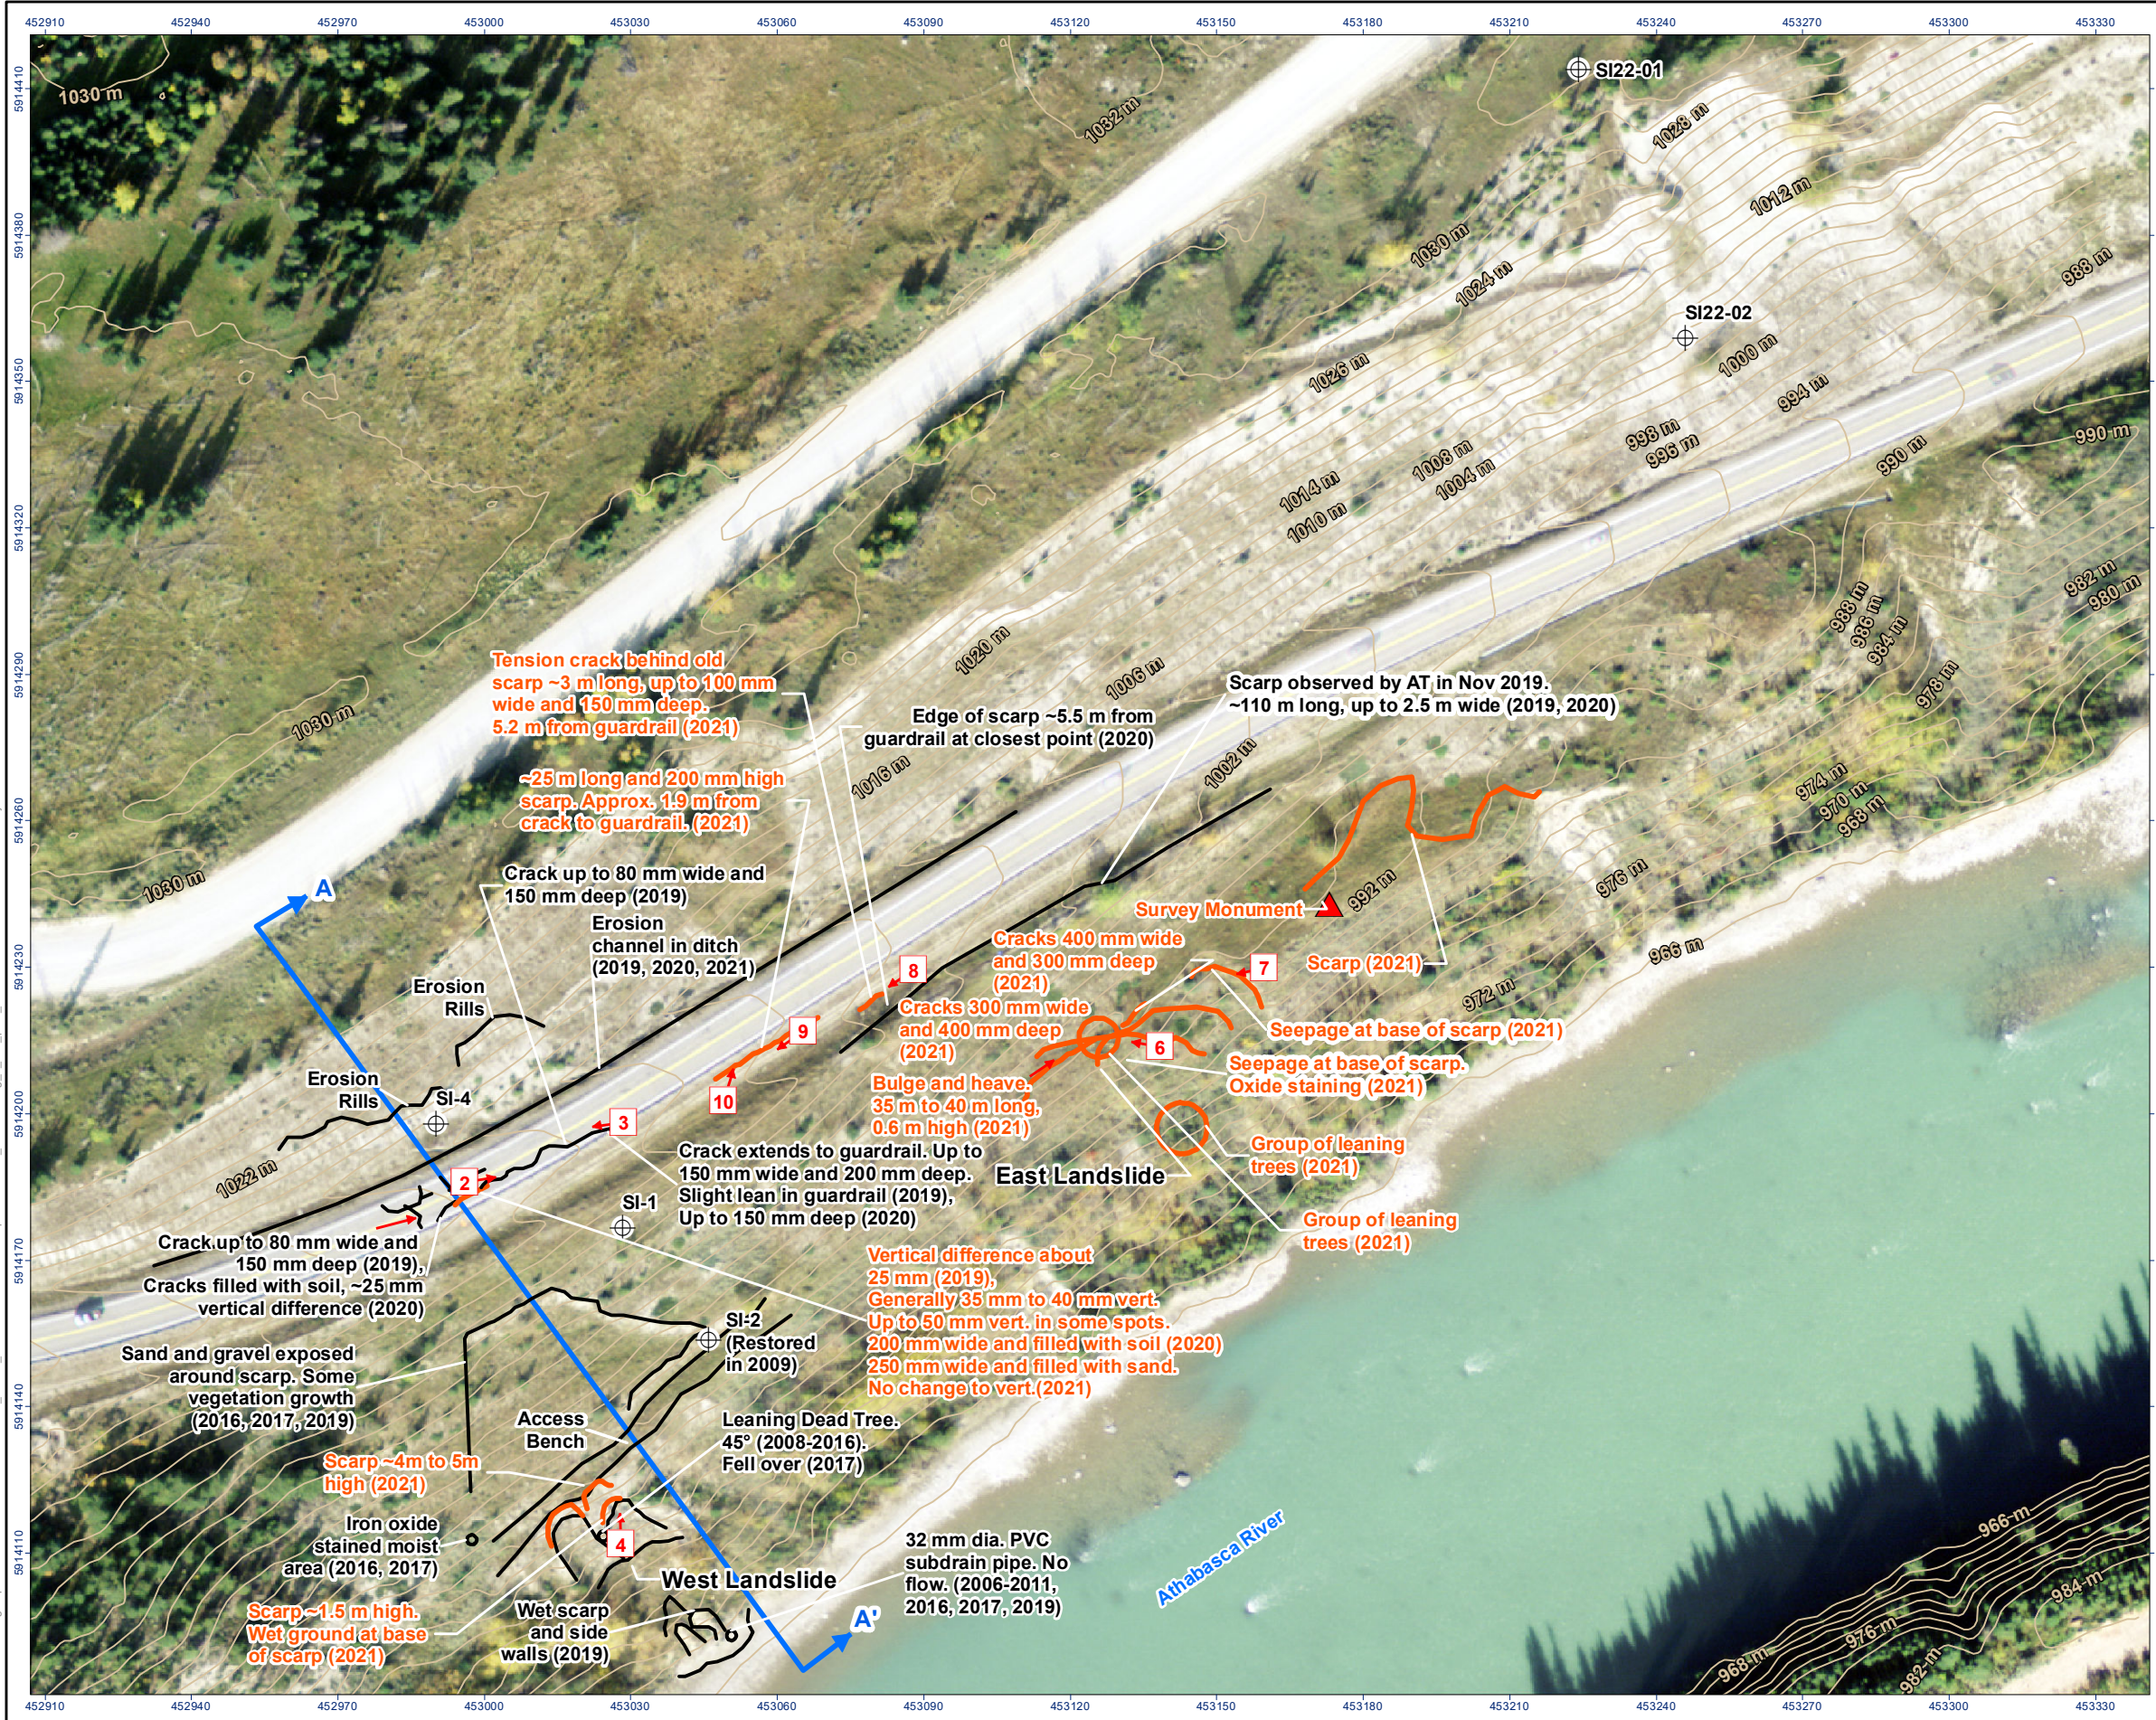
Figure No.
1

The Fall 2024 reading cycle consisted of instrument readings of two slope inclinometers (SI2 and SI22-01). **Figure 1** attached provides a schematic of the site. The instrument readings were taken by Benjamin Lou, EIT and Olawale Odusi, Geotechnical Technologist, on September 23, 2024.

SI22-02 was damaged during construction and was not readable.

SI22-02 was damaged during backslope flattening during the current monitoring cycle.

SI22-01 may require reinitialization upon completion of construction. It is recommended that the next reading cycle take place in Spring 2025.
