To:	Amy Driessen	From:	Leslie Cho and Xiteng Liu
	Transportation and Economic Corridors		Stantec Consulting Ltd.
File:	123315222	Date:	June 18, 2024

Reference: North Central Region, Edson/Stony Plain, Site NC011 – Highway 40:30 5.5 km North of Highway 16 (Near Hinton), Spring 2024 Instrumentation Monitoring Report

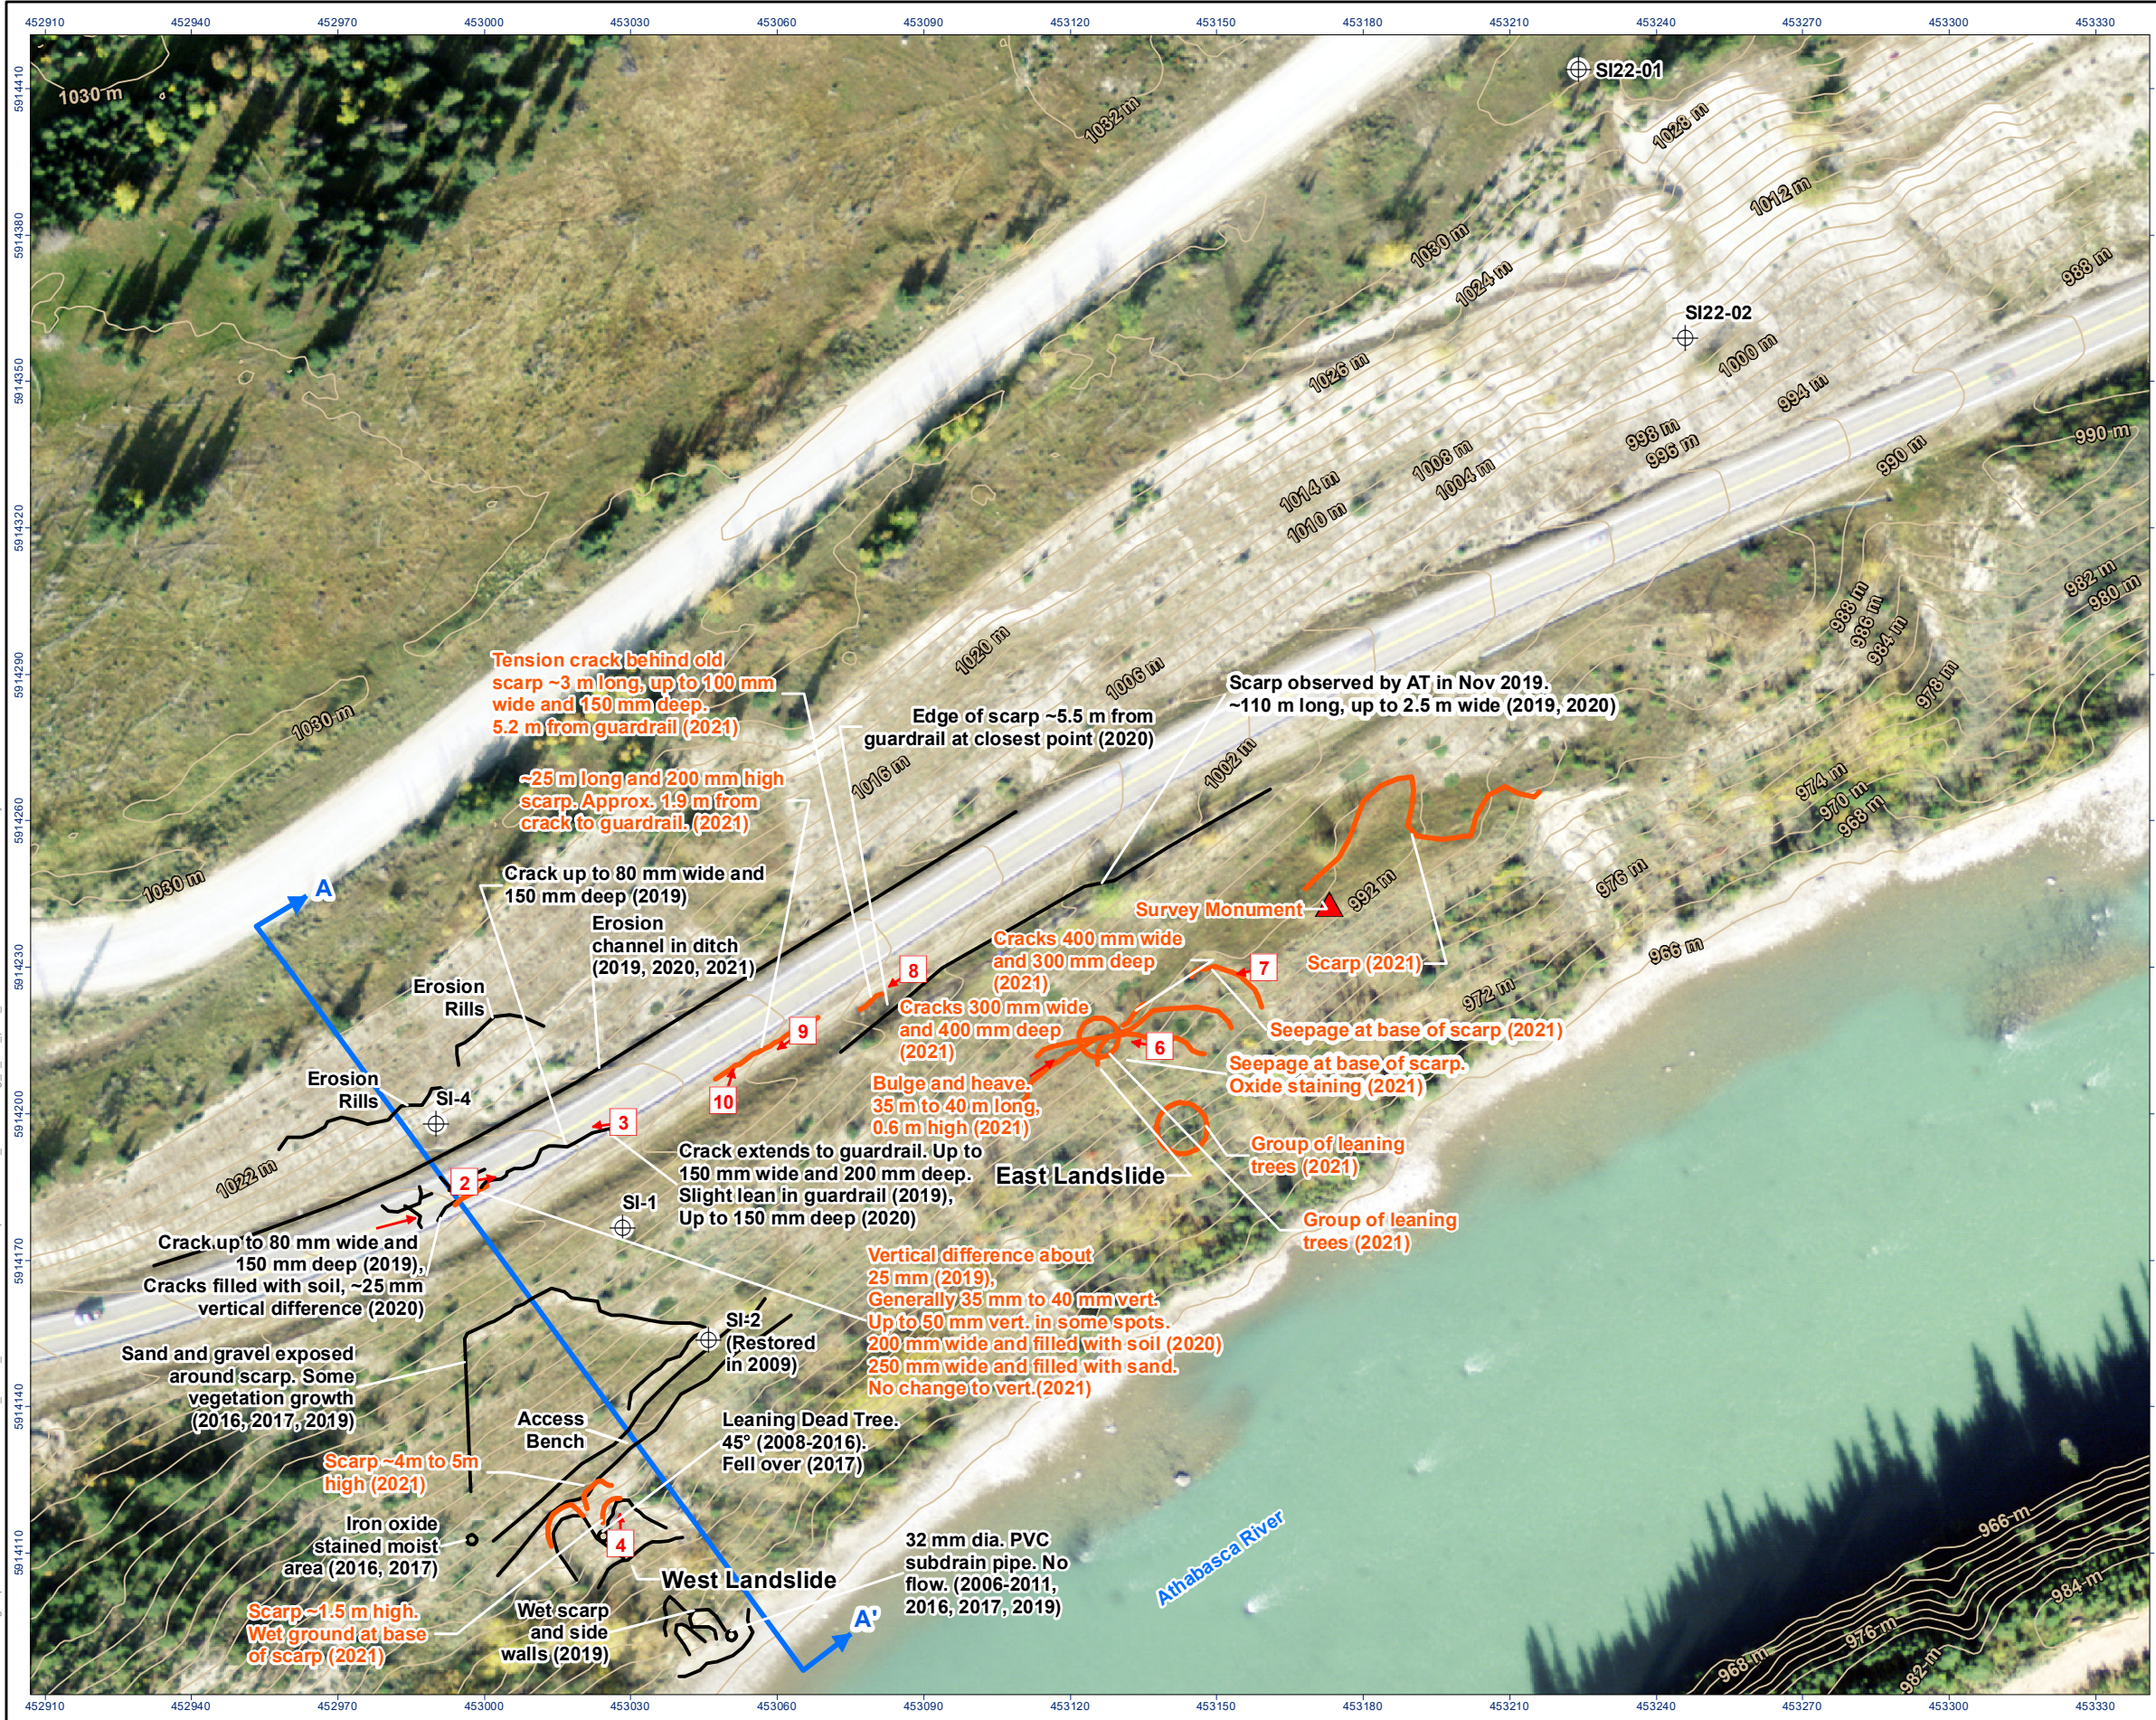
Figure No.
1

The Spring 2024 reading cycle consisted of instrument readings of two slope inclinometers (SI2 and SI22-01). **Figure 1** attached provides a schematic of the site. The instrument readings were taken by Andres Padros, Technician and Olawale Odusi, Geotechnical Technologist, on May 14, 2024.

SI22-02 became buried under construction and was not readable.
