To:	Amy Driessen Alberta Transportation	From:	Leslie Cho and Carrie Murray Stantec Consulting Ltd.
File:	123315222	Date:	June 13, 2022

Reference: North Central Region, Edson/Stony Plain, Site NC048 – Highway 40:30 Fred Creek Slide, Spring 2022 Instrumentation Monitoring Report

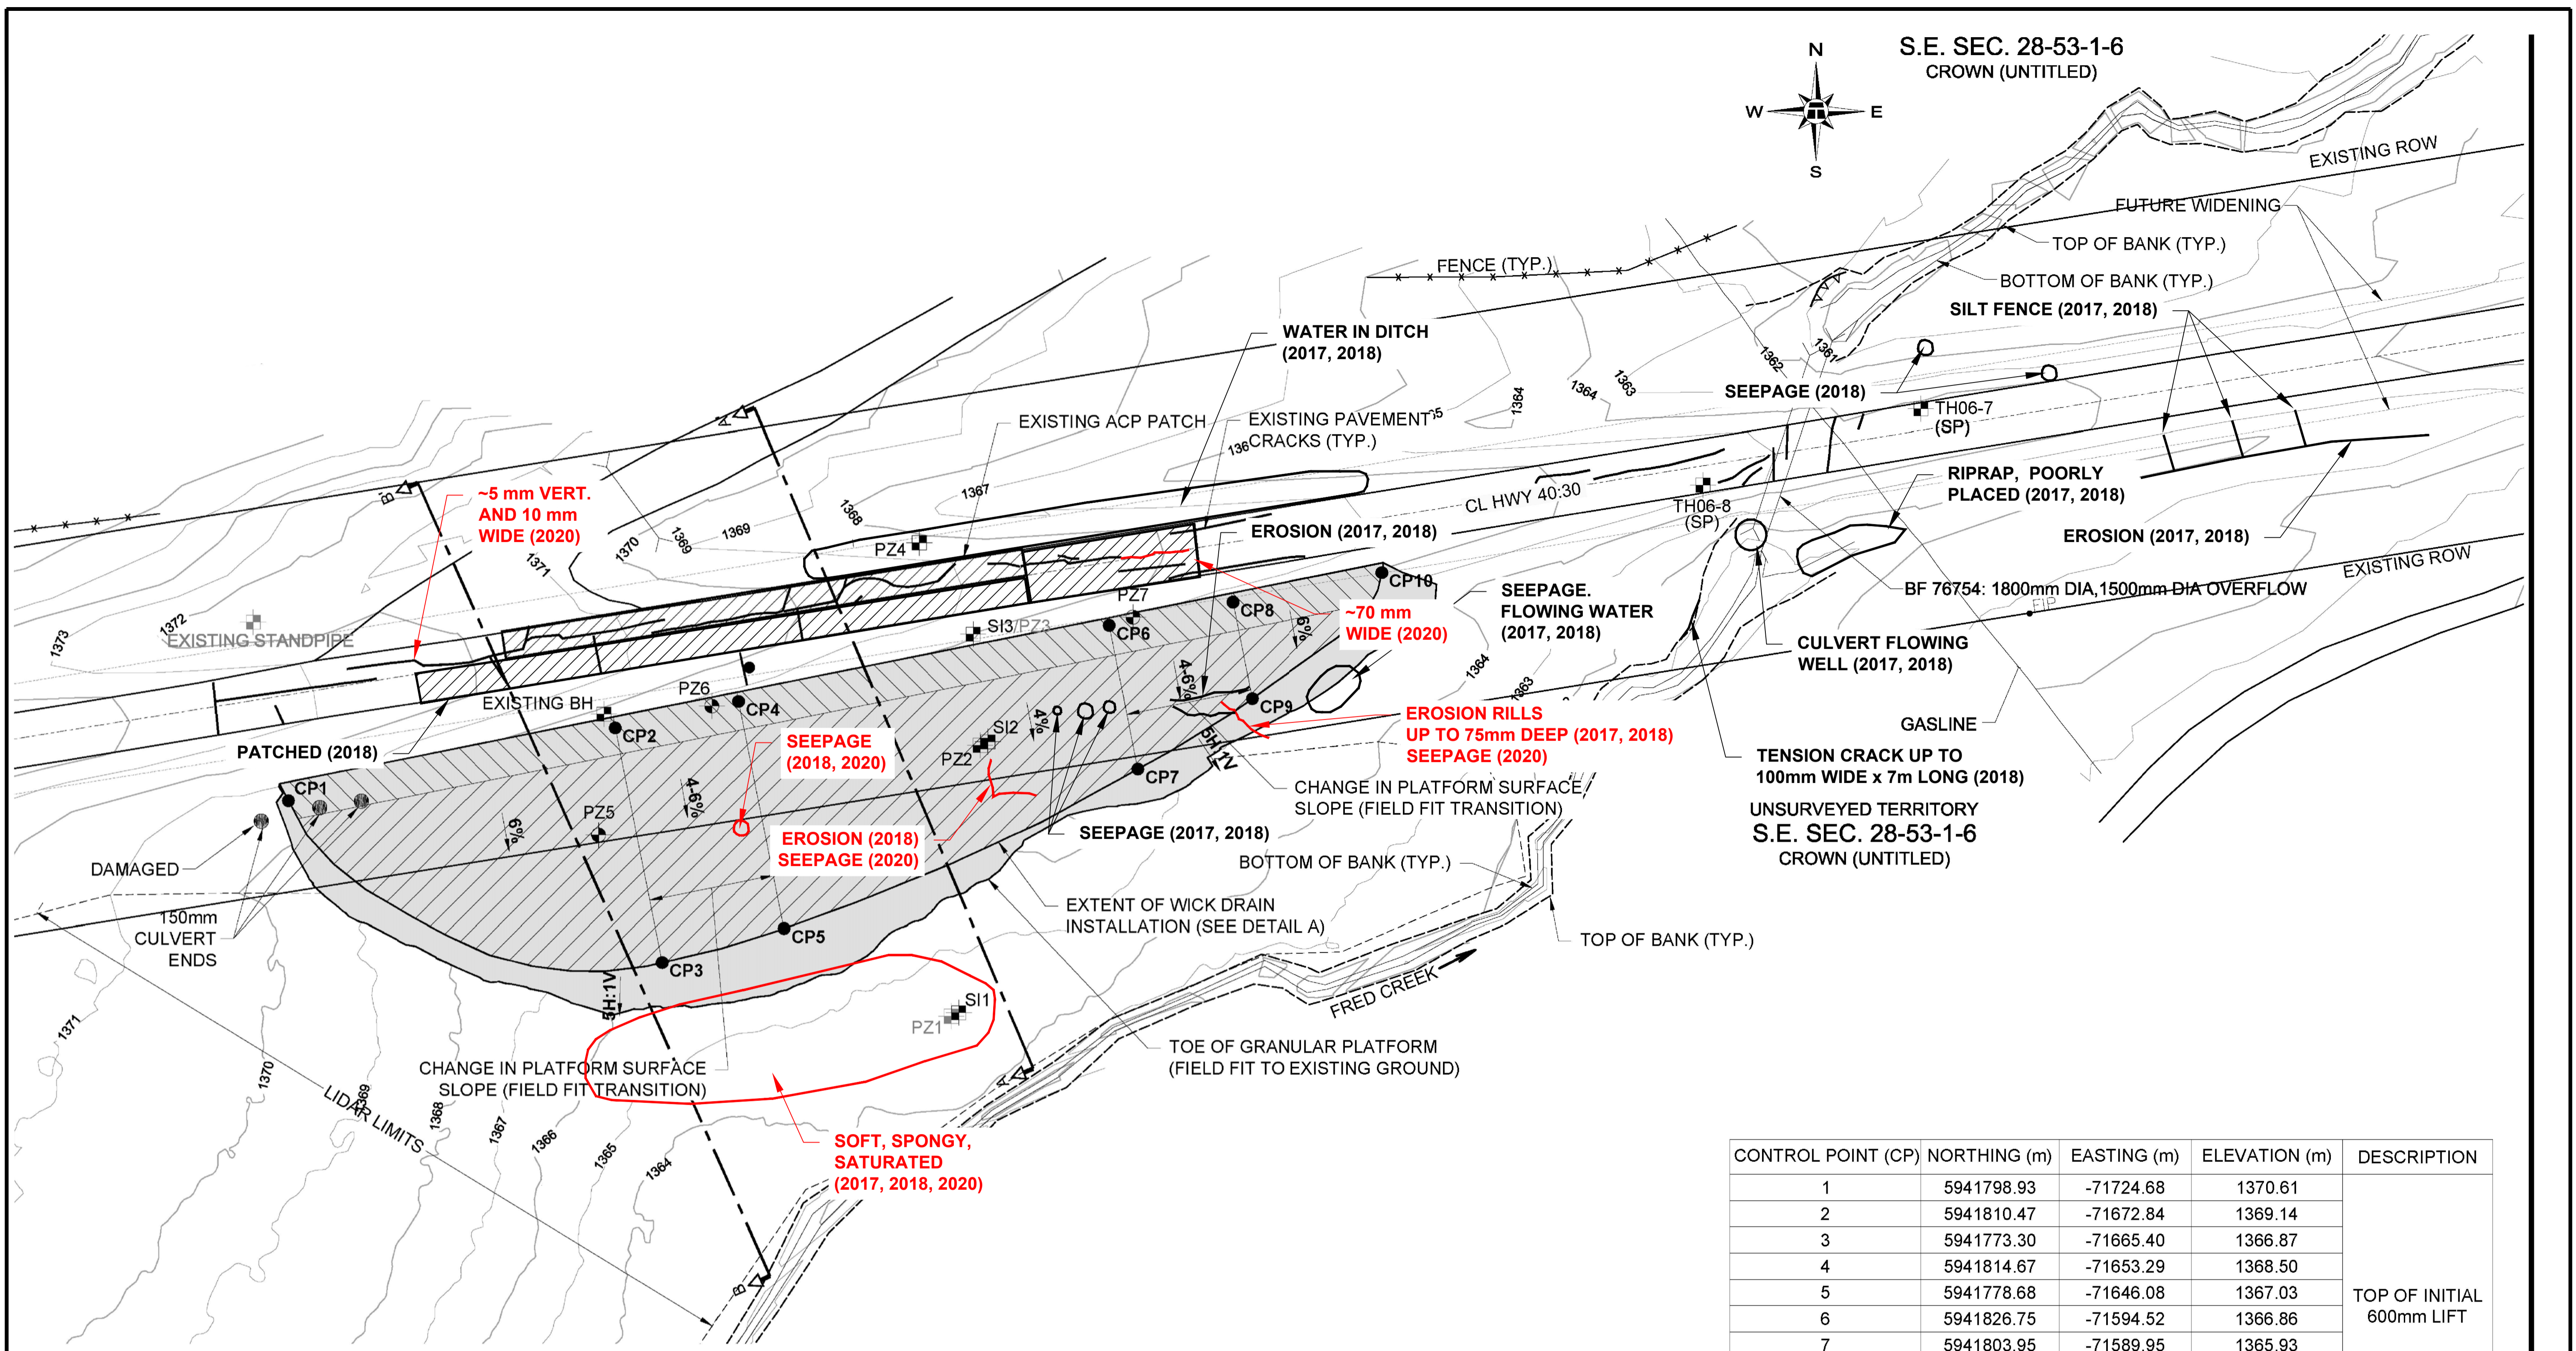
FIGURE -1

Slope inclinometer SI1 and the pneumatic piezometer PZ7 were found damaged during the Spring 2022 reading cycle.

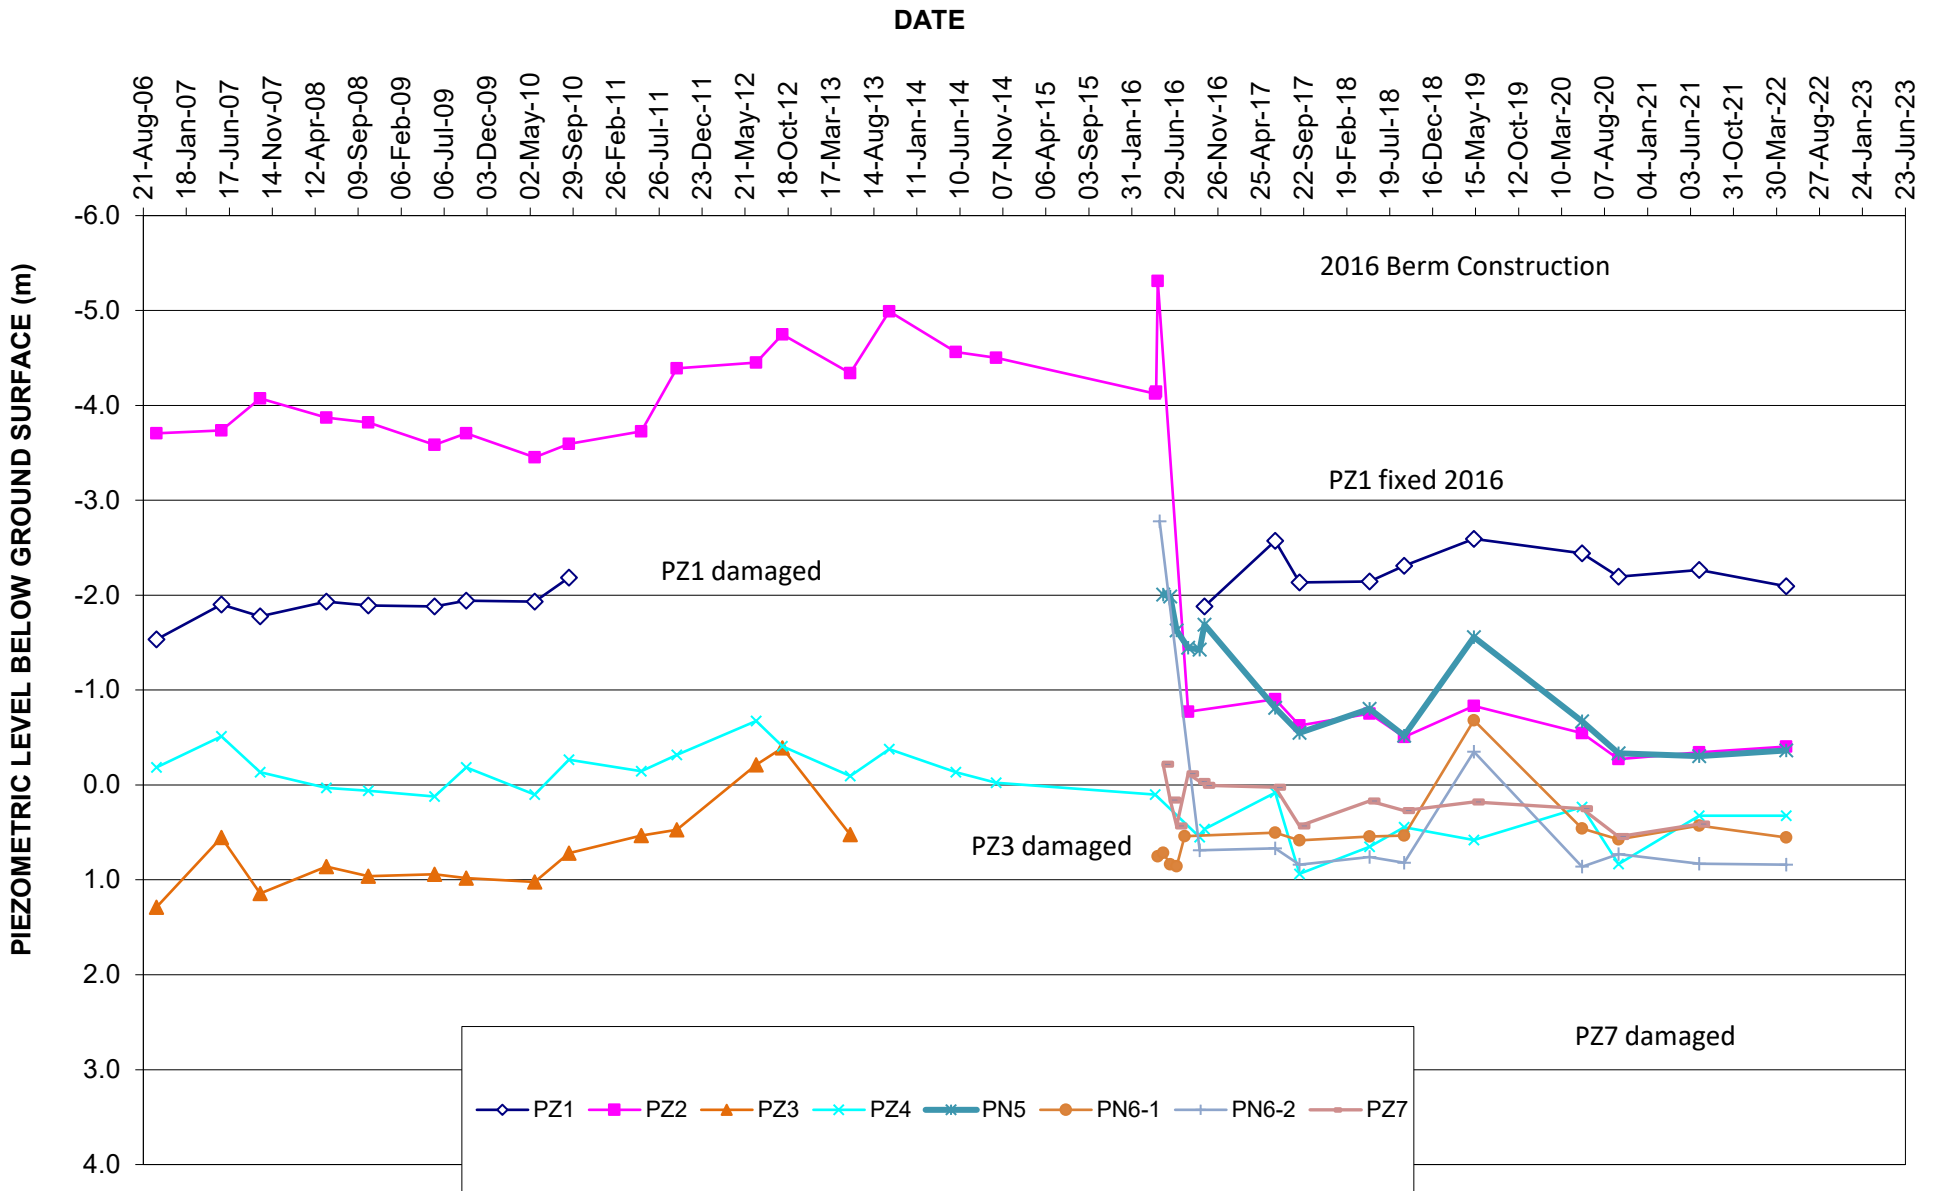
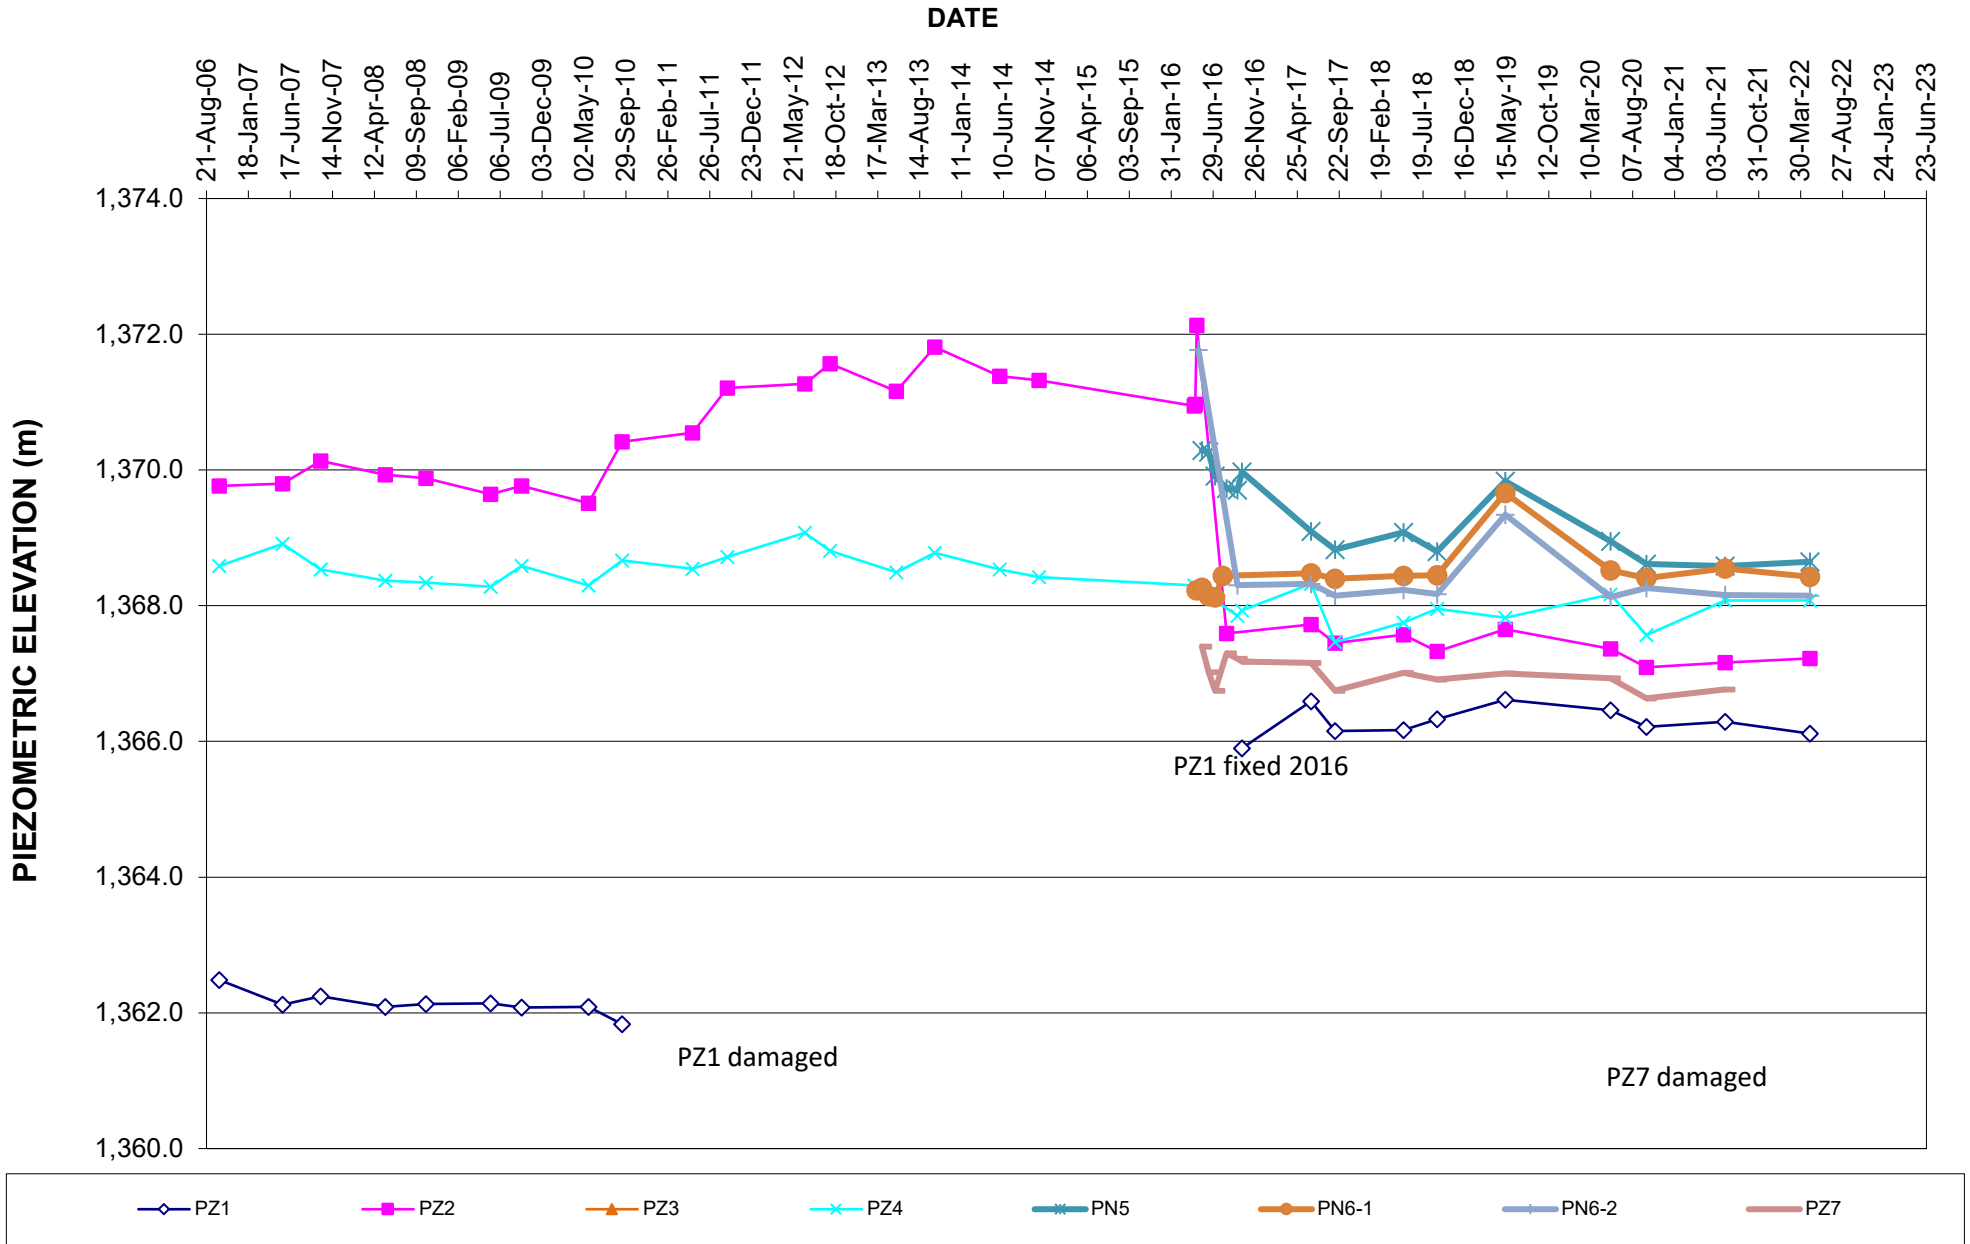
NC048 Spring 2022 Damaged Instruments Photo

SI1 was found blocked at about 1 m below ground surface (bgs) and may be potentially unrepairable without completing minor excavations around the SI, cutting the SI casing to clear the blockage, and splicing with new casing. An attempt to repair PZ7 can be made by replacing the tubing if requested.
