To:	Amy Driessen	From:	Leslie Cho and Xiteng Liu
	Transportation and Economic Corridors		Stantec Consulting Ltd.
File:	123315222	Date:	June 18, 2024

#### Reference: North Central Region, Edson/Stony Plain, Site NC048 – Highway 40:30 Fred Creek Slide, Spring 2024 Instrumentation Monitoring Report

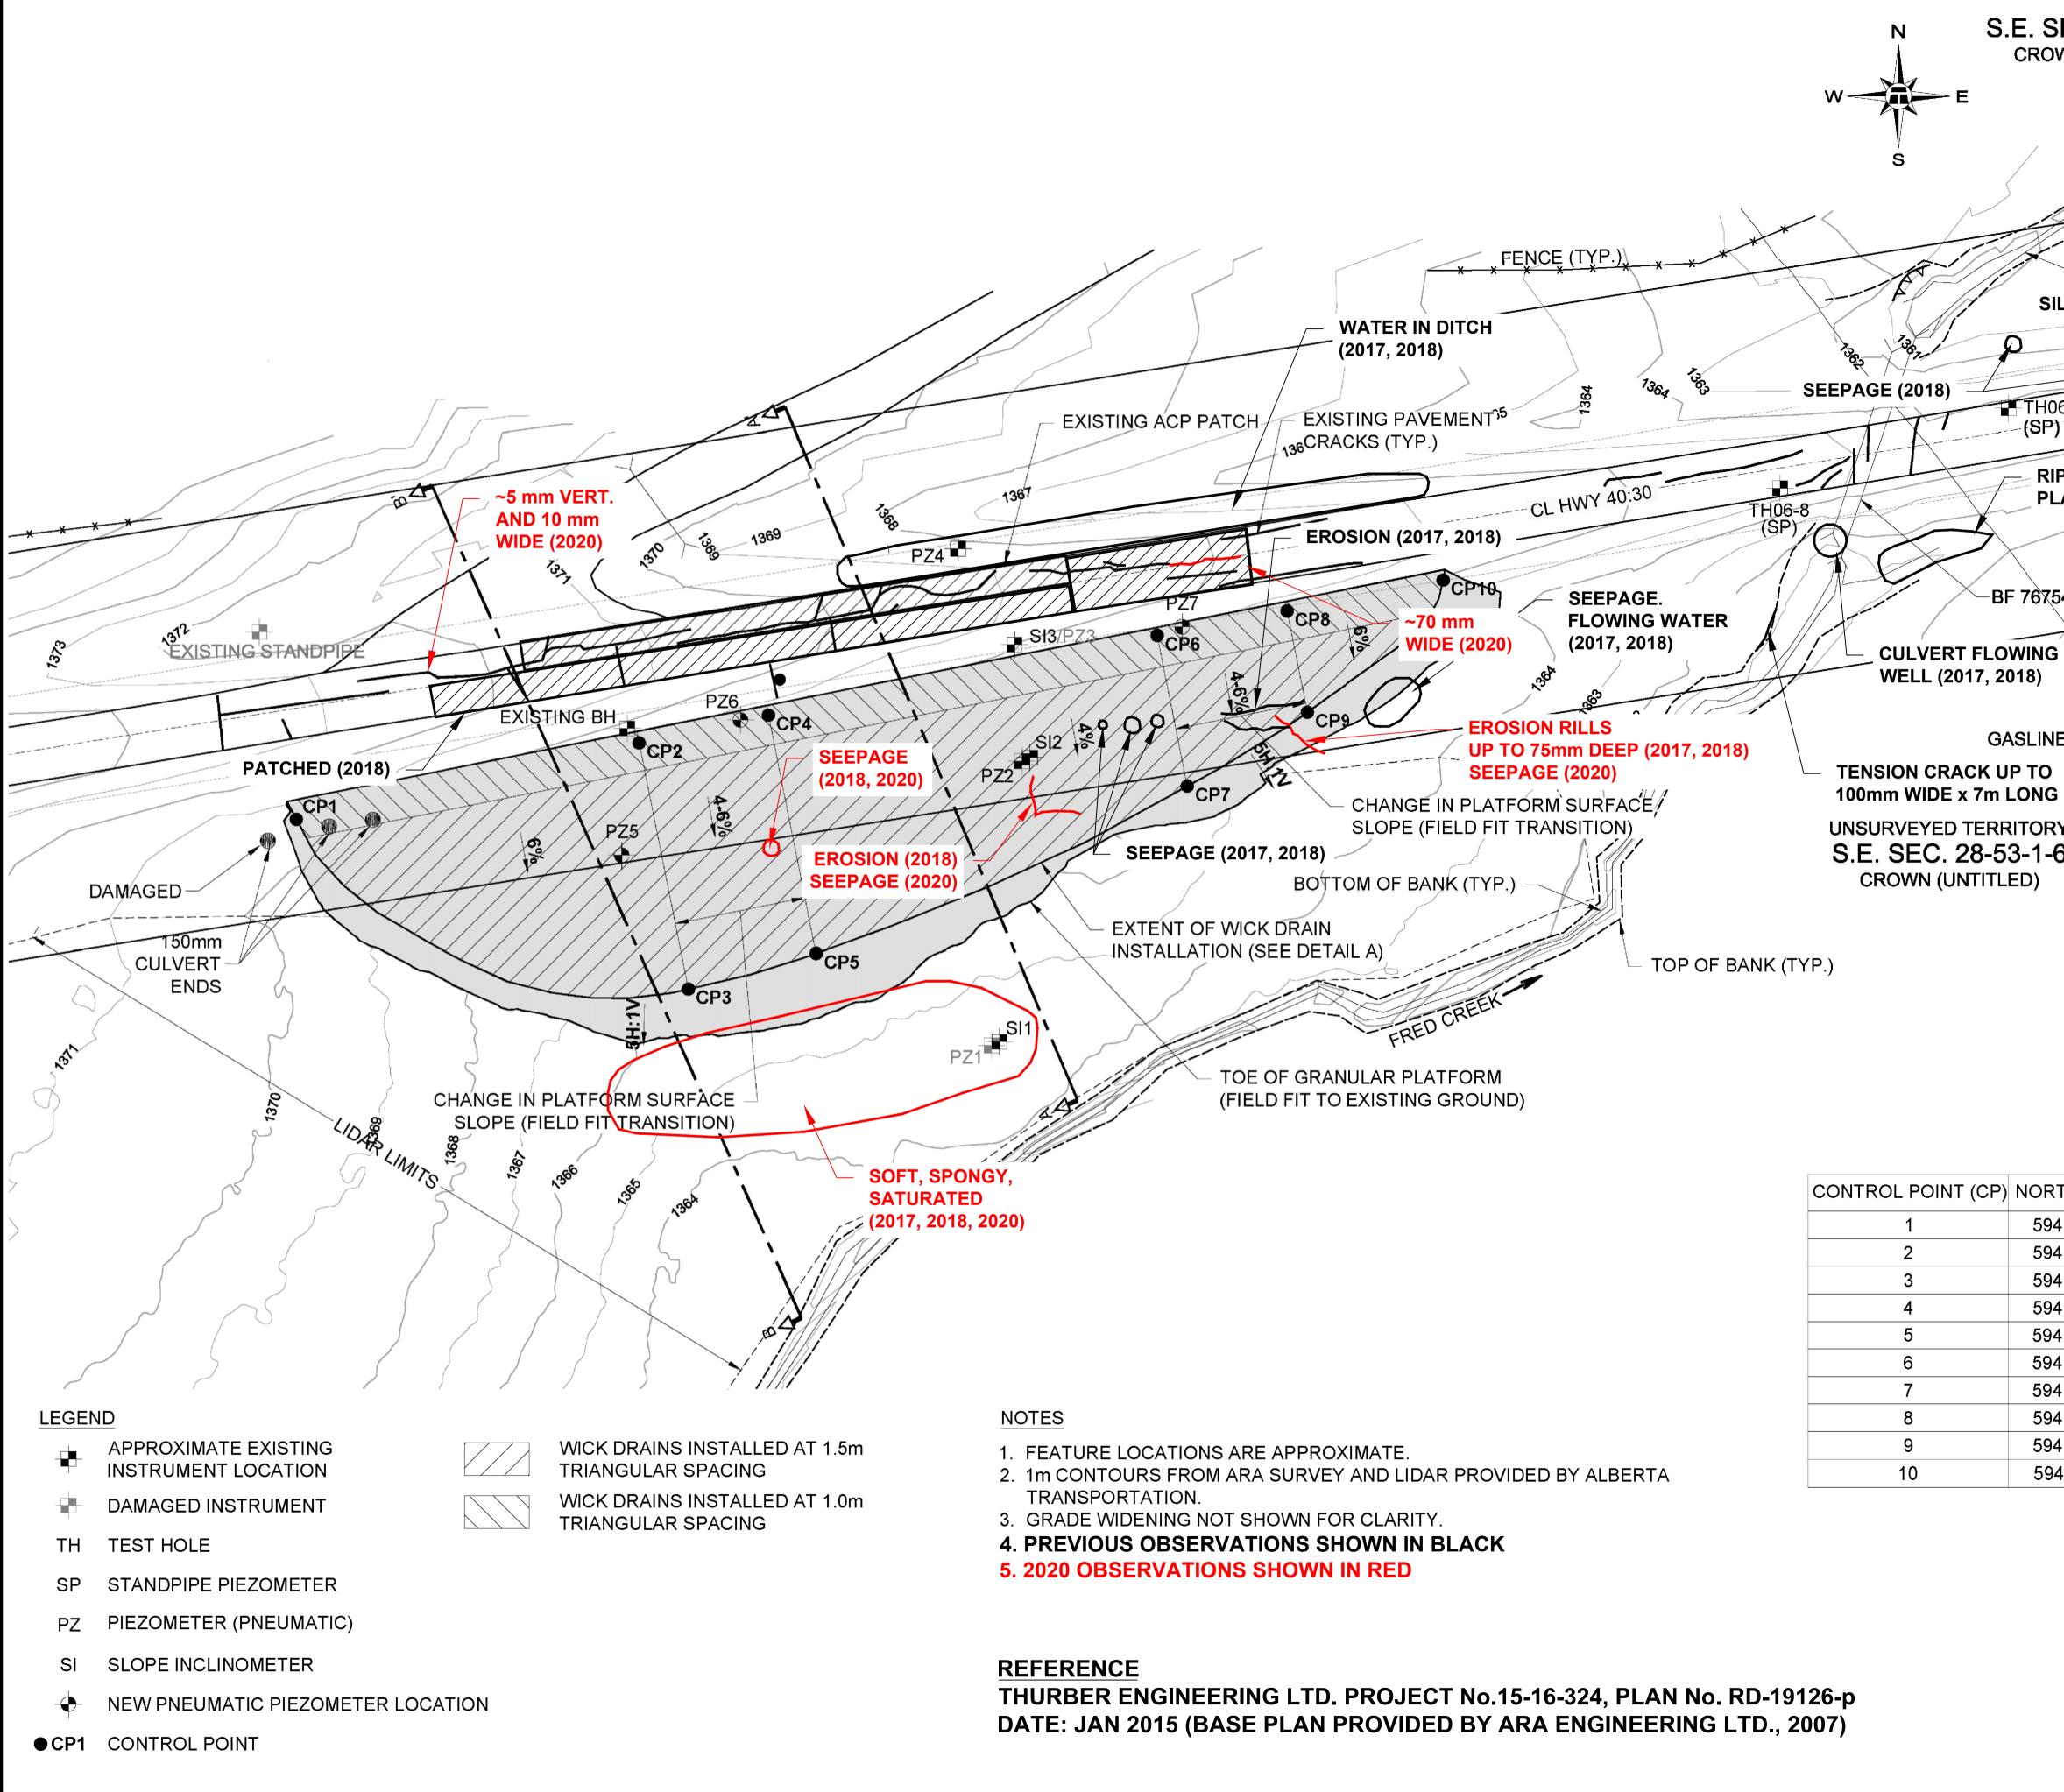
Attachment: Figure 1 – Site Plan SI1 Slope Inclinometer Plots Standpipe Piezometer Level Depth vs Time Plot Standpipe Piezometric Elevation vs Time Plot

SEC	28-5	53-1-6					
WN (U				1		×.	
			10	EXIS	TING ROW		
	Í,			EAR			
H.	/	EUTUR	E WIDENING-	$\mathcal{N}$	{		
<b>7</b>	<u> </u>	OP OF BANK	(TYP.)				
		M OF BANK (T	YP.)	$\rightarrow$			
ILT FEI	NCE (	2017, 2018)	A				
			A				
06-7	-0						
)						and the second	
IPRAP,	POC	DRLY					
		7, 2018)		$\square$			
		EROSION (20	17, 2018) 🚽	7
