To:	Amy Driessen Alberta Transportation	From:	Leslie Cho and Xiteng Liu Stantec Consulting Ltd.
File:	123315222	Date:	October 7, 2022

Reference: North Central Region, Edson, Site NC083 - Highway 40:30 West of Wildhay River, Fall 2022 Instrumentation Monitoring Report

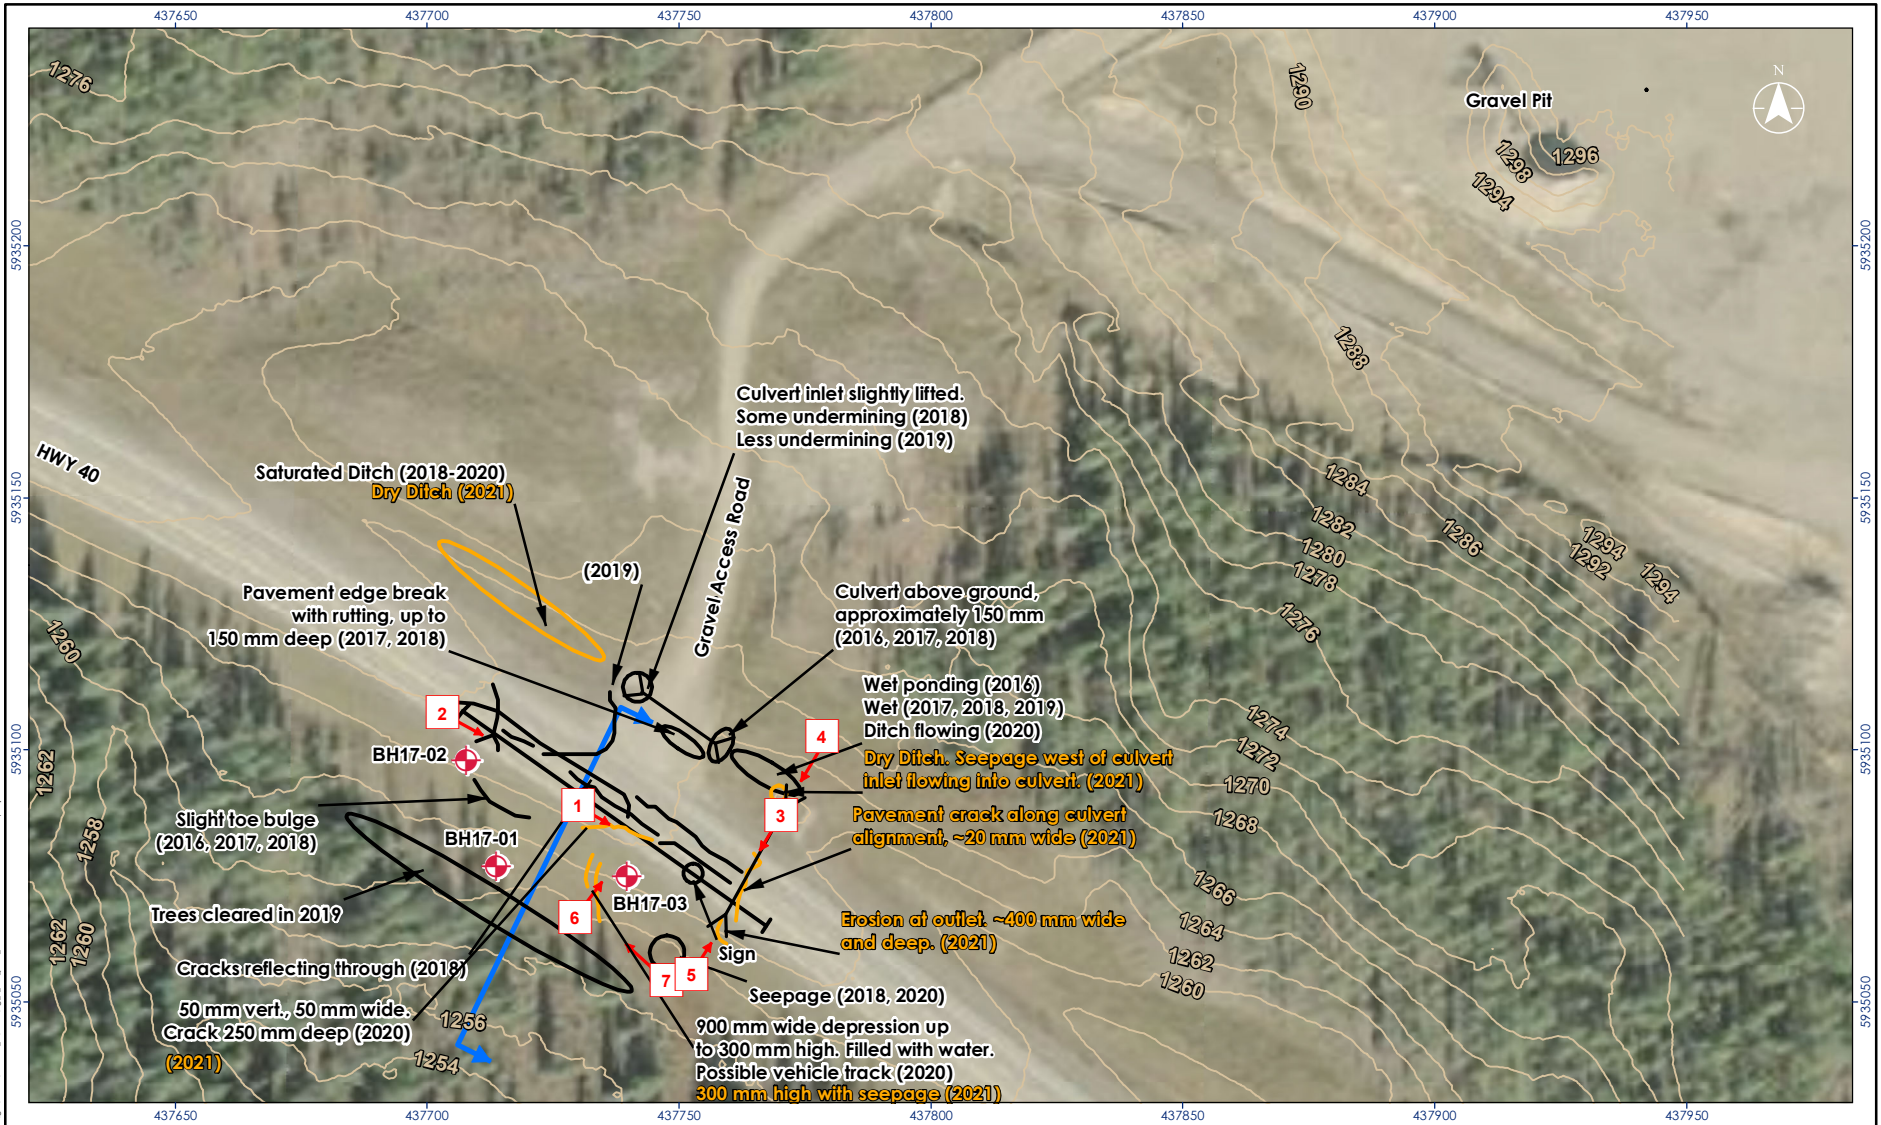
Figure No.
1
 Title
Site Plan

The Fall 2022 reading cycle consisted of instrument readings of three slope inclinometers (SI17-01, SI17-02, and SI17-03) and three vibrating wire piezometers (VW17-01, VW17 02, and VW17-03). **Figure 1** attached provides a schematic of the site. The instruments were read by Sonja Pharand, EIT and Brian Qin, EIT on September 8, 2022.
