SITE NUMBER AND NAME: NC083 – West of Wildhay River	HIGHWAY AND KM: 40:30, km 37.368	PREVIOUS INSPECTION: July 17, 2022	CURRENT INSPECTION: May 30, 2023
LEGAL DESCRIPTION: SE-08-53-27-W5	NAD83 COORDINATES: UTM11U 5935069N, 437757E		RISK ASSESSMENT: PF: 11 CF: 5 Total: 55
AVERAGE ANNUAL DAILY TRAFFIC (AADT): 1,690 (2022)		CONTRACTOR MAINTENANCE AREA (CMA): 508

2023 Site Inspection Photos at NC083

Client/Project: Transportation and Economic Corridors
 Geohazard Monitoring Program
 NC83 – West of Wildhay River

Figure No.: 1
 Title: **Site Plan**

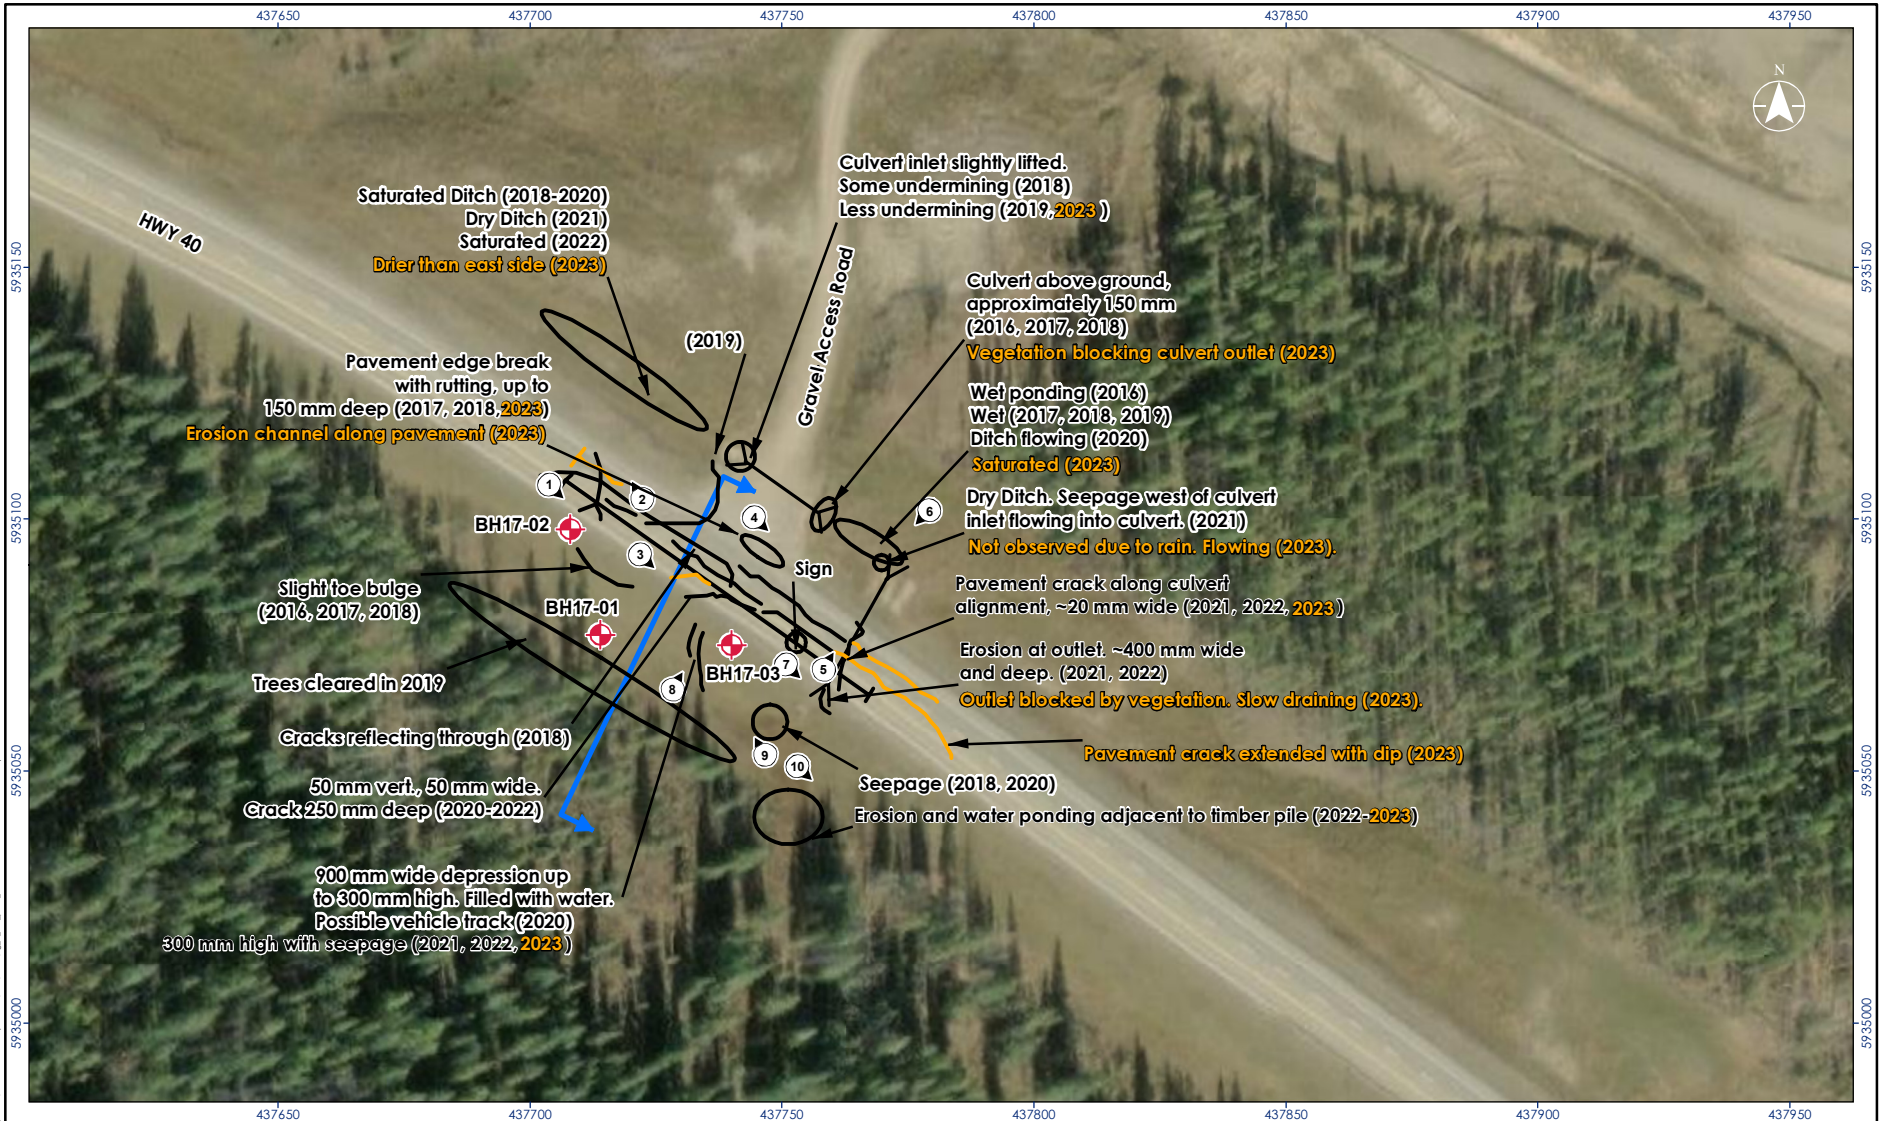
- The south slope appeared to have a “hummocky” appearance and was soft and spongy to traverse (Photo 9).
- Significantly more erosion features with ponded water were observed near the timber stockpile (Photo 10).

Photo 10: Erosion and ponded water in tree clearing area. Looking southeast.
