SITE NUMBER AND NAME: NC081 – Evansburg Slide	HIGHWAY AND KM: 16A:08, km 8.230	PREVIOUS INSPECTION: May 25, 2020	CURRENT INSPECTION: July 14, 2021
LEGAL DESCRIPTION: SW 30-53-07-W5M	NAD83 COORDINATES: UTM11U 5941007N, 630586E		RISK ASSESSMENT: PF: 11 CF: 6 Total: 66
AVERAGE ANNUAL DAILY TRAFFIC (AADT): 790 (2020)		CONTRACTOR MAINTENANCE AREA (CMA): 508

NORTH CENTRAL REGION GRMP
EDSON / STONY PLAIN
SITE INSPECTION FORM

2021 Site Inspection Photos at NC081

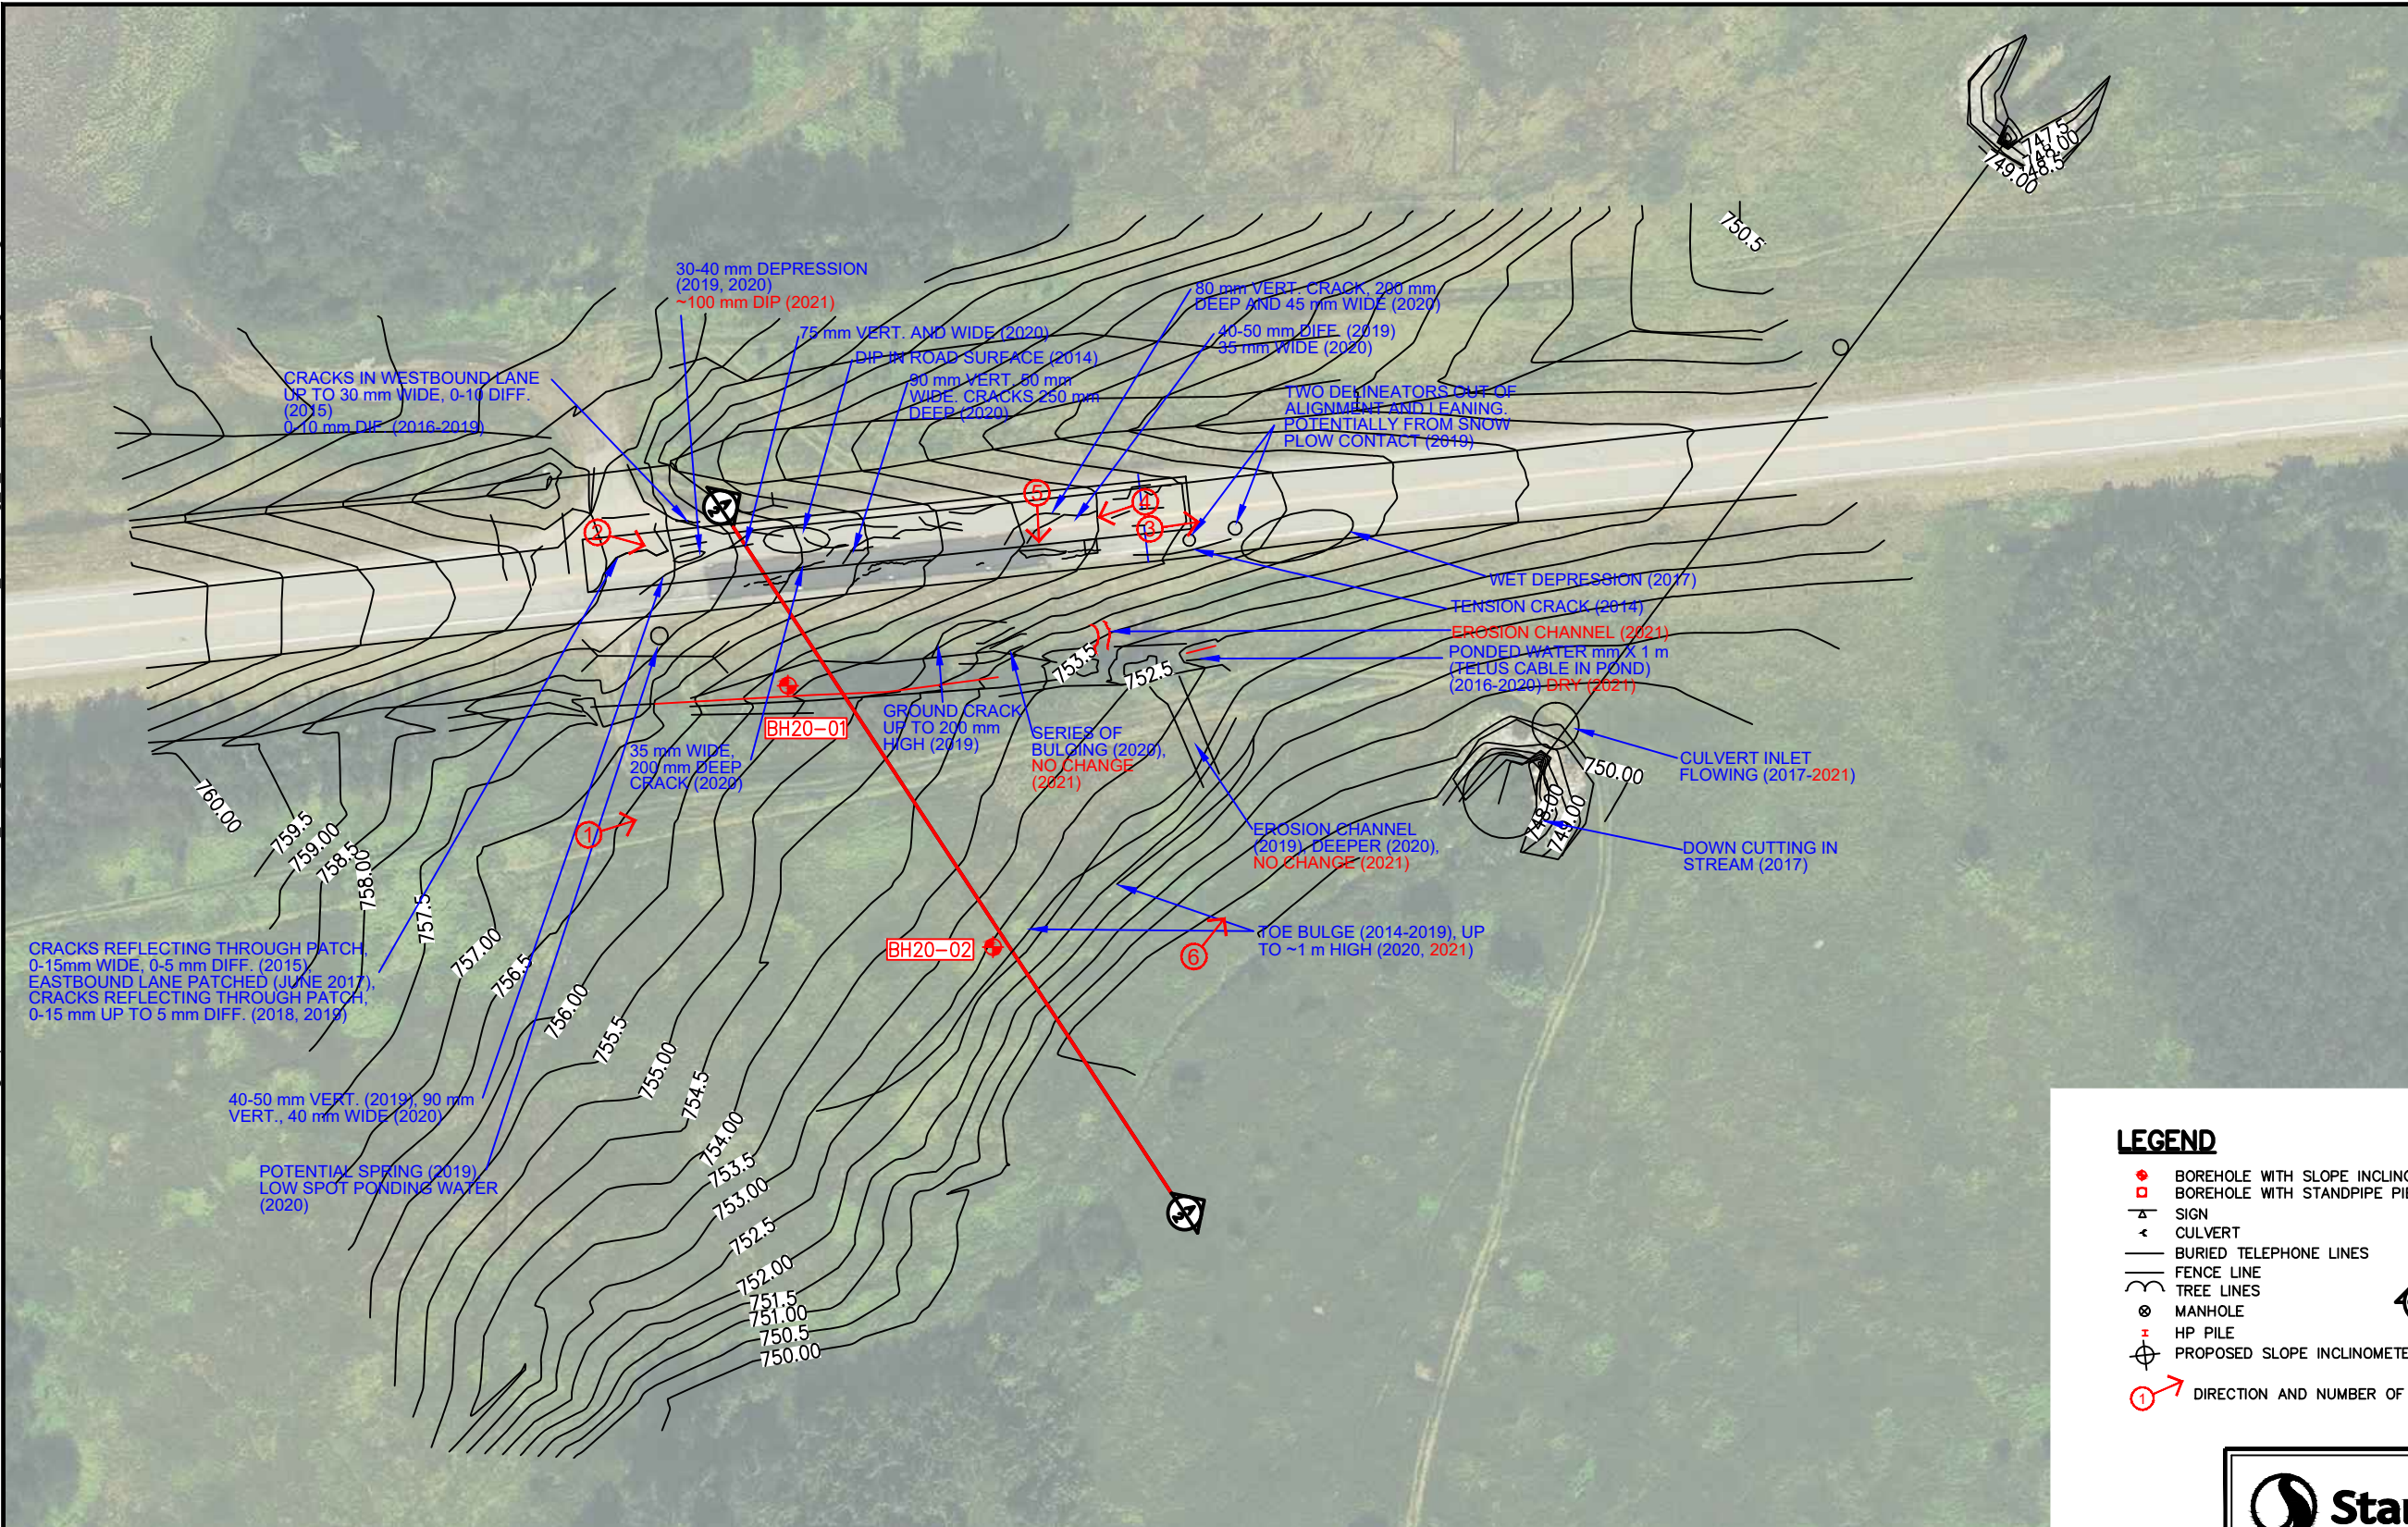
ALBERTA TRANSPORTATION
 GEOHAZARD MONITORING PROGRAM
 NC81 EVANSBURG SLIDE
 SITE PLAN

ITEM	CONDITIONS EXIST		DESCRIPTION AND LOCATION	NOTICEABLE CHANGE FROM LAST INSPECTION	
	YES	NO		YES	NO
Pavement Distress	X		Successive pavement drops within patched area.		X
Slope Movement	X		SI in BH20-01 shows 12 mm movement. Pavement cracks through highway patch. Bulging along south slope near creek.		X
Erosion	X		Upslope from exposed Telus cable at east group of trees on southside of highway.	X	
Seepage		X			
Bridge/Culvert Distress		X

COMMENTS
<ul style="list-style-type: none"> Cracks were reported by the MCI to be about 100 mm wide in the Fall of 2020. An 8 to 10 tonne patch was placed in October to improve the road rideability. An approximately 100 mm dip in pavement was observed on the westbound lane (WBL). The SI installed in BH20-01 recorded about 12 mm of incremental movement at a depth of about 2 m since October 2020 suggesting the landslide is at the clay fill and native clay interface. The SI installed in BH20-02 also showed movement at a depth of about 2 m in the native clay. This movement appears to be localized to the observed toe bulge feature. The piezometers showed a decrease in water level ranging from 1.0 m to 2.0 m. Water levels range from 3.0 m to 4.3 m below ground surface. An exposed Telus cable was observed between the two groups of trees near the fence line. Previously, this cable was observed to be submerged below standing water. However, no water was observed during the current inspection. This may be related to the overall decrease in water level at the site. New erosion channels were observed upslope from the exposed cable.

- The culvert (BF71355) is in good condition and does not appear to be affected by the landslide.
- The erosion channel near BH20-02 was mostly vegetated and appears unchanged.
- No apparent change to the toe bulge was observed.
- The south slope was very well vegetated at the time of inspection and may have obscured some landslide features.
