<b>SITE NUMBER AND NAME:</b> NC081 – Evansburg Slide	<b>HIGHWAY AND KM:</b> 16A:08, km 8.230	<b>PREVIOUS INSPECTION:</b> July 14, 2021	<b>CURRENT INSPECTION:</b> June 16, 2022
<b>LEGAL DESCRIPTION:</b> SW 30-53-07-W5M	<b>NAD83 COORDINATES:</b> UTM11U 5941007N, 630586E		<b>RISK ASSESSMENT:</b> PF: 3 CF: 3 Total: 9
<b>AVERAGE ANNUAL DAILY TRAFFIC (AADT):</b> 850 (2021)		<b>CONTRACTOR MAINTENANCE AREA (CMA):</b> 508

2022 Site Inspection Photos at NC081

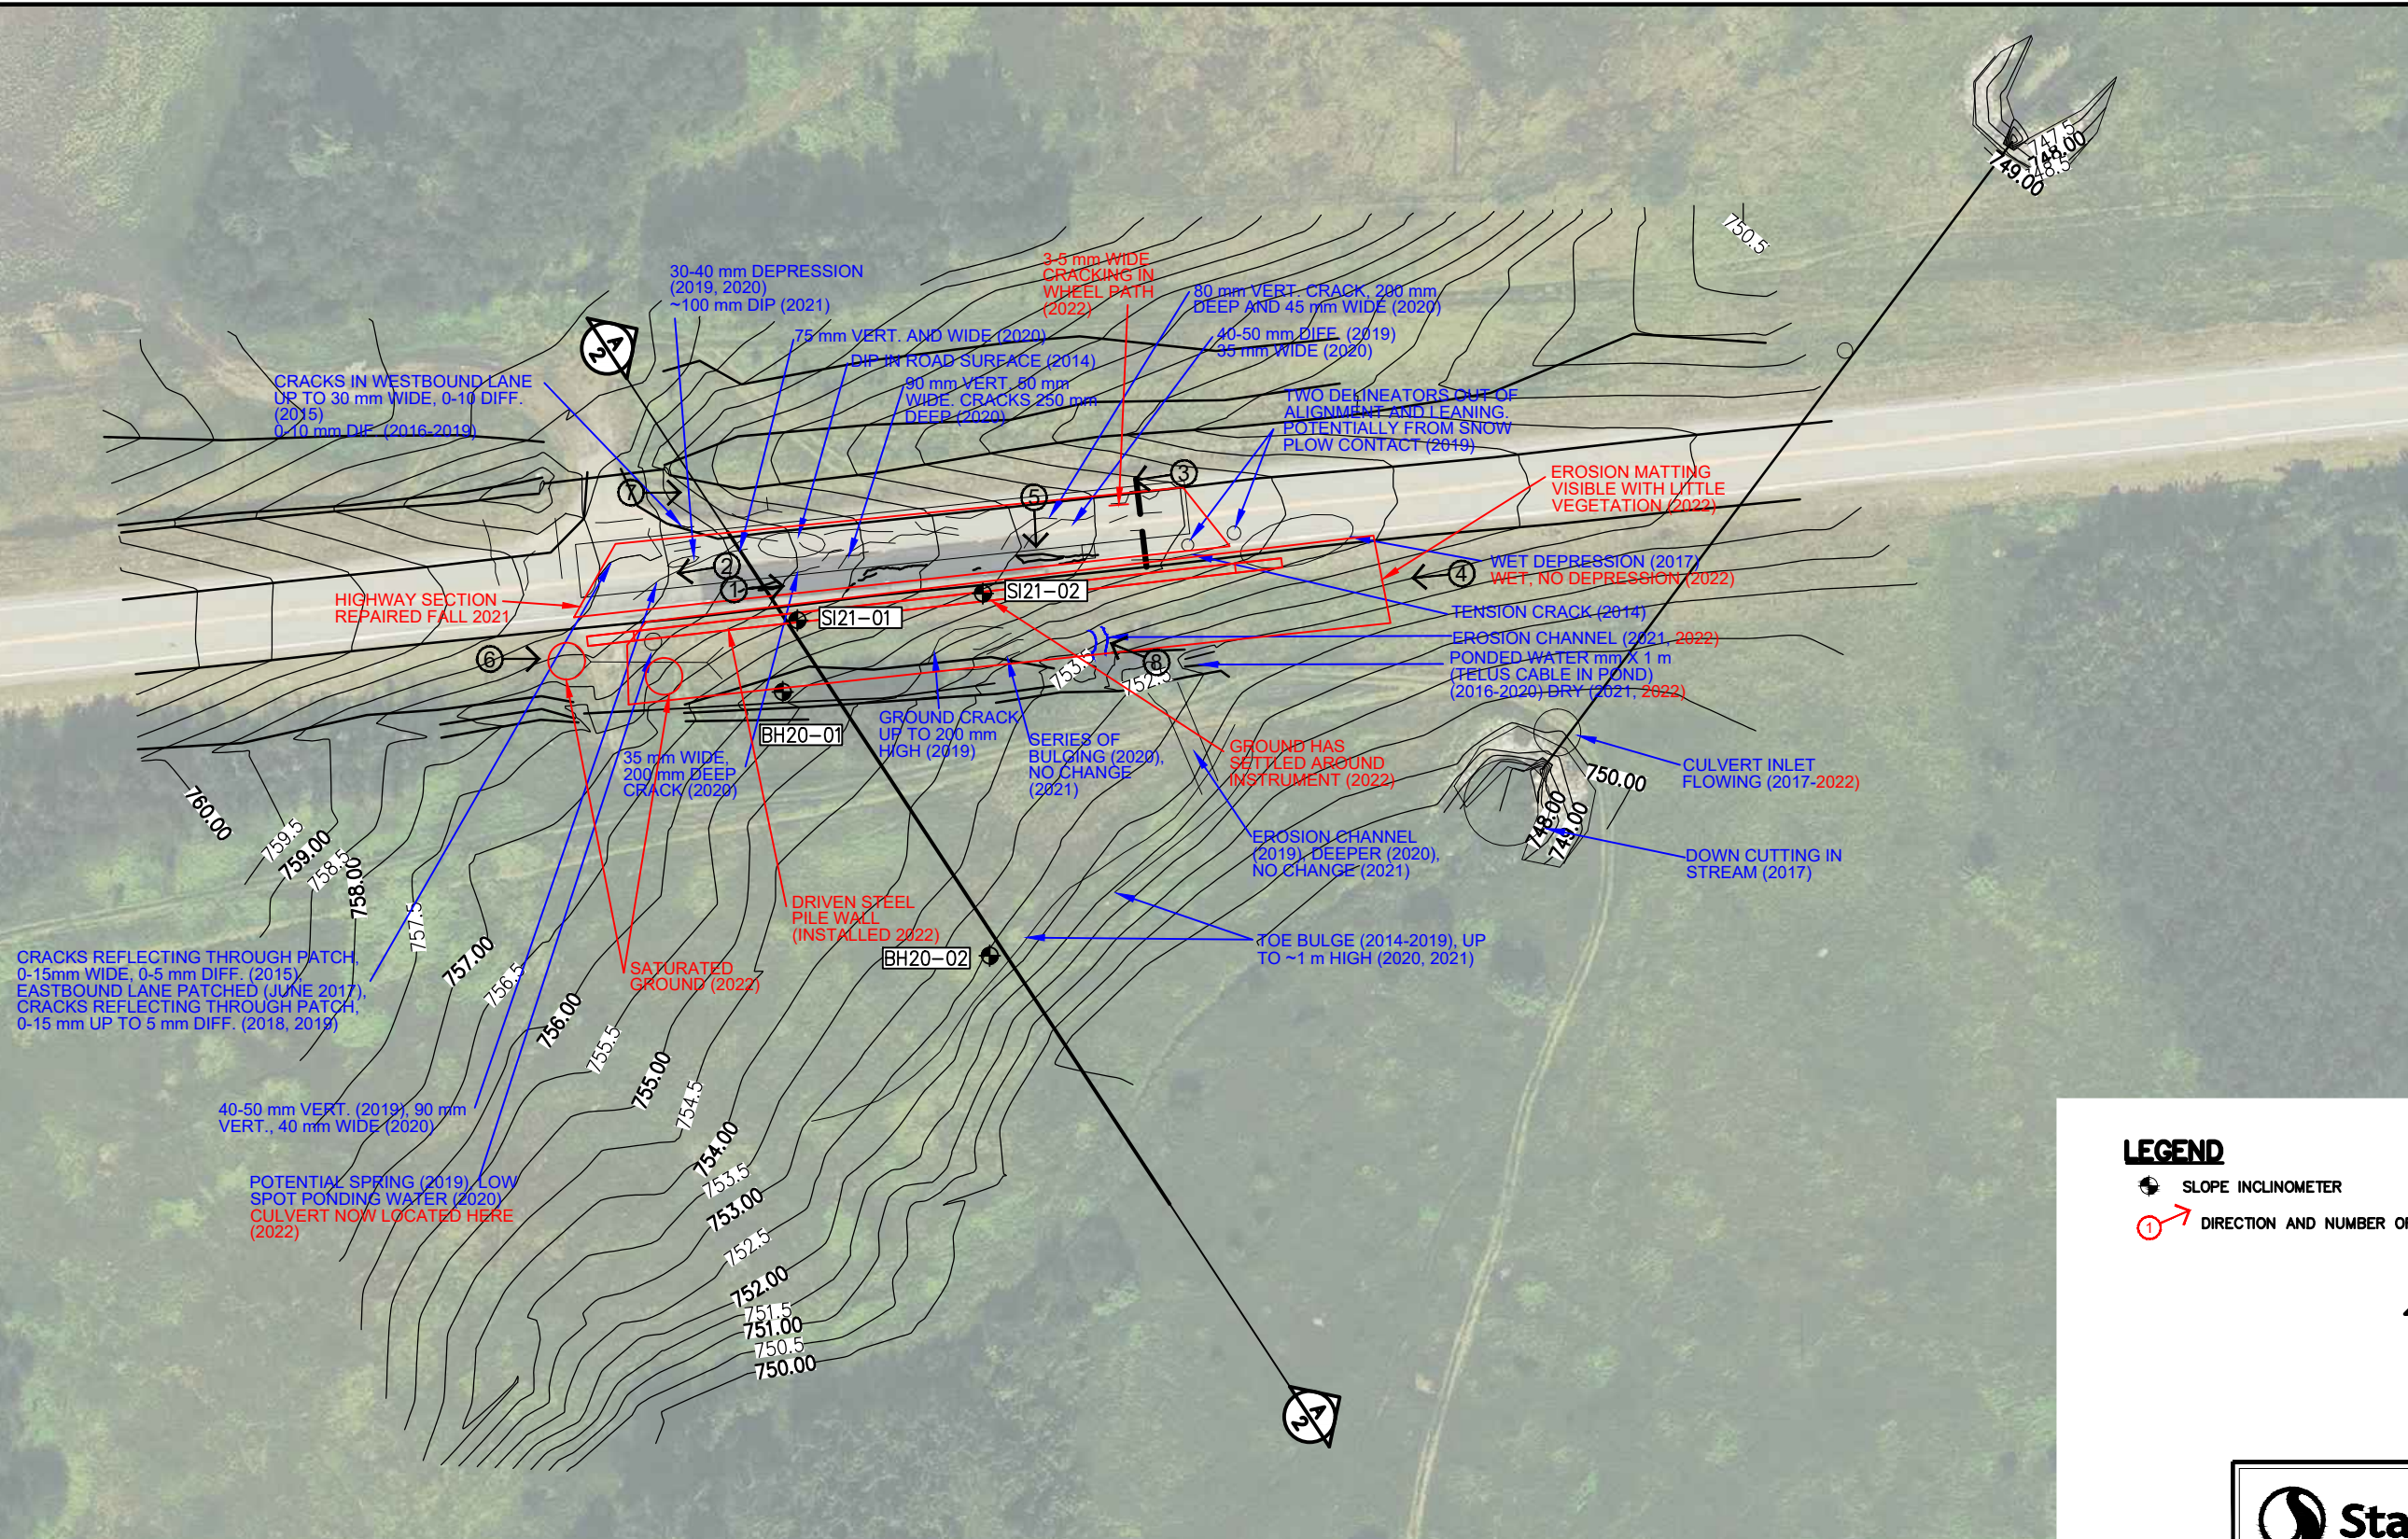
STANTEC CONSULTING 400-10220 103 AVENUE NW EDMONTON, ALBERTA, CANADA T5J 0K4			
		ALBERTA TRANSPORTATION GEOHAZARD MONITORING PROGRAM NC81 EVANSBURG SLIDE SITE PLAN			
DRAWN	KE	CHECK	XL	APPROVE	LC
DATE	04 OCT 2022	SCALE	AS SHOWN	PROJECT #	123315222
FIGURE - 1					-

1. FEATURE LOCATIONS ARE APPROXIMATE.
2. PREVIOUS OBSERVATIONS SHOWN IN BLUE
3. 2022 OBSERVATIONS SHOWN IN RED
