| SITE NUMBER AND NAME: NC081 – Evansburg Slide | HIGHWAY AND KM: 16A:08, km 8.230 | PREVIOUS INSPECTION: June 16, 2022 | CURRENT INSPECTION: June 13, 2024 |

| PRIMARY SITE ISSUE: Shallow slope failure on south side of highway. | |

2024 Site Inspection Photos at NC081

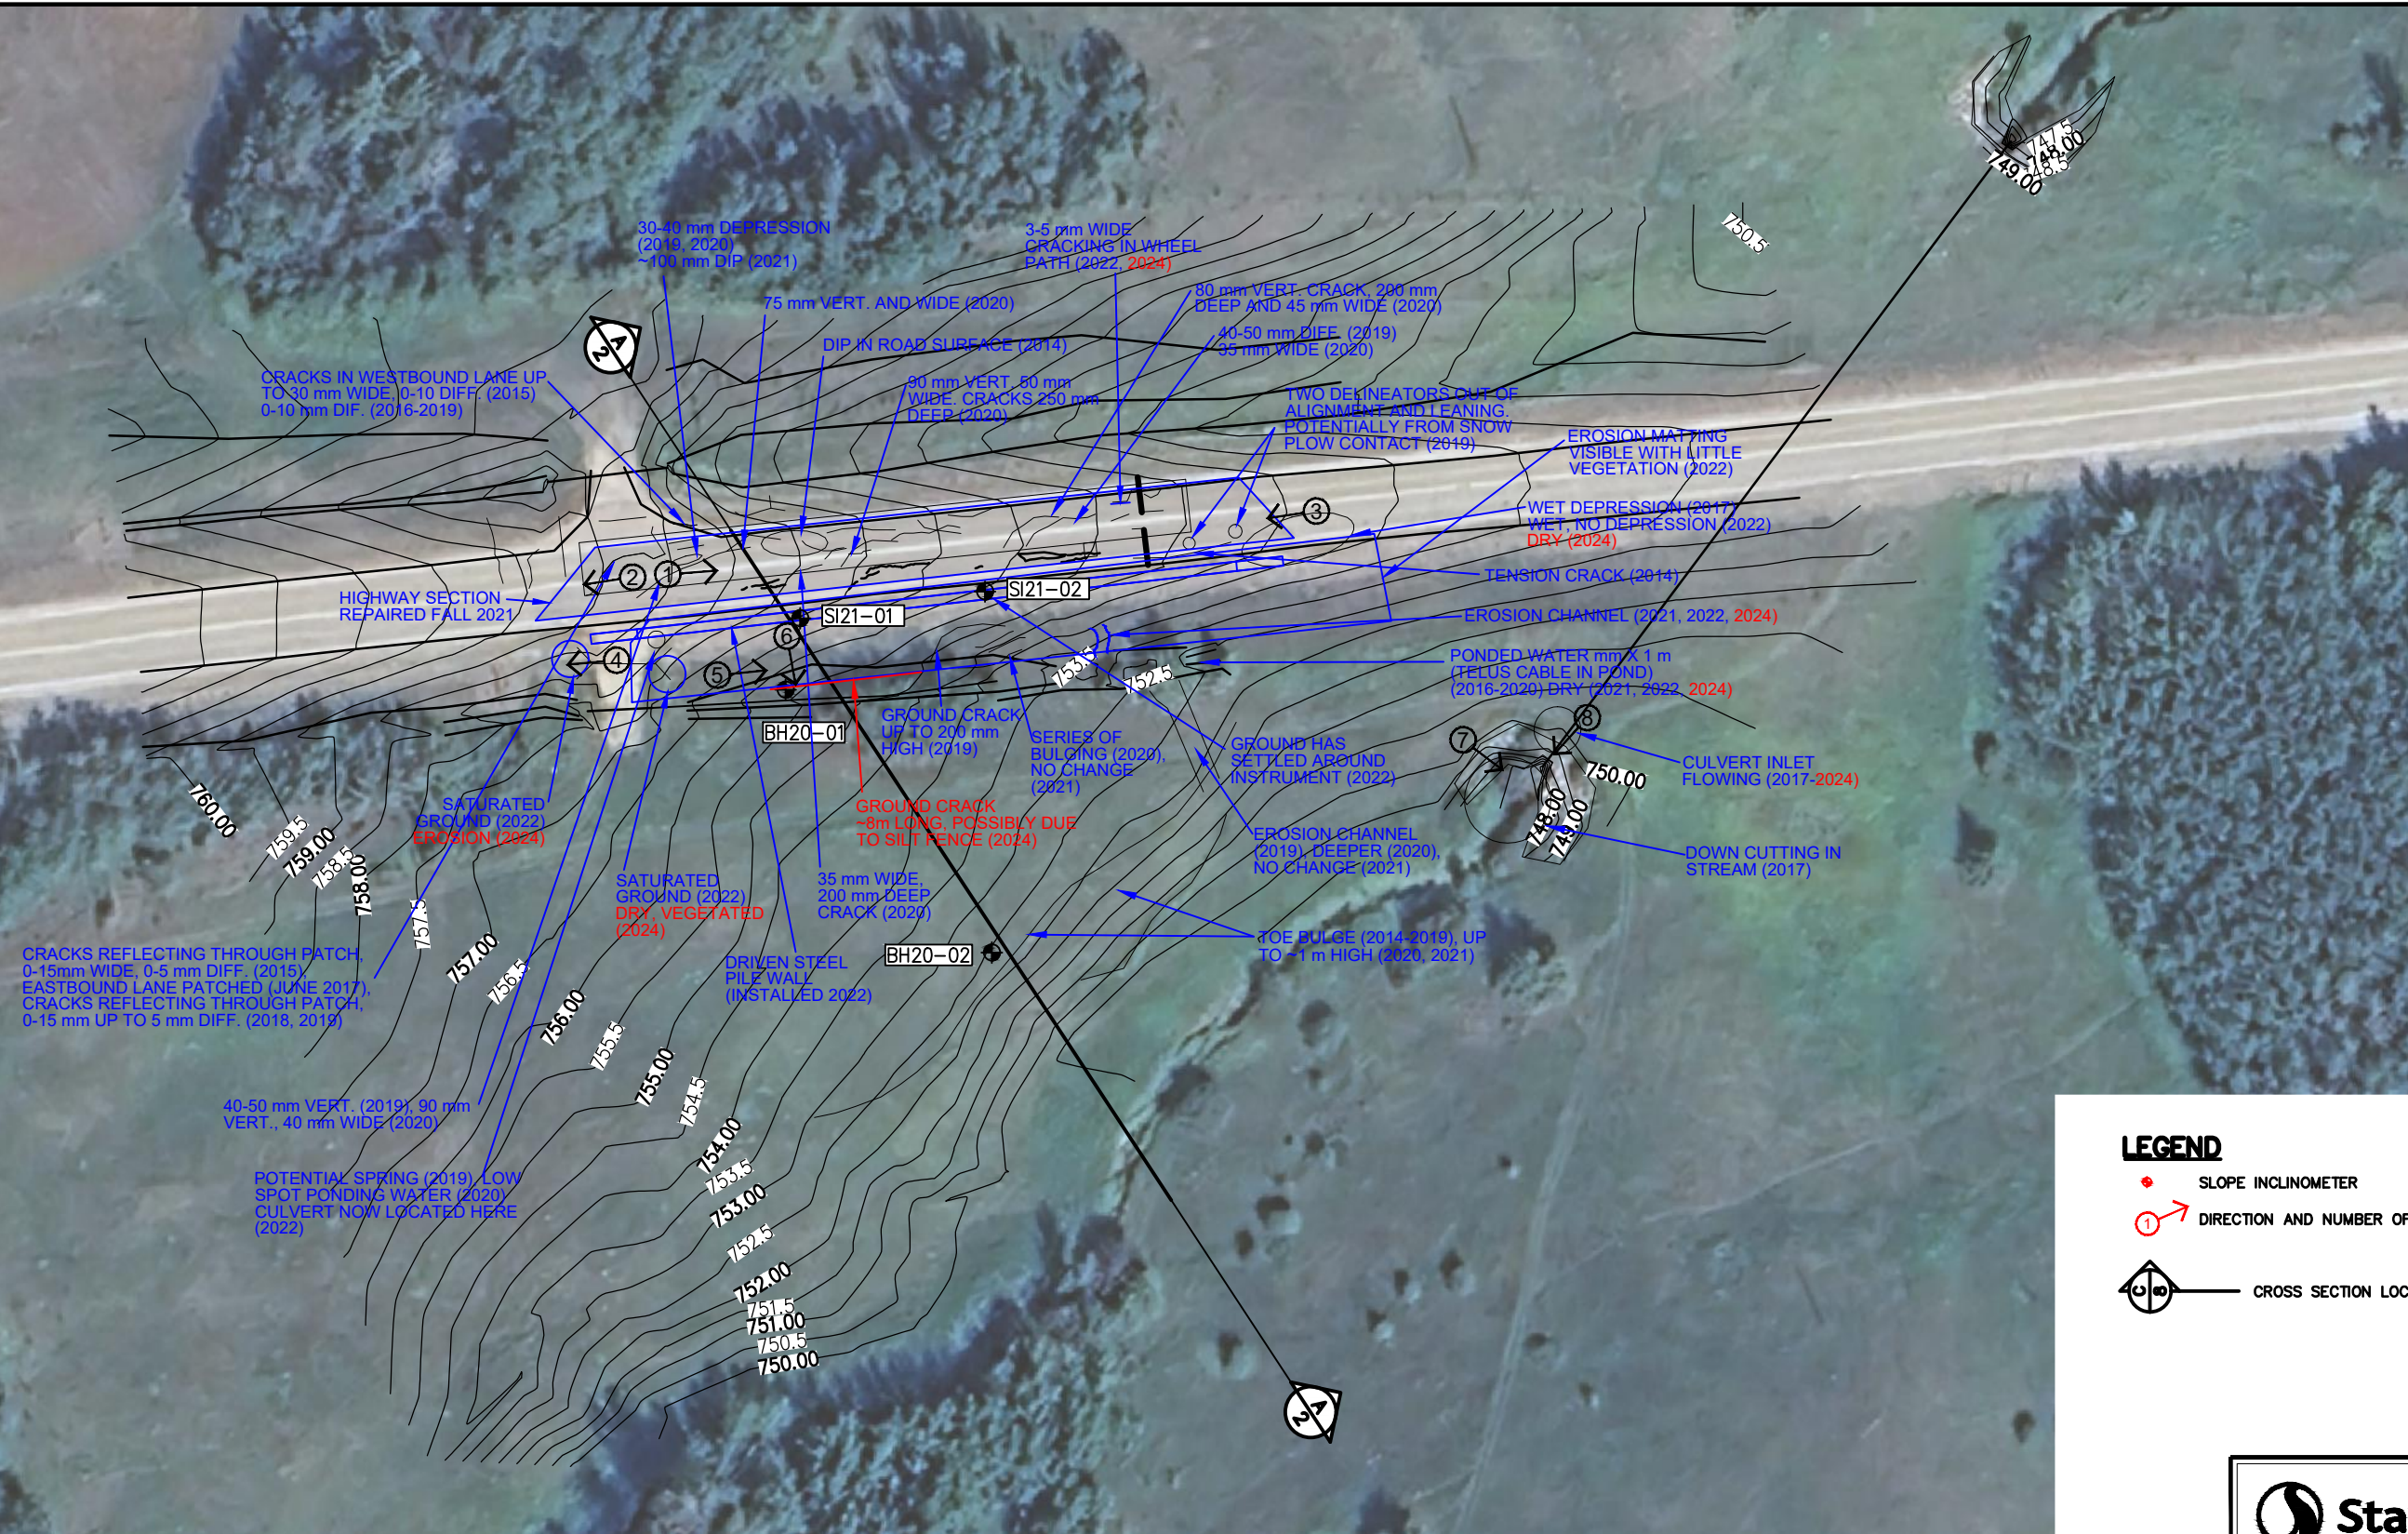
FIGURE - 1

- The south ditch was observed to be dry and well vegetated. A ground crack, approximately 8 m long and 60 mm wide was observed near the south fence line (Photos 5 & 6). This crack may be due to removal of the silt fencing that was observed in 2022.
- The culvert (BF71355) is in good condition and does not appear to have been affected by the landslide or construction (Photos 7 & 8).
- The erosion channel near BH20-02 was mostly vegetated and appears unchanged since 2022.
- The south slope beyond the tree line was very well vegetated at the time of inspection and may have obscured some landslide features.

- Pavement cracks should be monitored by the MCI and sealed to prevent water infiltration into the embankment and pavement structure.
- The ground crack along the fence line should be regraded to prevent water infiltration into the embankment.
- The MCI should continue to monitor the culverts on a regular basis to ensure they are free flowing to reduce surface water penetration of the embankment and pavement structure.
- The site inspection frequency can be reduced given installation of the pile wall and re-vegetation of the slopes. An inspection frequency of once per contract cycle is recommended.
- Instrumentation monitoring should continue to be completed twice annually in the spring and fall.
