SITE NUMBER AND NAME: NC109 - Highway 734 North of BF77316	LOCATION: On Highway 734, about 200 m north of BF 77316	HIGHWAY: 734:22	KM: 27.257
LEGAL DESCRIPTION: NW-16-45-18-W5	NAD83 COORDINATES: UTM11U 5859050 N, 529722 E		
AVERAGE ANNUAL DAILY TRAFFIC (AADT): 130 (2022)		CONTRACTOR MAINTENANCE AREA (CMA): 508

PRIMARY SITE ISSUE: Washed-out northbound lane (NBL) of highway
APPROXIMATE DIMENSIONS: 15 m long by 3 m wide
<p>SITE BACKGROUND AND HISTORY:</p> <p>A call-out inspection was conducted by Thurber Engineering Ltd. (2003). Background information obtained by Thurber included:</p> <ul style="list-style-type: none"> • Highway 734:22 was first constructed in 1970s as a gravel surfaced road. • Erosion of the west ditch from about 100 m to 350 m north of the bridge has been occurring during periods of high precipitation. Stantec estimates this to be in the same area as the current call-out inspection. • Silt and sediment have been entering the stream downslope of the road and may impact the Brazeau River. • The road fill extending from 100 m to 350 m north of the bridge is steeply inclined and exhibits signs of settlement, shallow soil slides, and gully erosion associated with a cul

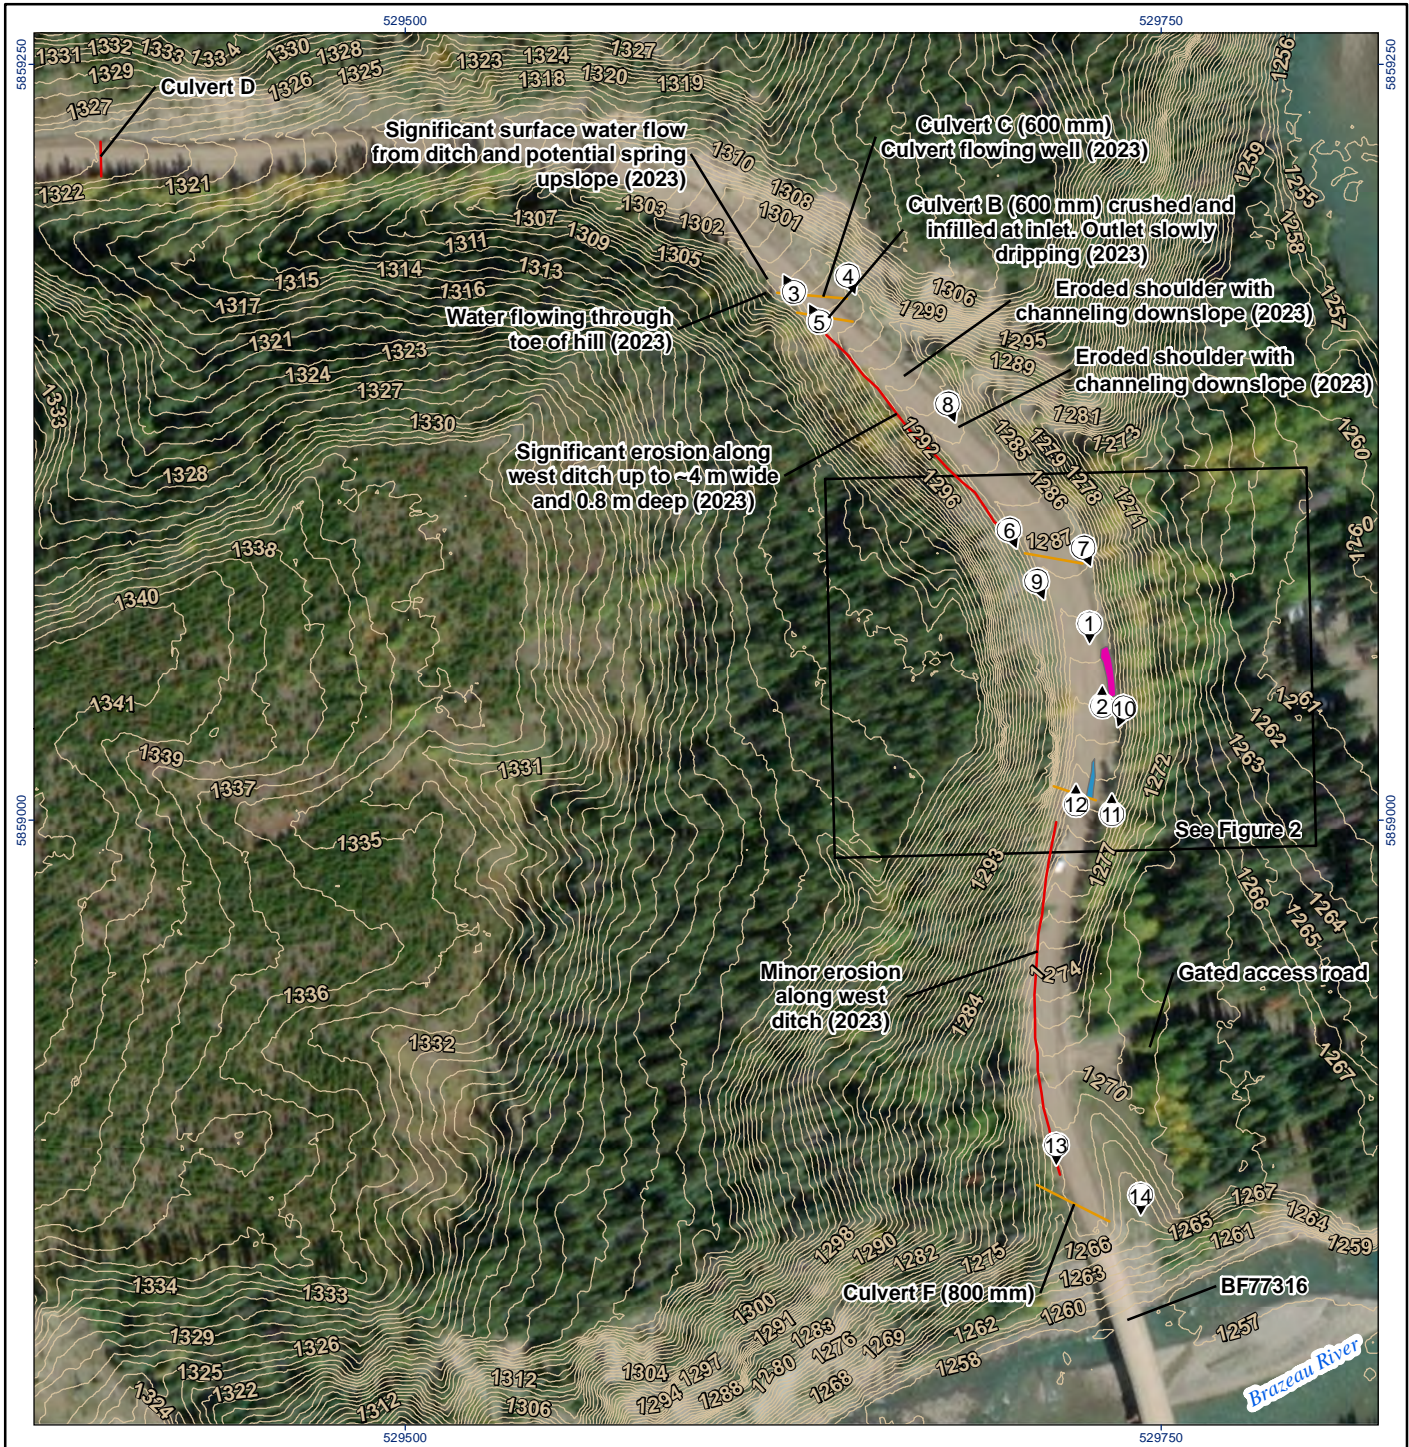
- A fifth culvert (Culvert F, 800 mm dia.) was observed just north of BF77316. This culvert appeared to be in good condition (Photos 13 and 14).
- Based on the site history, there appears to be a history of surface water issues (icing and erosion).

Photo 14: Culvert F discharging near Brazeau River. Note sediment buildup at beveled end. Looking south.

- All culverts should be inspected to maintain functionality. Damaged culverts should be replaced. The hole in the 450 mm dia. culvert should be repaired or covered to enhance motorist safety.
