SITE NUMBER AND NAME: NC109 – Highway 734 North of BF77316	HIGHWAY AND KM: 734:22, km 27.437	PREVIOUS INSPECTION: June 2, 2023	CURRENT INSPECTION: June 12, 2024
LEGAL DESCRIPTION: NW-16-45-18-W5	NAD83 COORDINATES: UTM11U 5859050 N, 529722 E		RISK ASSESSMENT: PF: 6 CF: 3 Total: 18
AVERAGE ANNUAL DAILY TRAFFIC (AADT): 40 (2023)		CONTRACTOR MAINTENANCE AREA (CMA): 508

Client/Project
Alberta Transportation and Economic Corridors
Geohazard Monitoring Program,
NC109 Highway 734:22

2024 Inspection Photos at NC109

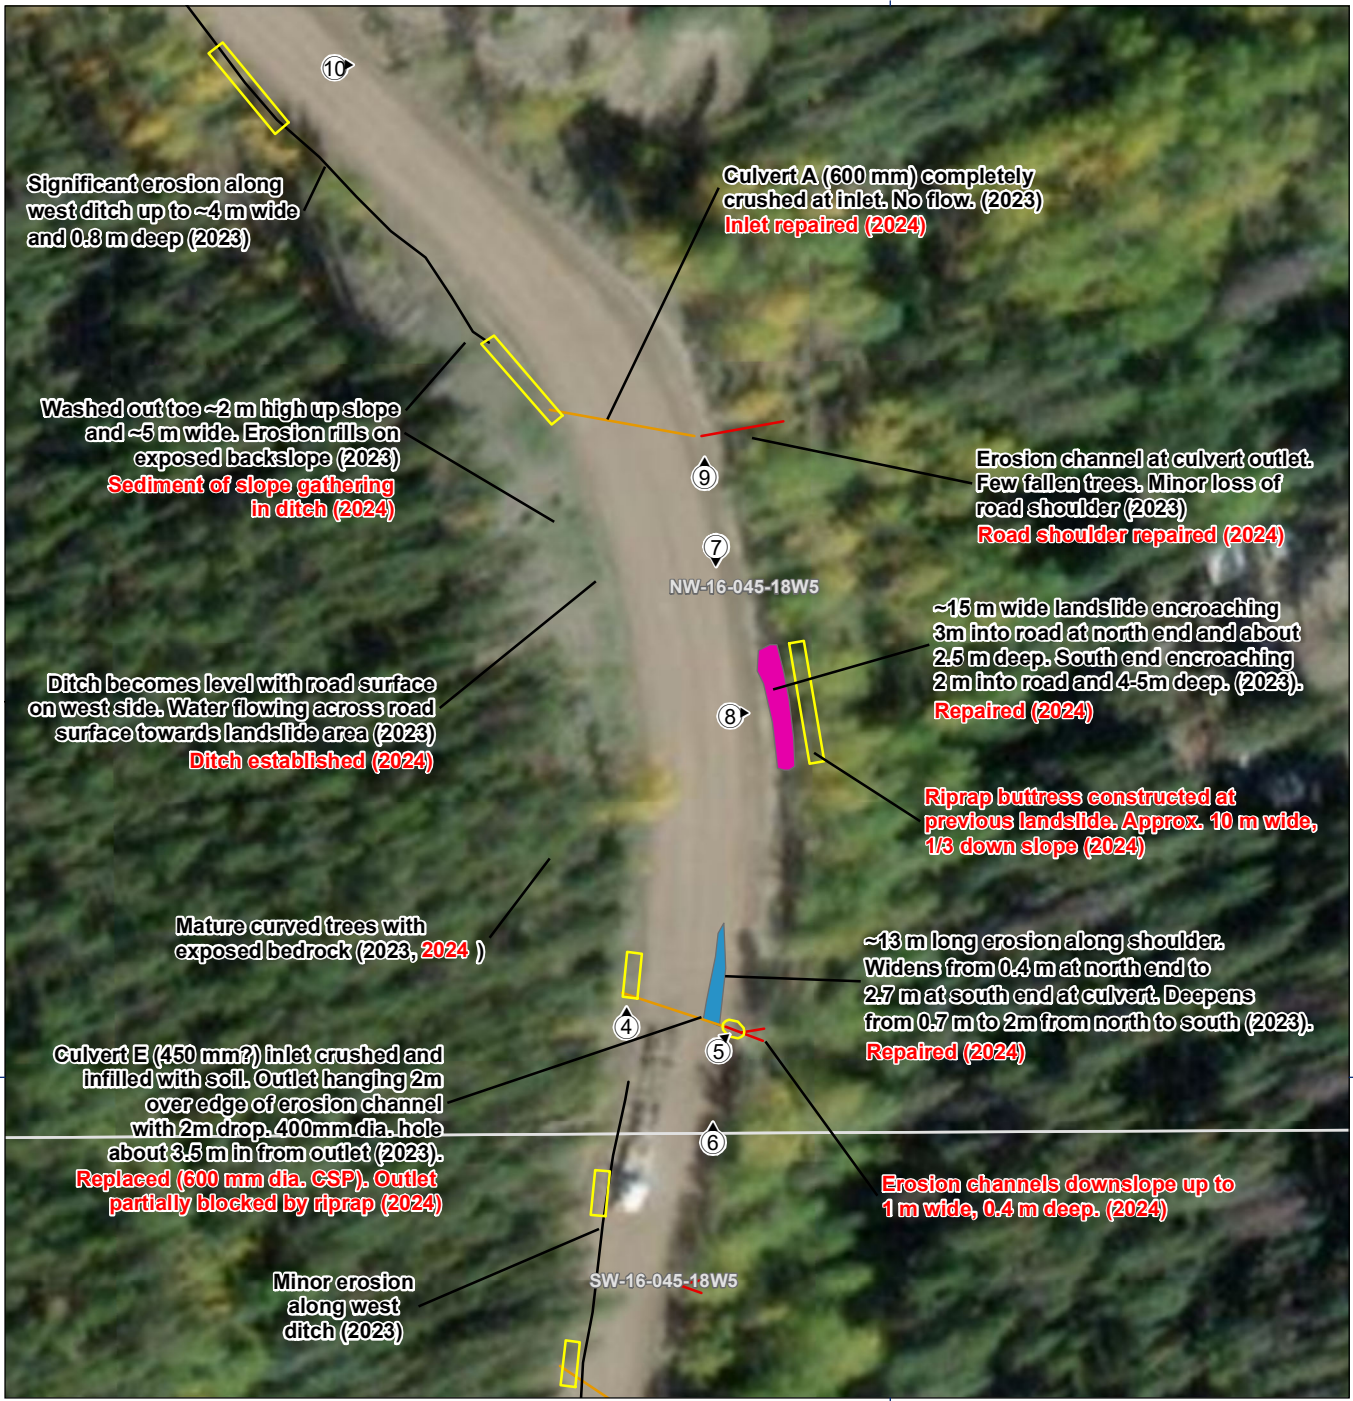
Title
Landslide Area

- A Probability Factor of 6 has been selected since the highway embankment slide is considered inactive after repairs, with a moderate probability of remobilization. Due to the presence of cuts and fills, active erosion and sedimentation, and the previous loss of a portion of the NBL, a Consequence Factor of 3 was assessed.

- Use of the area at the southeast toe should be restricted to reduce the risk to public safety.
- All culverts should be inspected regularly to maintain functionality. Damaged culverts should be replaced, and inlets/outlets should be cleaned out. Additional riprap could be placed at the outlets of the culverts to reduce further erosion of the embankment.
- Given the icing concerns noted in the history of the site, guardrails could be installed around the bend to enhance public safety.
- Erosion gullies should be repaired by backfilling with similar soils to reinstate the grade and placing riprap at eroded locations for protection against further erosion.

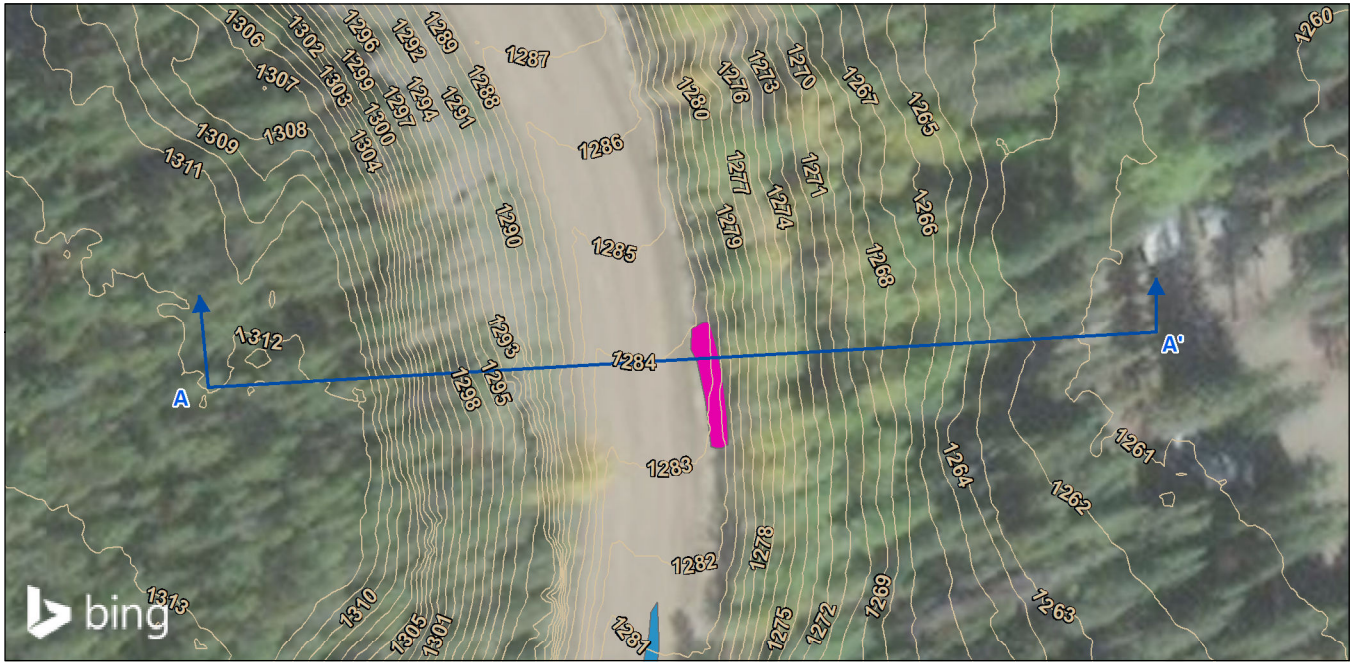
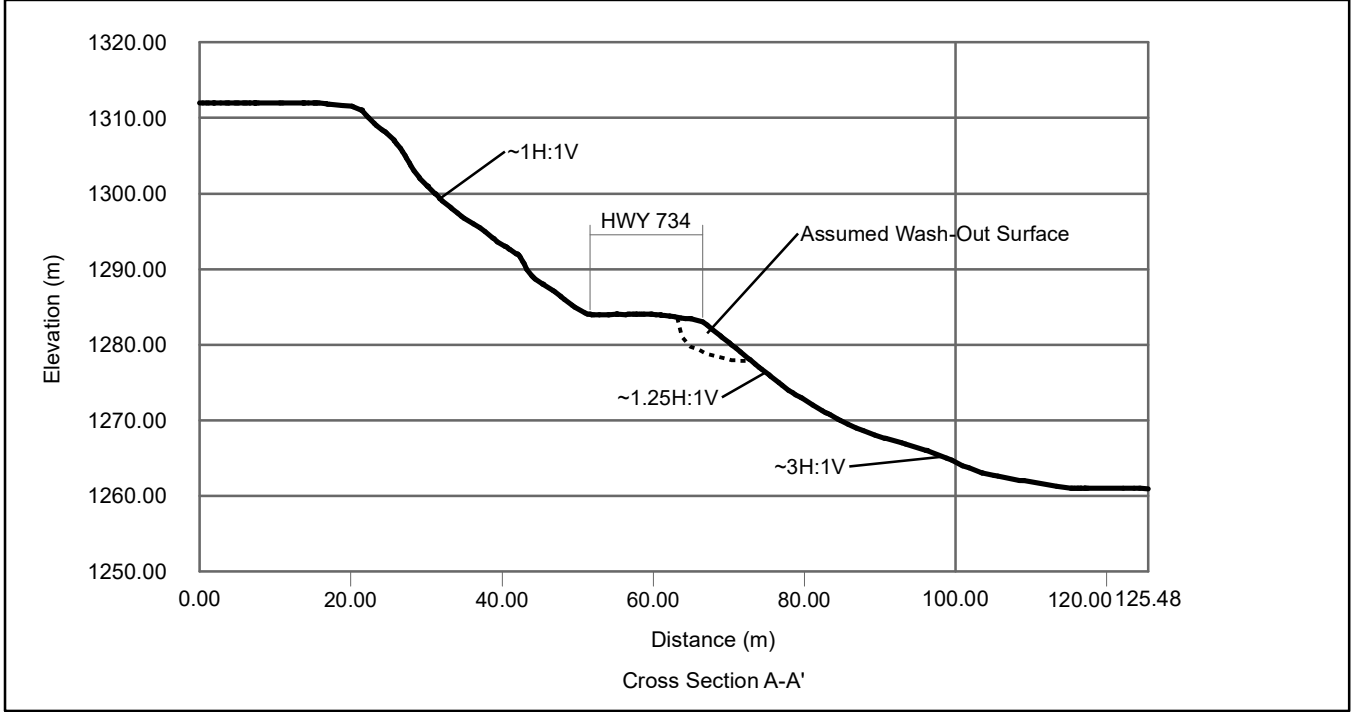
- ↔ Cross Section
- Ground Elevation Contours (m) (2012 LiDAR)
- 2023 Landslide Area
- 2023 Eroded Shoulder
